**TEN-YEAR PERFORMANCE OF DOWEL BAR RETROFIT –
APPLICATION, PERFORMANCE, AND LESSONS LEARNED**

For presentation at the
2003 TRB Annual Meeting
Prepared July 2002

TEN-YEAR PERFORMANCE OF DOWEL BAR RETROFIT – APPLICATION, PERFORMANCE, AND LESSONS LEARNED

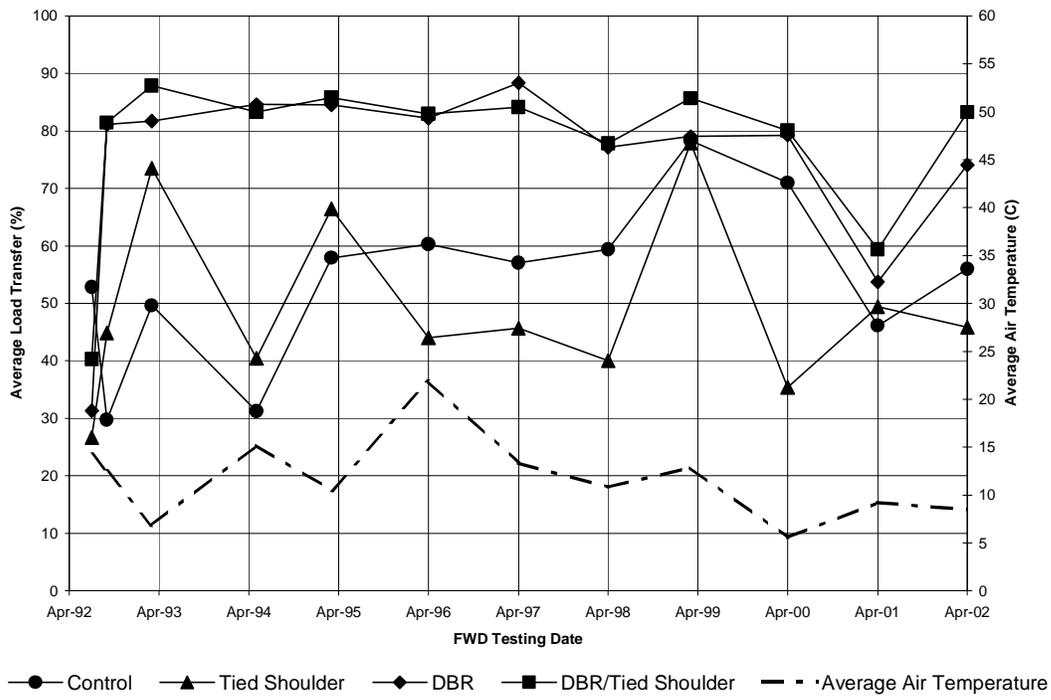
In summary, the experimental features that contain retrofitted dowel bars, have maintained an average joint load transfer between 70 to 90 percent over the last 10 years, excluding anomalies. In addition, the dowel bar retrofit sections have the following joint faulting measurements:

As can be seen in Figure 3, there are several locations where the average load transfer changes dramatically from one year to the next (for instance in 1995 and 1999 for the control and tied shoulder sections, and in 2001 for both of the dowel bar retrofitted sections). These changes do not appear to correlate with the air temperature during the time of FWD testing, however, the test section is located in an area subjected to significant freeze/thaw effects. Since the FWD testing is conducted during the spring of each year, these changes are related to the effects of spring thaw rather than air temperature.

FIGURE 3 Average load transfer analysis.

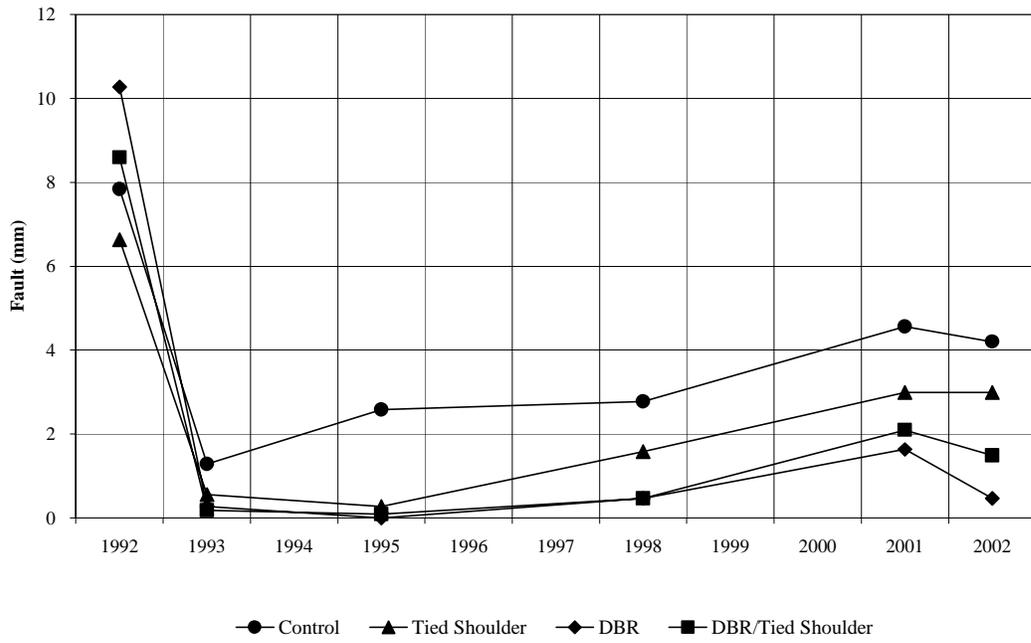
- 25 joints have no faulting,
- 16 joints with 1.6 mm (1/16 inch) faulting, and
- 7 joints with 3.2 mm (1/8 inch) faulting

- 3 joints with 1.6 mm (1/16 inch) faulting,
- 14 joints with 3.2 mm (1/8 inch) faulting, and
- 5 joints with 4.8 mm (3/16 inch) faulting

- 4 joints with no faulting,
- 1 joint with 1.6 mm (1/16 inch) faulting,
- 8 joints with 3.2 mm (1/8 inch) faulting,
- 8 joints with 4.8 mm (3/16 inch) faulting, and
- 2 joints with 6.4 mm (1/4 inch) faulting

FIGURE 4 Average fault measurements.

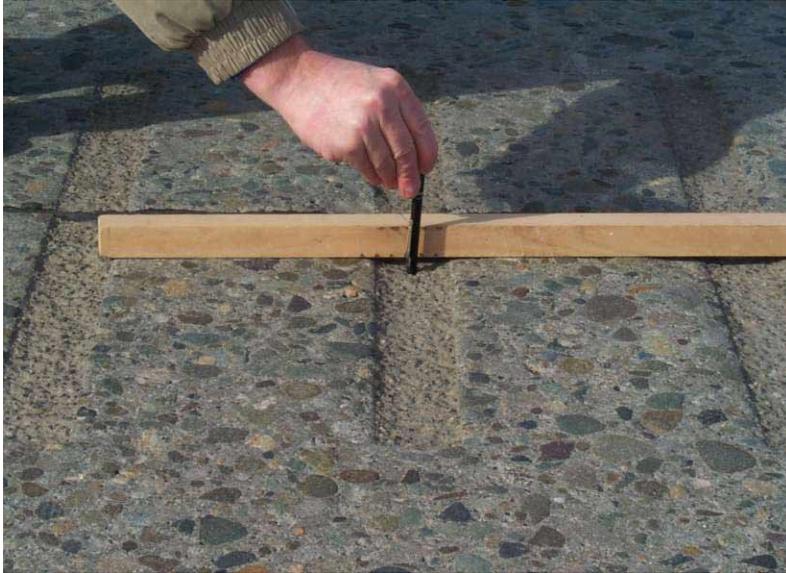
This type of distress (Figure 5) was common on the first two projects, with the majority of the dowel bar slots exhibiting accelerated wear. The primary cause of the slot wear was due to the use of studded tires and chains in this area of Washington state (vicinity of Snoqualmie Pass) and an insufficient quantity of large stone aggregate. To reduce surface wear, WSDOT modified the aggregate size in the patching material from AASHTO Grading No. 57 (7) to AASHTO Grading No. 7. This change occurred in 1997, and since that time, no appreciable wear has occurred on any of the dowel bar slots.

FIGURE 5 Example of accelerated wearing of grout in dowel bar slot.

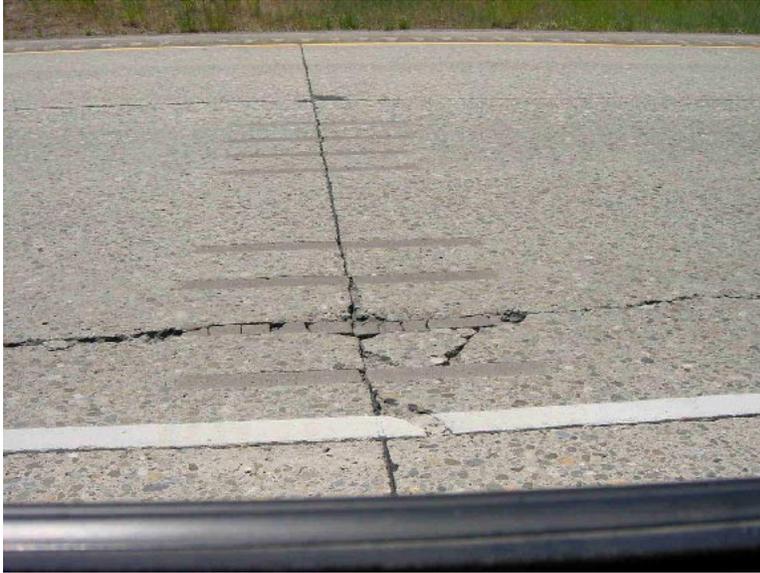
Existing longitudinal cracks that intersect dowel bar slots (Figure 6) have caused isolated problems on several projects. This problem occurs when a dowel bar slot is located over an existing longitudinal crack. The failure mechanism is typically the debonding of the pour back material from the walls of sawed slots. To eliminate this distress, WSDOT recommends either aligning the slots to miss any existing longitudinal cracks or by not placing a dowel bar in this location.

FIGURE 6 Longitudinal cracking in dowel bar slots.

- Slots should be aligned to miss existing longitudinal cracks.
- For ease of construction when gang saws are used, slots may be sawed but not retrofitted to miss any existing longitudinal crack. Non-retrofitted saw cuts should be cleaned and sealed with an epoxy resin.

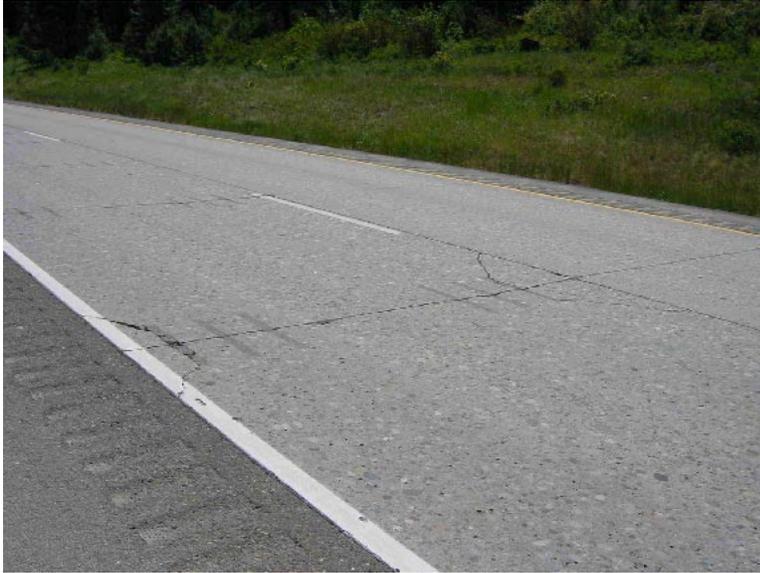
Normally, 45-degree cracking is not seen on WSDOT dowel bar retrofit projects, however, several hundred instances (Figure 7) of this distress were found on an eight-kilometer (five-mile) section. A forensic investigation was conducted to determine the cause(s) of the 45-degree cracking. The results of this investigation determined the following causes:

- The slots were cut too deep causing cracking in the bottom of the dowel bar slot and placement of the dowel bar below the mid depth of the slab. Cores showed that slots were cut up to 178 mm (7 inch) deep on a 230 mm (9 inch) slab.
- Heavy (27 kg (60 lb)) jackhammers were used for concrete removal. Heavy jackhammers can punch through the bottom of slots during concrete removal.

FIGURE 7 45-degree cracking.

As a result of these findings, WSDOT revised the dowel bar retrofit special provision to prohibit the use of any jackhammer greater than 14 kg (30 lb) and to ensure dowels are placed at mid depth of the concrete slab.

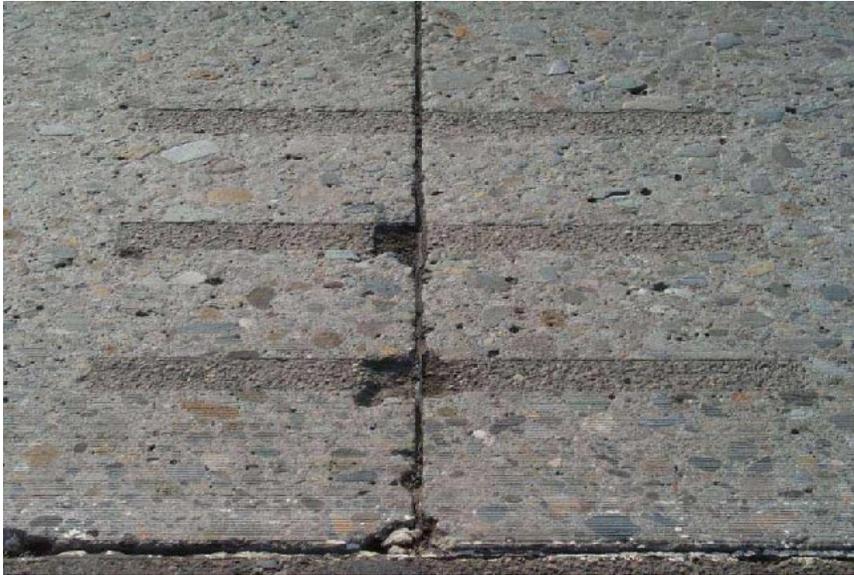
Spalling is another common, but infrequent, distress (Figure 8). Approximately 19 joints per kilometer (12 joints per mile) are typically affected. In most cases, spalling is caused by the misalignment of the core board.

FIGURE 8 Joint spalling due to misaligned core board.

- The core board that is positioned on the dowel bar is used to ensure that a joint is formed directly in line with the existing joint and to allow for the expansion of the pour back material. The core board (closed cell foam with plastic or poster board faced material) should be of sufficient quality to allow a tight fit to all edges of the slot during placement of the pour back material. Care should be given to ensure the core board extends beneath the dowel bar to the slot bottom.

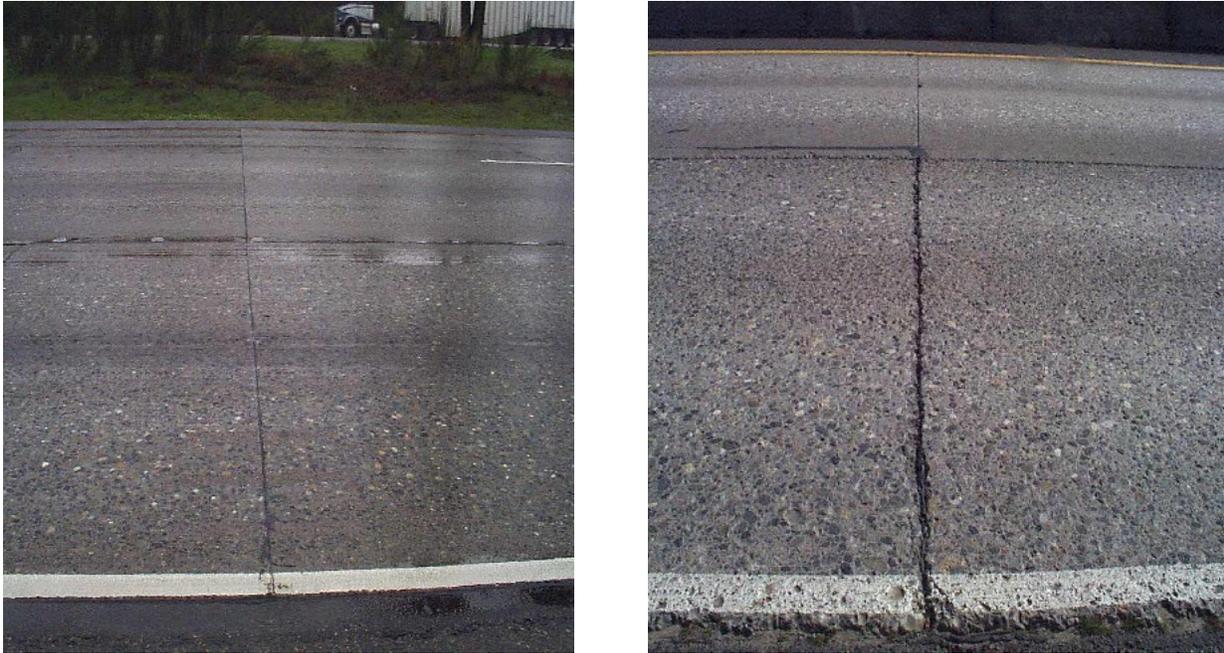
The use of a roto-mill machine (using a triple head carbide mandrel) for re-establishing PCC pavement ride and texture has been suggested on a number of dowel bar retrofit projects in Washington state. This treatment has been evaluated on two separate projects, with similar results. As shown in Figure 9a, the diamond ground surface (diamond ground in 1995, photo taken in 1998) shows no damage to the transverse or longitudinal joint. While the amount of spalling that occurs on the transverse joint with the roto-milled surface, shown in Figure 9b, (roto-milled in 1996, photo taken in 1998) is unacceptable for long-term performance. In the roto-milled surface photo, the right lane (in the foreground) was roto-milled while the adjacent lane (in the background) received no treatment. As can be seen, the roto-milling process causes significant joint spalling. Over time, typically 3 to 5 years, the roto-milled surface develops an unacceptable ride. Therefore, due to the poor performance and the high risk of distress that occurs in the longitudinal and transverse joints (and potential damage to the dowel bar slots), roto-milling of PCC pavements is not a viable treatment.

FIGURE 9(a) and (b) Surface texture for diamond grinding and roto-milling.

Restoration of the surface should be done by diamond grinding. Diamond grinding cuts into the concrete aggregate to improve the surface and ride. Use of a roto-milling machine impacts the surface and results in the “popping” out of aggregate rather than cutting it. The roto-milling process causes significant damage to the joint.
