# **Northeast Bridge Preservation Partnership Meeting**

## **Superstructure Preservation Strategies**

**Aetna Viaduct Superstructure Repairs  
Route I-84 – City of Hartford, CT  
State Project No. 63-648**

**David A. Cutler, P.E.  
Supervising Engineer  
Consultant Design - Bridge**

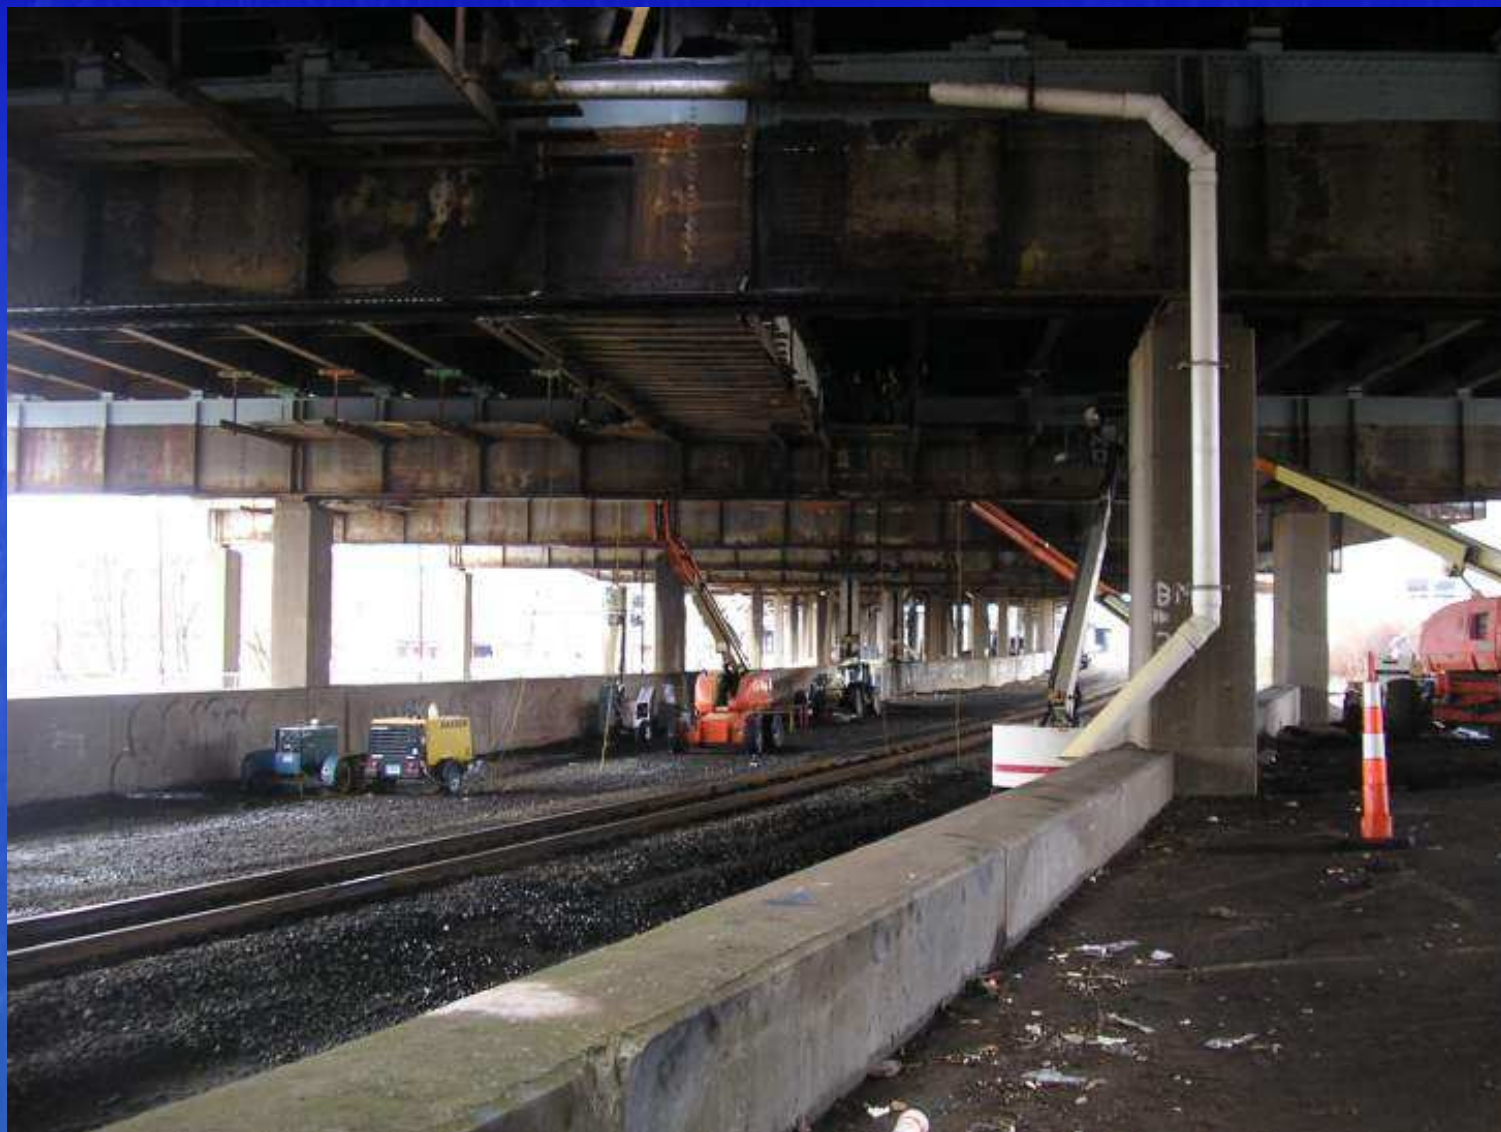
# ML30B Work Area

- **After supplemental inspection of spans over Amtrak, Pier Cap ML30B had a negative inventory load rating**
- **Top flange width to thickness ratio controls**
- **Top flange width assumed to be distance between webs**
- **Also checked using top flange width measured between rivet lines (probably more realistic)**
- **Inventory rating less than 36 Tons**

- **Wednesday design meeting – Restrict Permit Loads**
- **Thursday meeting with Contractor**
- **Designer expedited shop drawing review**
- **Contractor used on-hand material to start immediately and worked through the weekend**
- **Repair complete early next week**

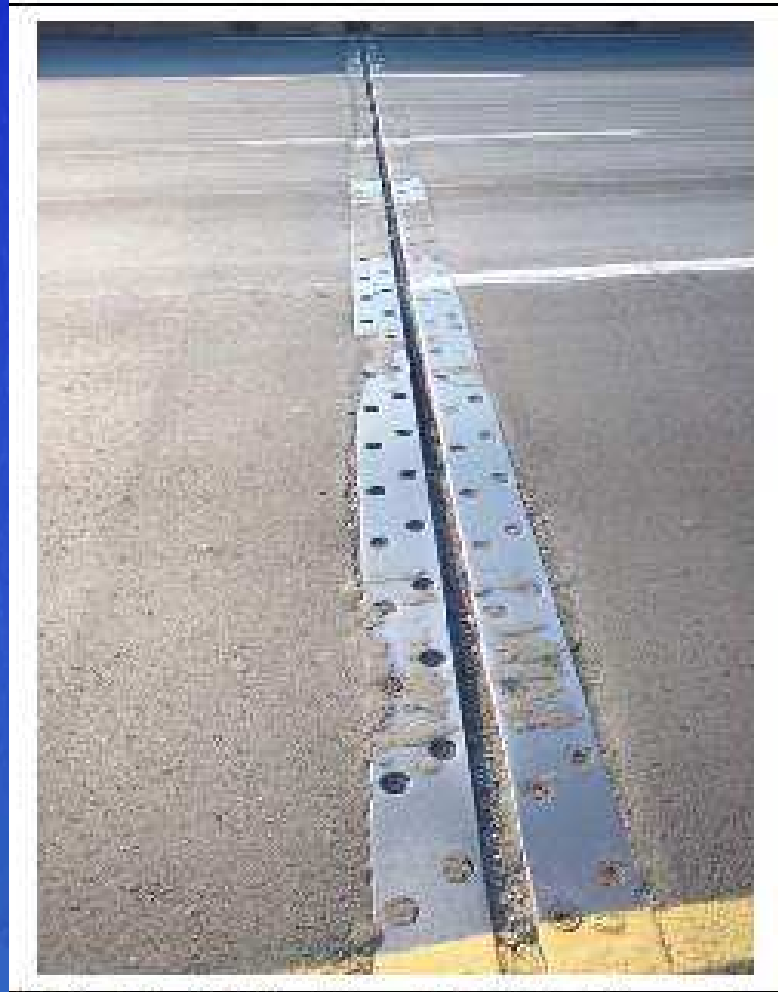
# Existing Plank Joint

- **Most deck joints asphaltic plug**
- **Some existing joints were to remain (“plank” joints over original finger joints)**
- **Contractor unable to perform deck patching adjacent to exposed plank joints due to bituminous ramping (1”/40’) requirement, these joints had to be removed**
