Mitigation of Girder Deck Construction Joint Slippage in T-beam and Box Girder Bridges

Anthony Gugino
WBPP meeting
Sacramento, CA
December, 2010

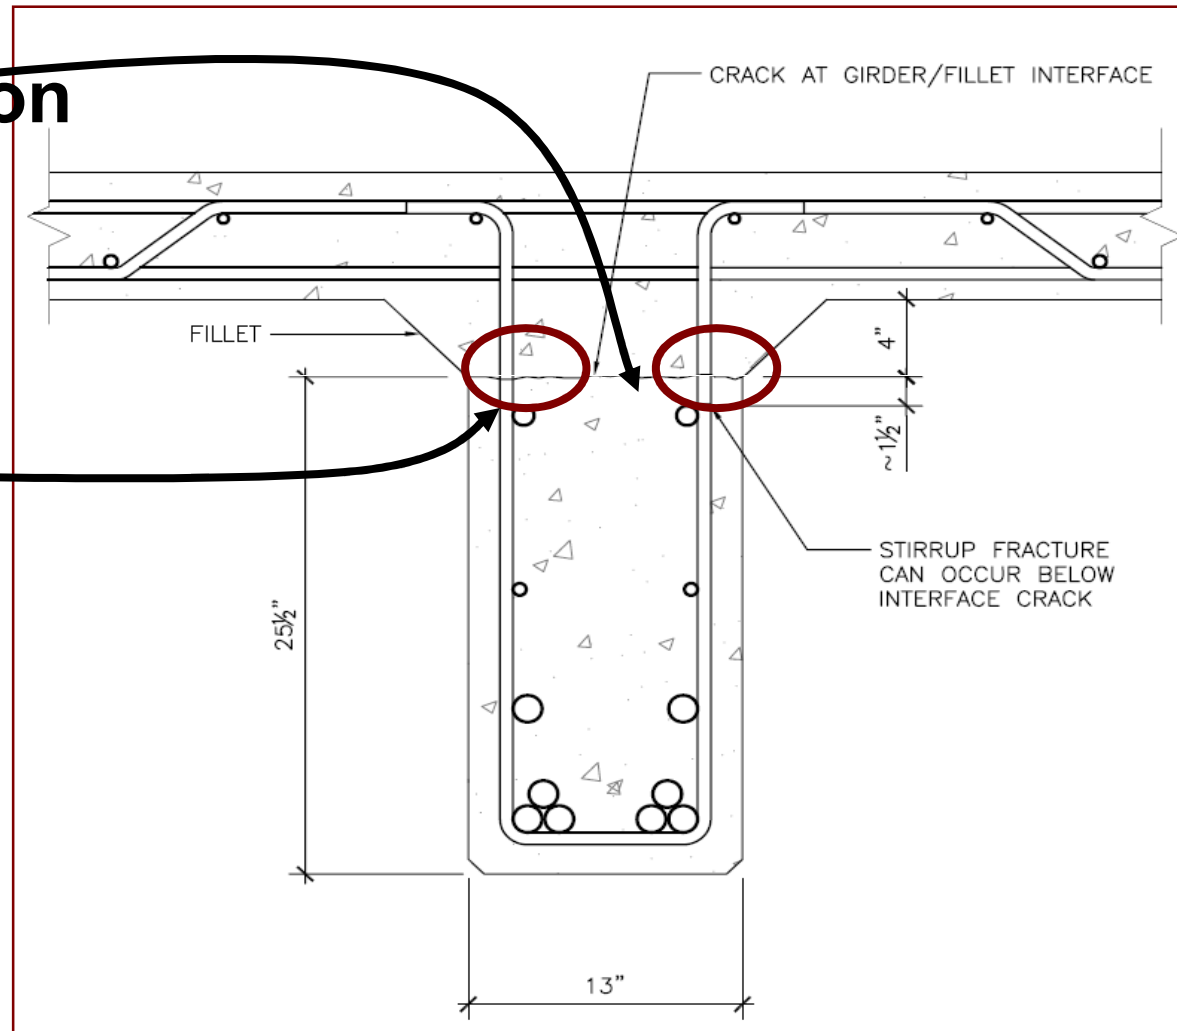
- In 2006, 12 Cast in Place T-beam girder bridges on Rte 40 experienced deck-girder interface joint failure
- 5 Girder - 3 interior girders had extensive interface cracking and movement the exterior girders were OK
- Interface cracks initiated at mid span, moved along the length and culminated in shear failure and fracture of shear and other reinforcement.
- All 12 bridges built under the same contract in 1973
- All 12 bridges replaced under emergency contract

**Slippage at construction
joint**

Fracture of rebar

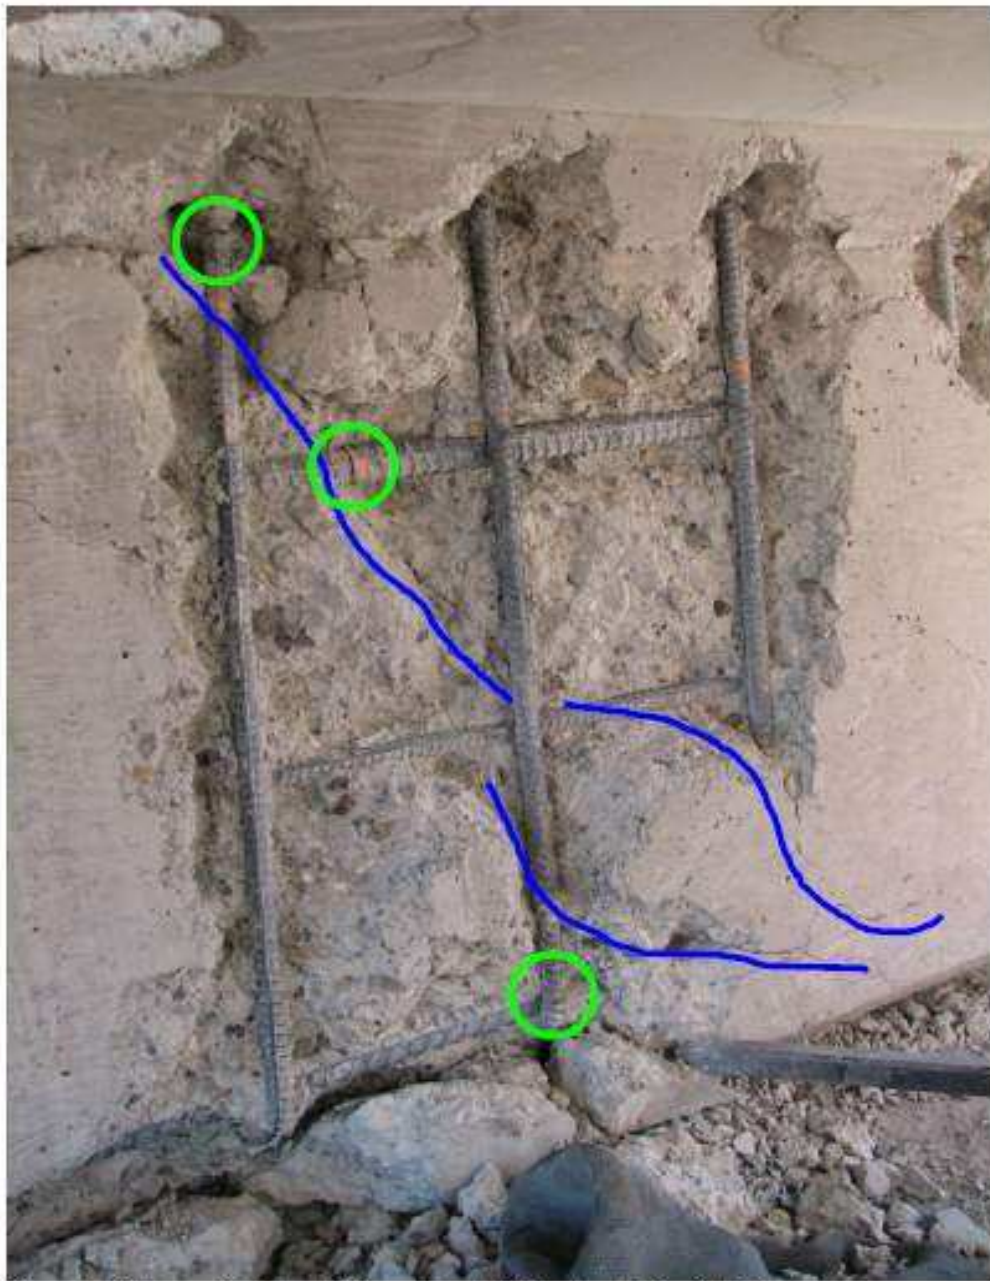
Figure 5: Mustang Section #4 Shear Crack & Fractured Bars [197.jpg]

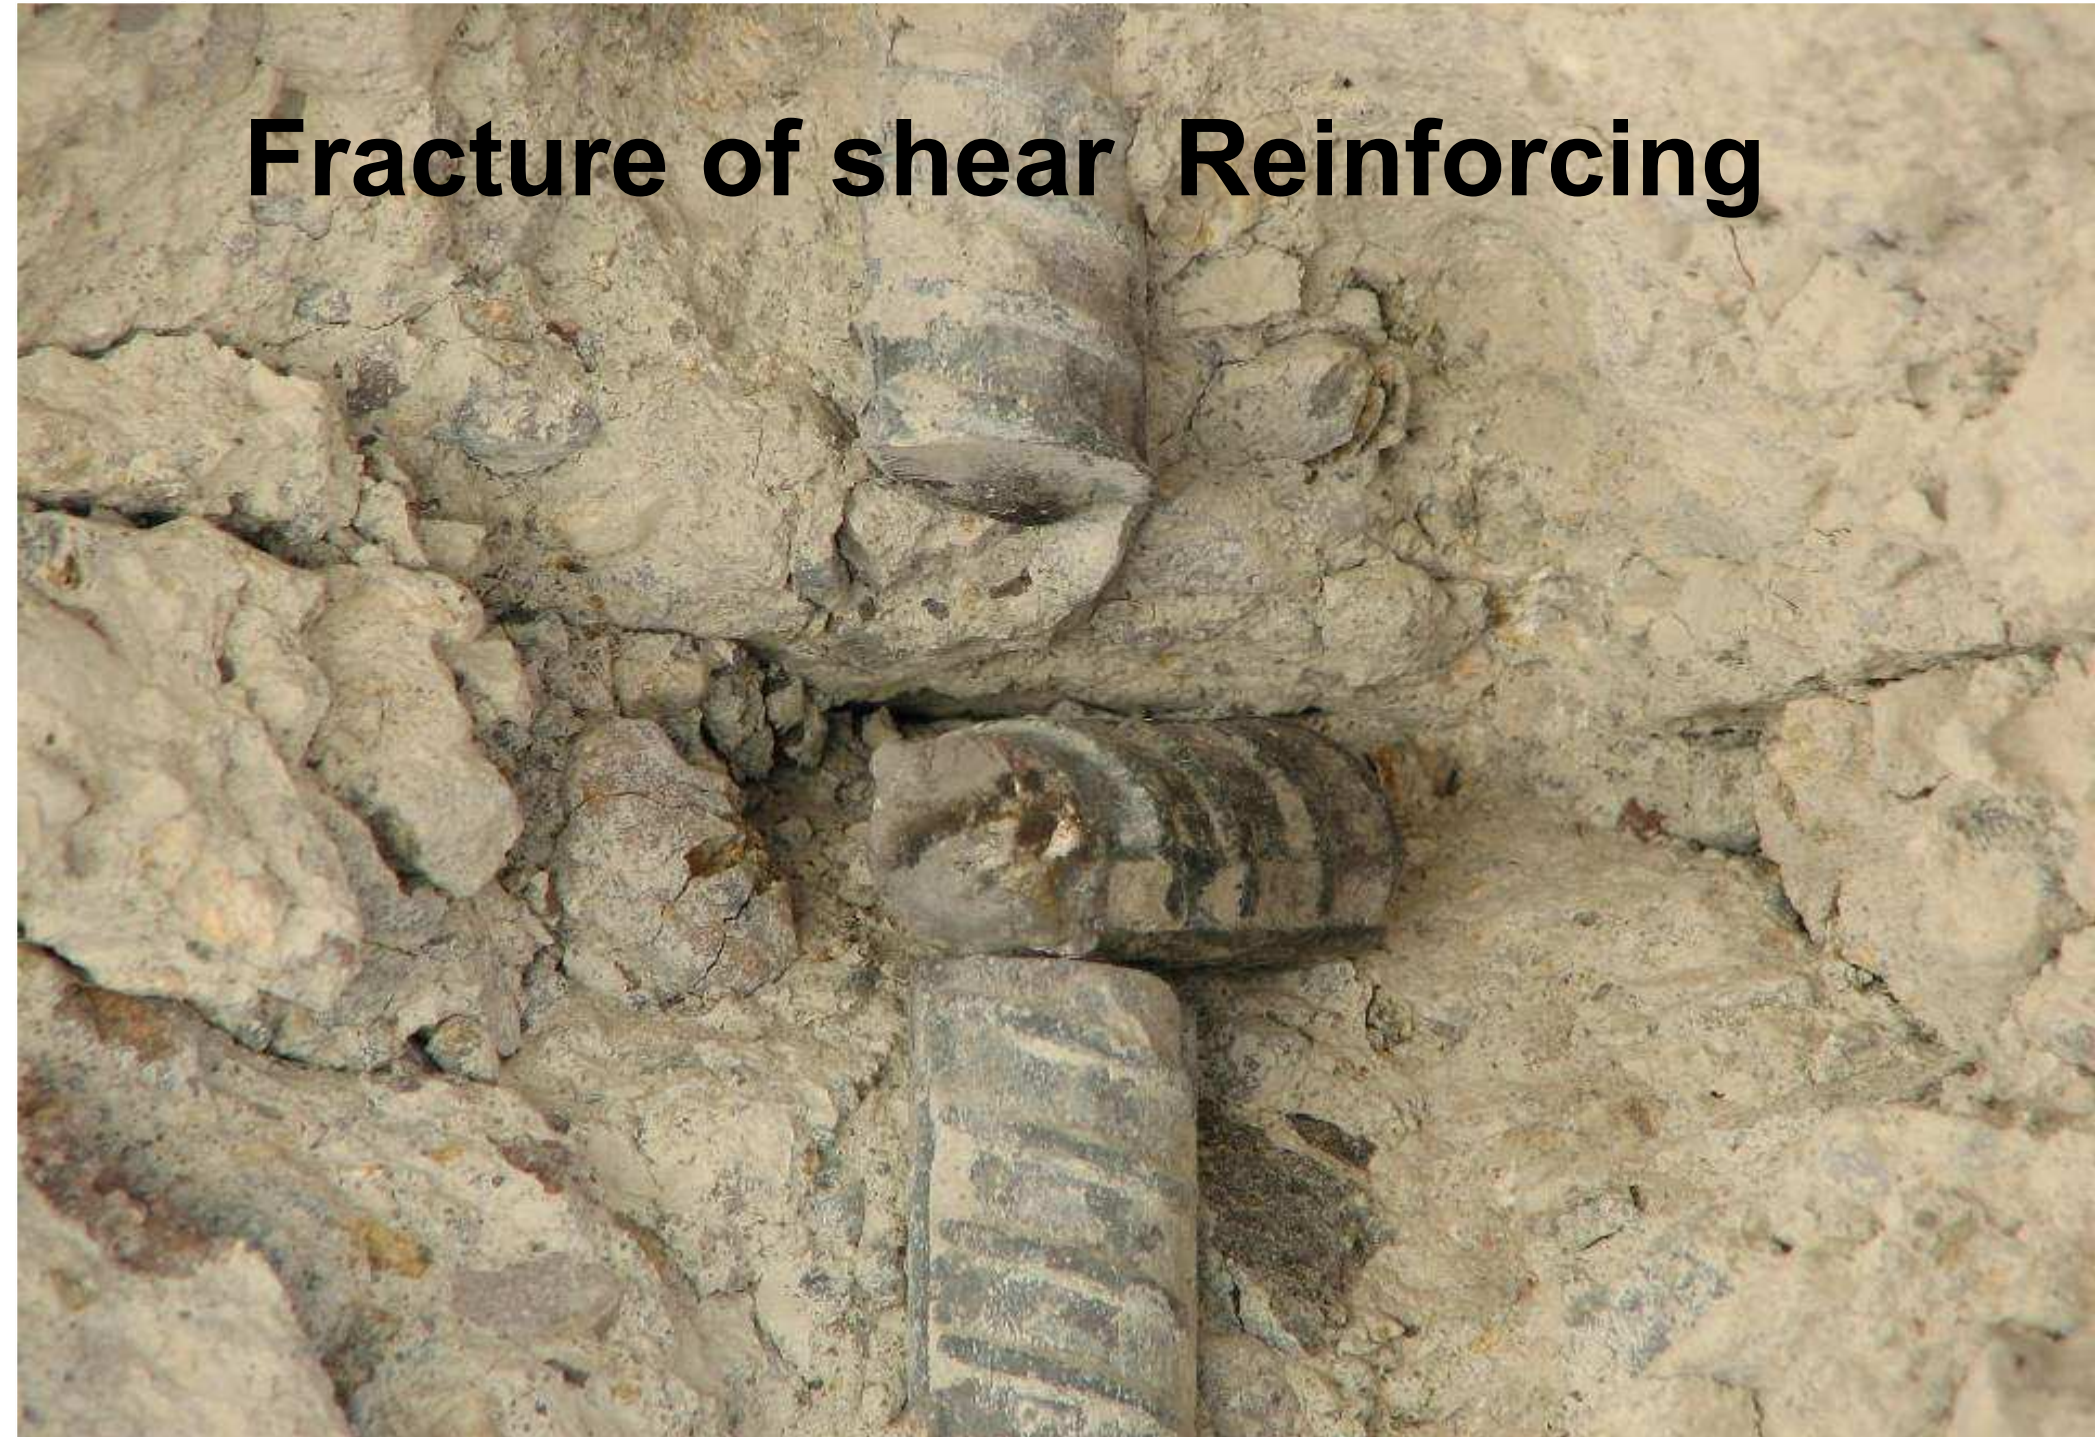
Fracture of shear Reinforcing

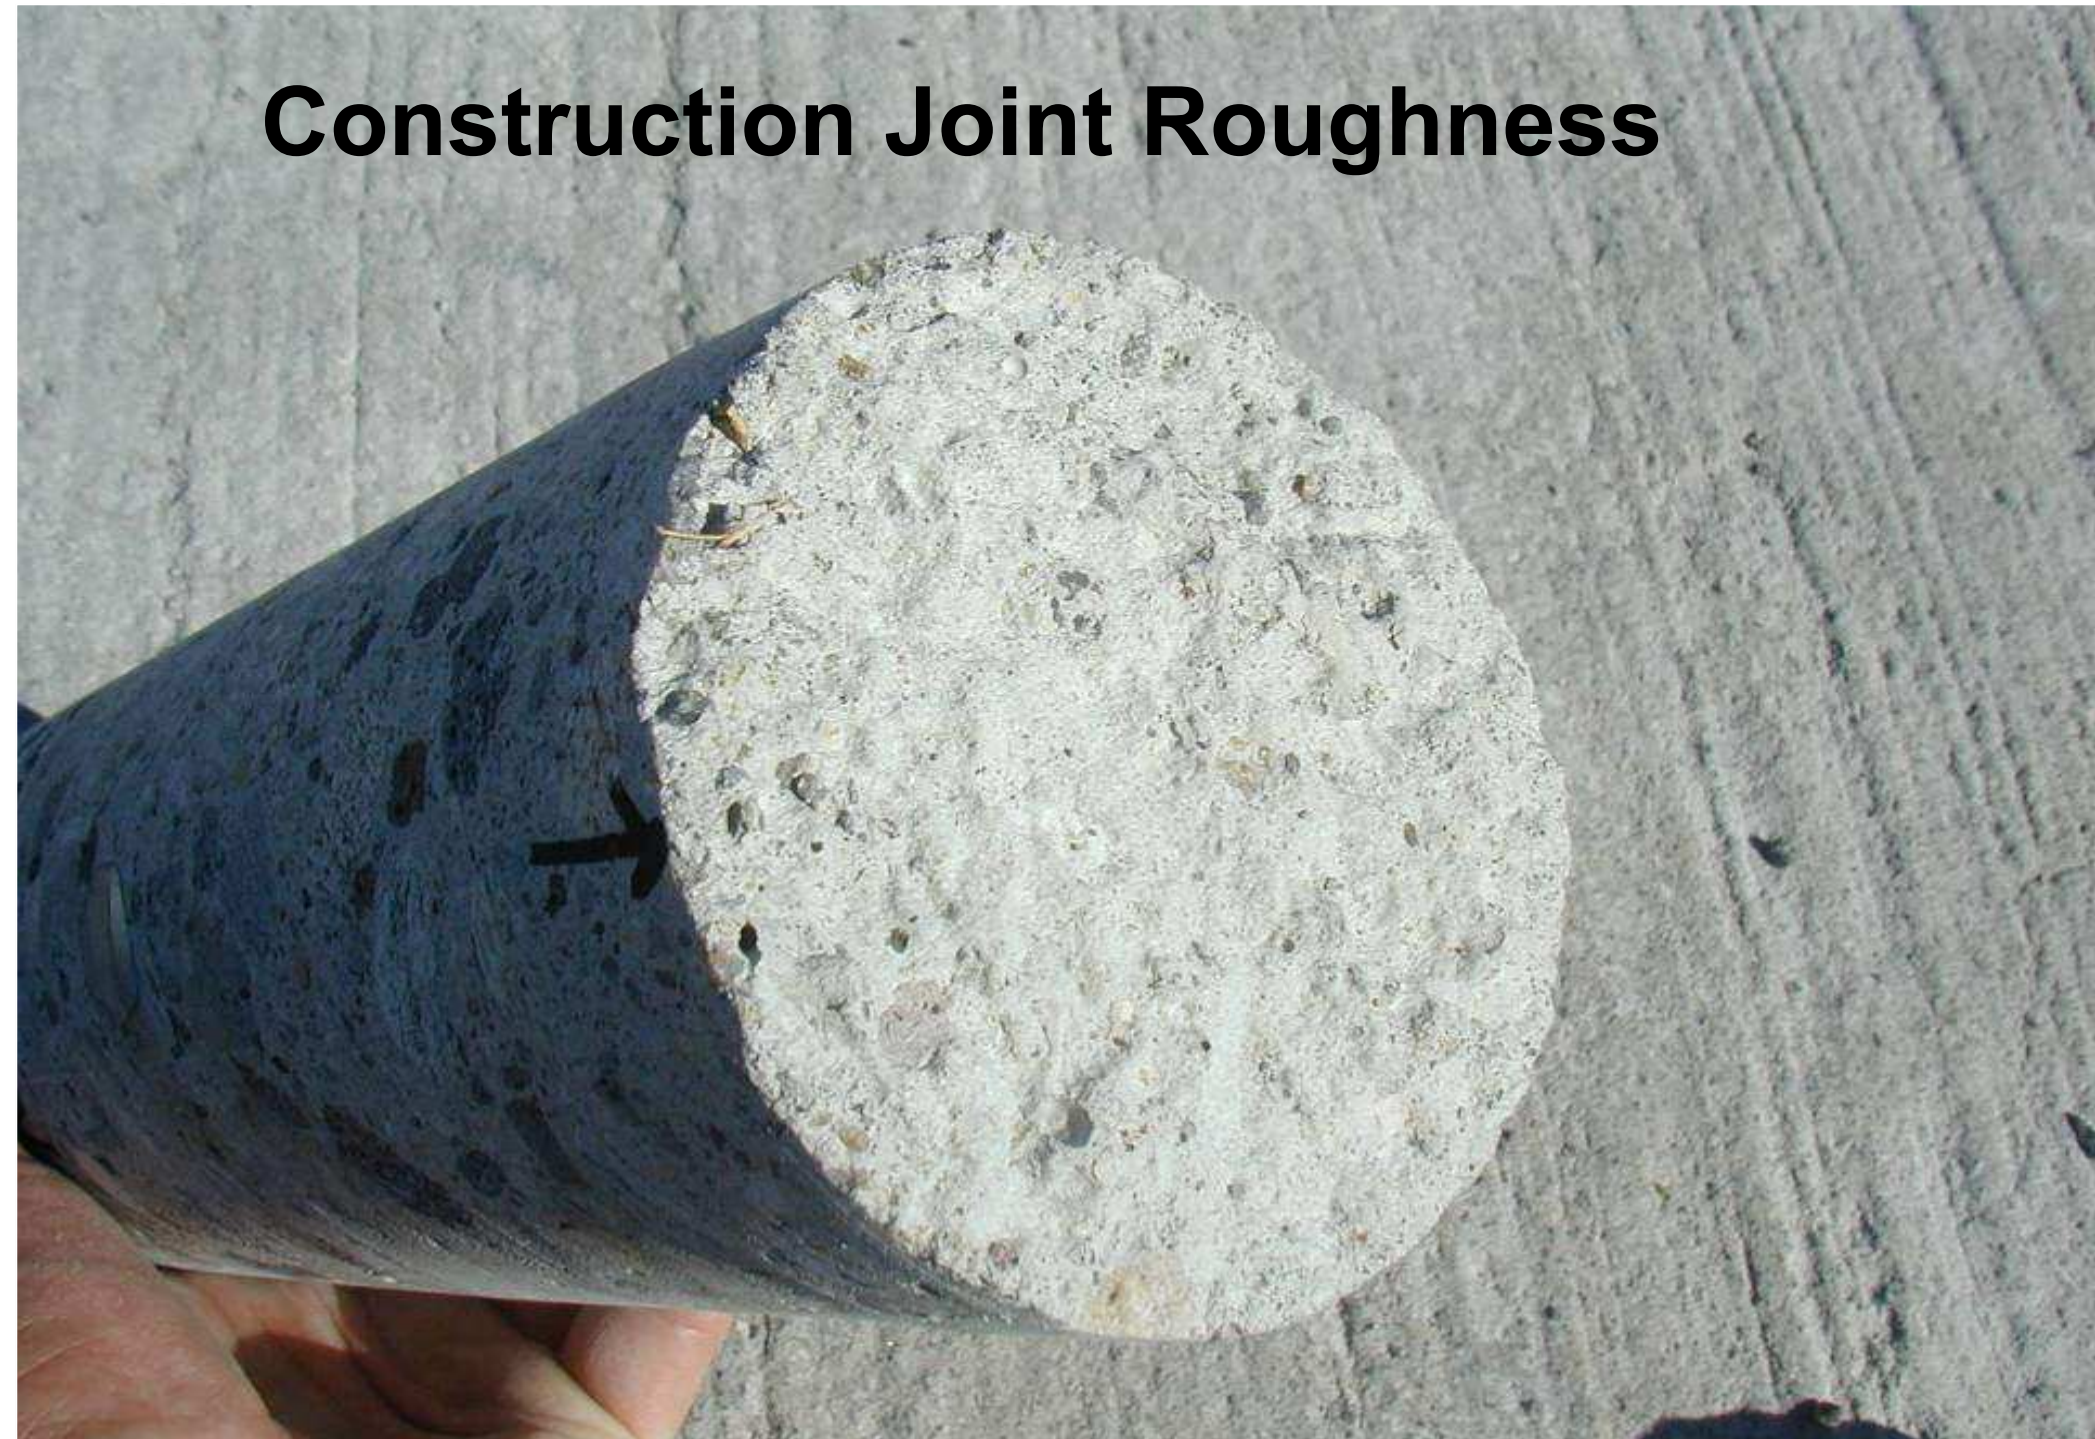
- **Primary Factors**
 - *Inadequate construction joint roughness*
 - **Design Specs - construction joint shear capacity dependant on joint roughness – joint fatigue**
 - **Inadequate quantity of joint/ shear reinforcement**
 - **Truck load intensity and frequency (high stress-high cycle)**
 - **Deck stiffness - Concrete Modulus 30% lower severe deck cracking**

Construction Joint Roughness

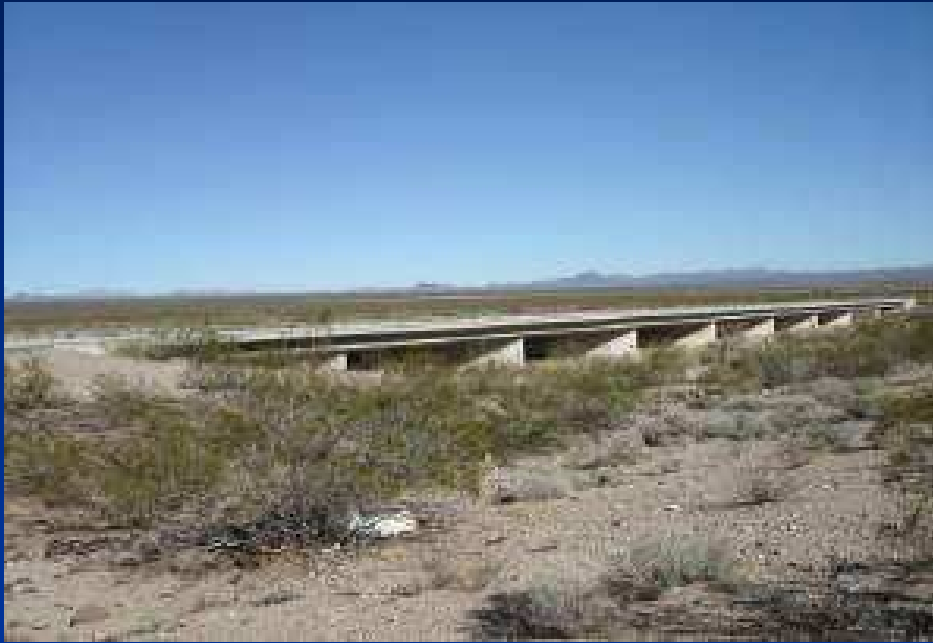
Clipper Wash L/R

Two of the Eight Box Girder Bridges with Deck/Girder Const Joint Cracks

- **Girder cracking similar to T beam bridges**
 - Begins at $1/3$ to $1/2$ span and progresses towards supports
 - Longitudinal Slippage up to $1/32$ " along joint
 - Cracking only in middle 3 girders
 - Crack lengths vary from 5 feet to 25 feet
 - Moderate to severe deck cracking
- **Slippage did not cause fracture of rebar**
 - Live load deflections seemed normal

- **Hydro Demo Deck above girder construction joint and re-pour Concrete**
- **Must stage concrete removal so as to not shore bridge**
- **Relative costs (for 8 bridges total)**
 - **Replace bridges** **\$23,000,000**
 - **Re-deck Bridges** **\$11.5 million**
 - **Repair slipping joint** **\$2.0 million**

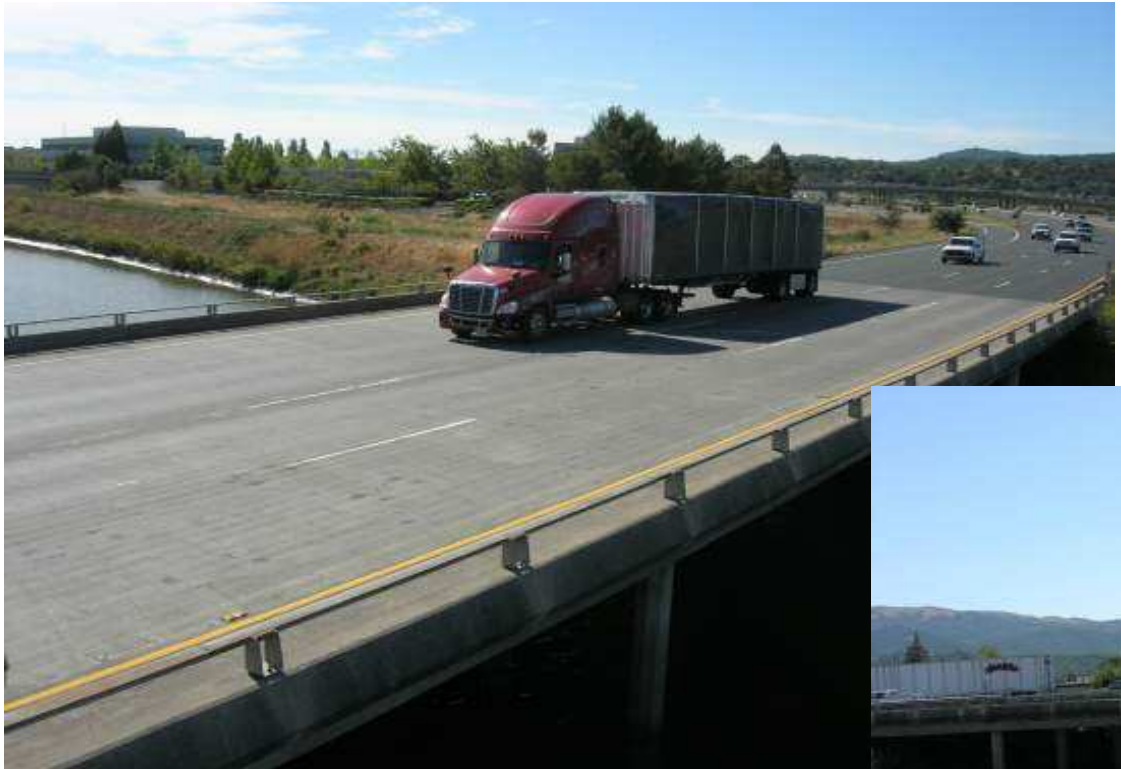
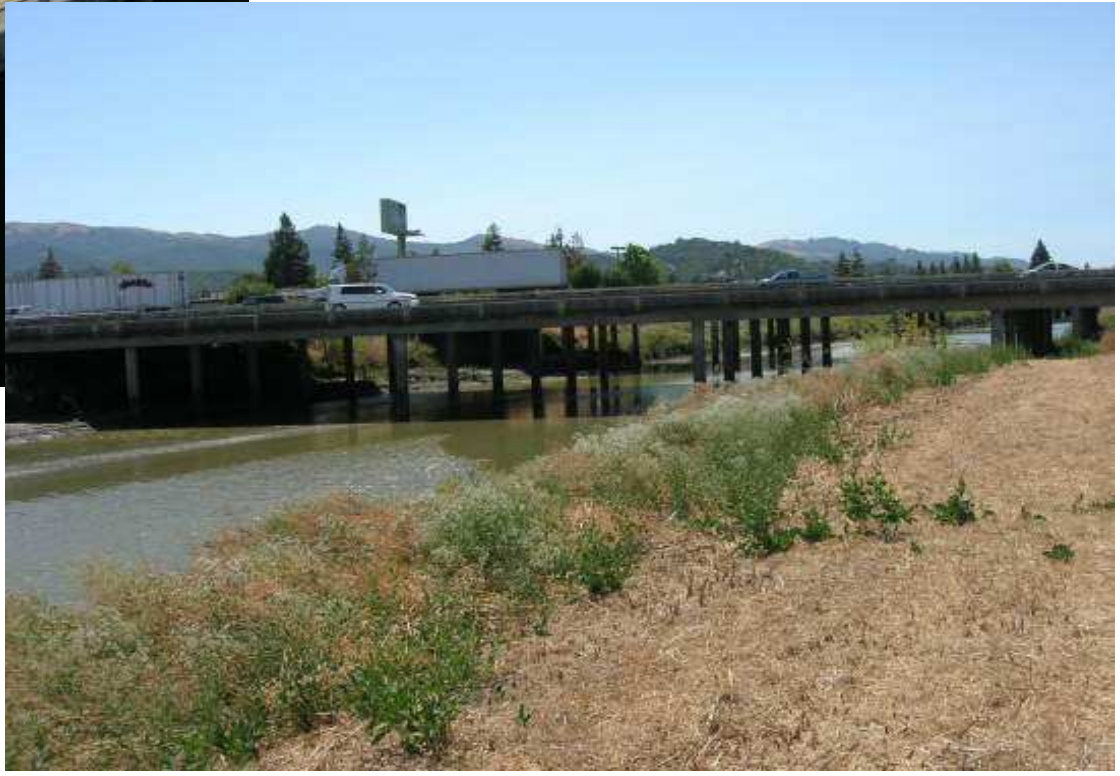
Novato Creek

- **Multi girder T-beam left and right bridge**
- **Highway 101 Marin County**
- **5 span continuous 38 foot spans**
- **Some slippage on interior girders**
 - **Right Bridge - 4 of 10 girder defective**
 - **Left Bridge - 3 of 8 girders defective**
- **Under truck lanes**

- **Drill and Bond new # 8 shear reinforcing headed bars 11 inches on center**
- **Epoxy inject one (worst) girder**
- **Install displacement devices to monitor effectiveness of repair over time**
- **This may not be a permanent repair**
- **This method of repair works well under traffic**

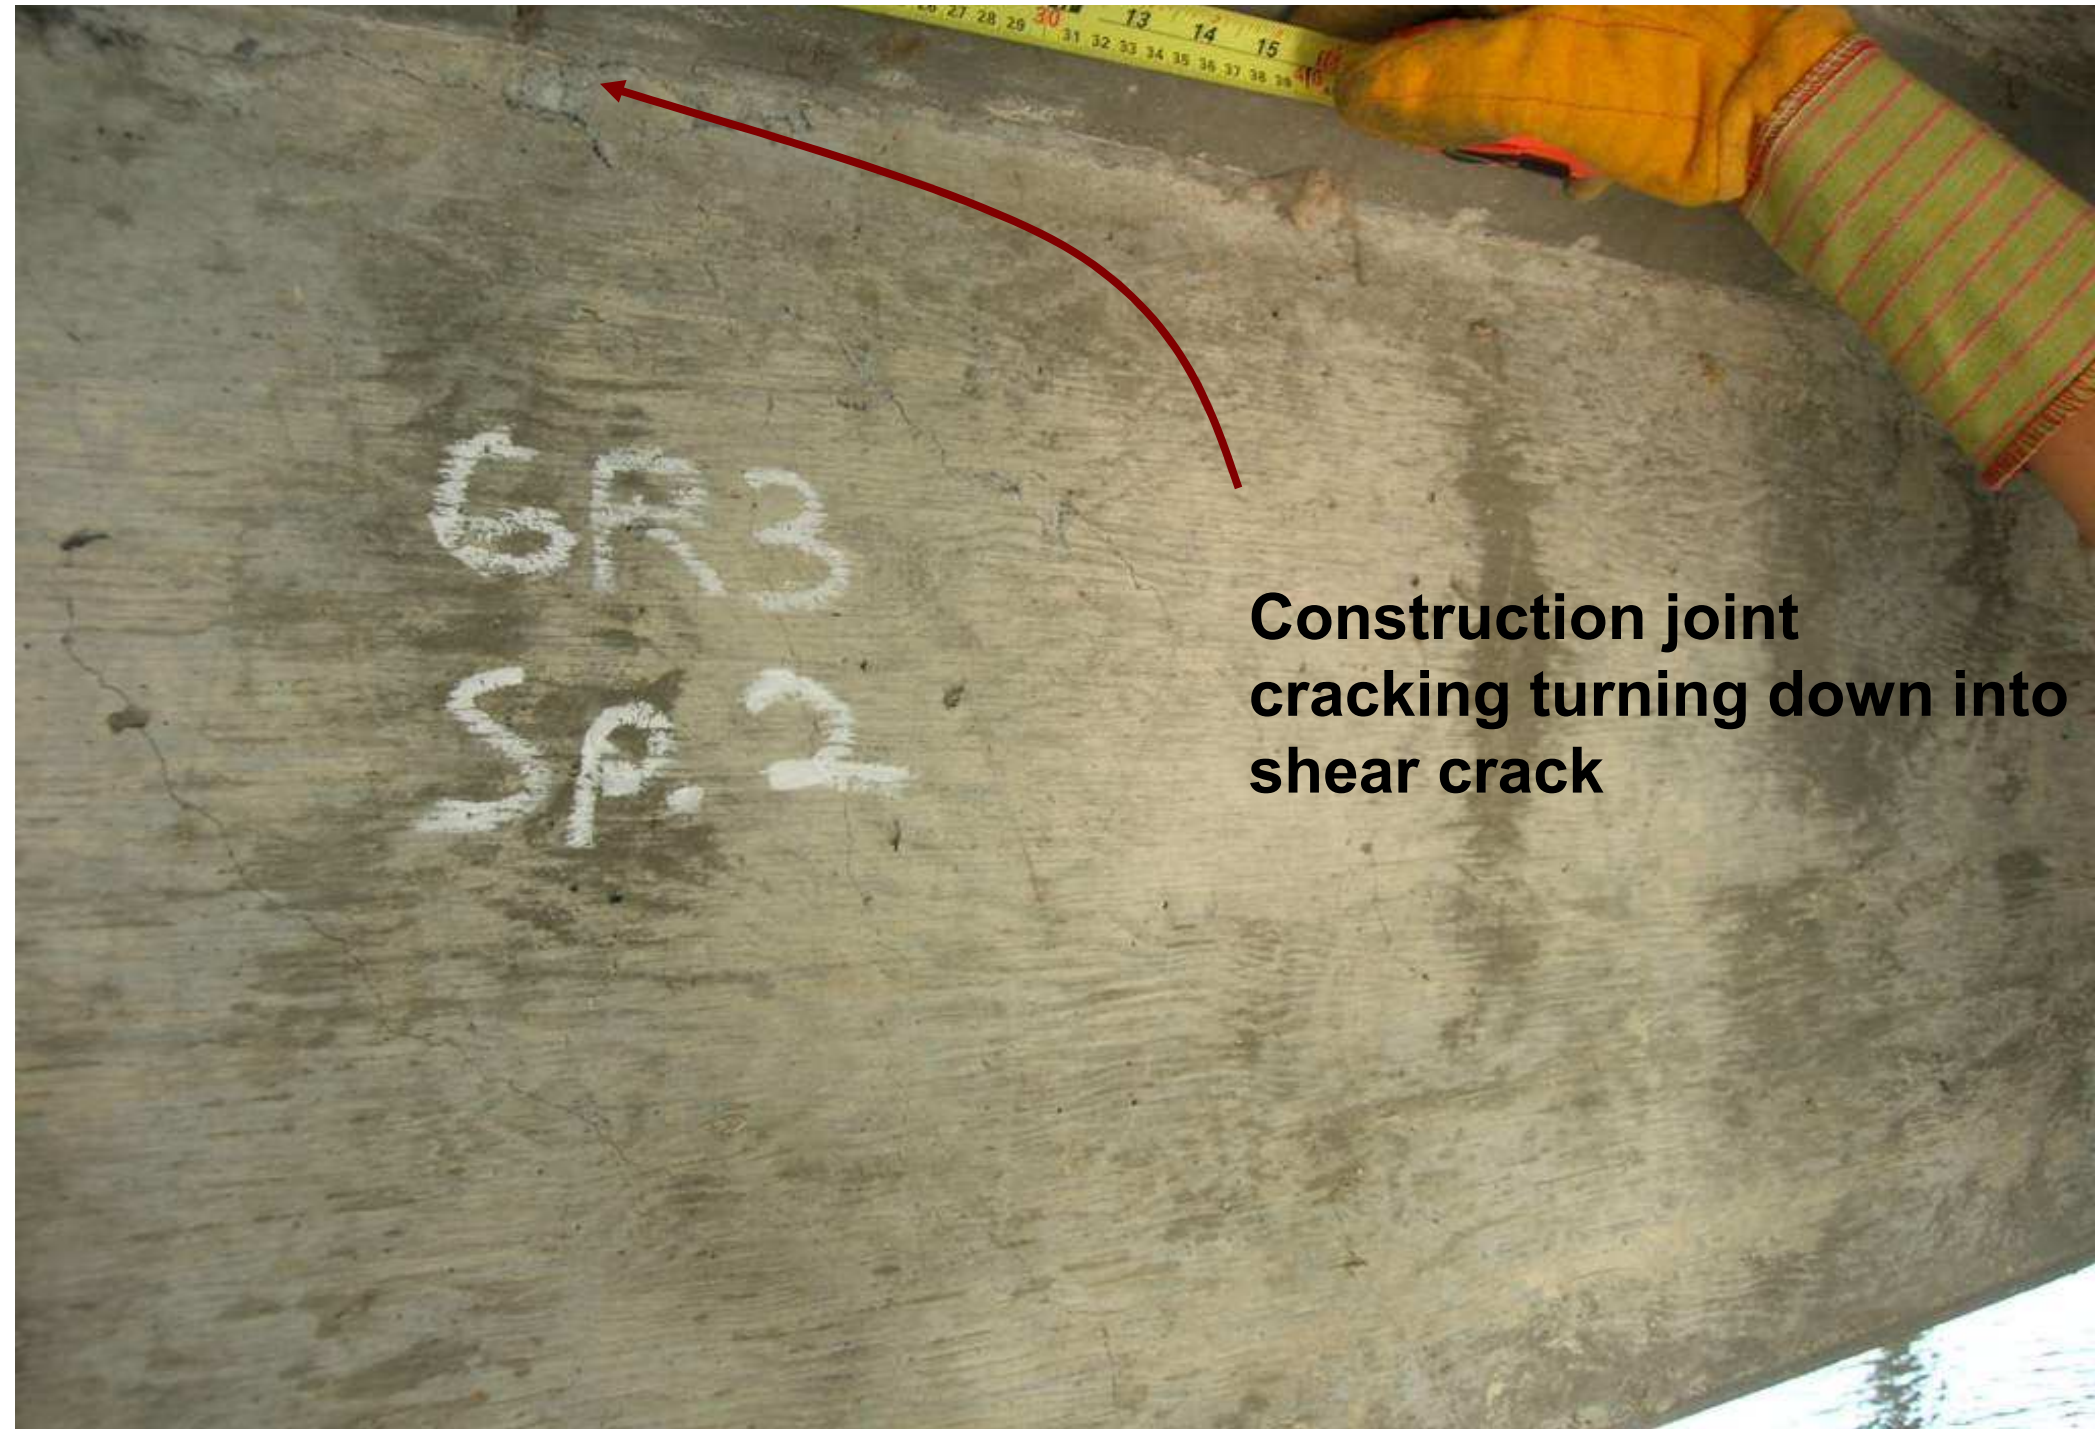
**Construction joint
cracking turning down into
shear crack**

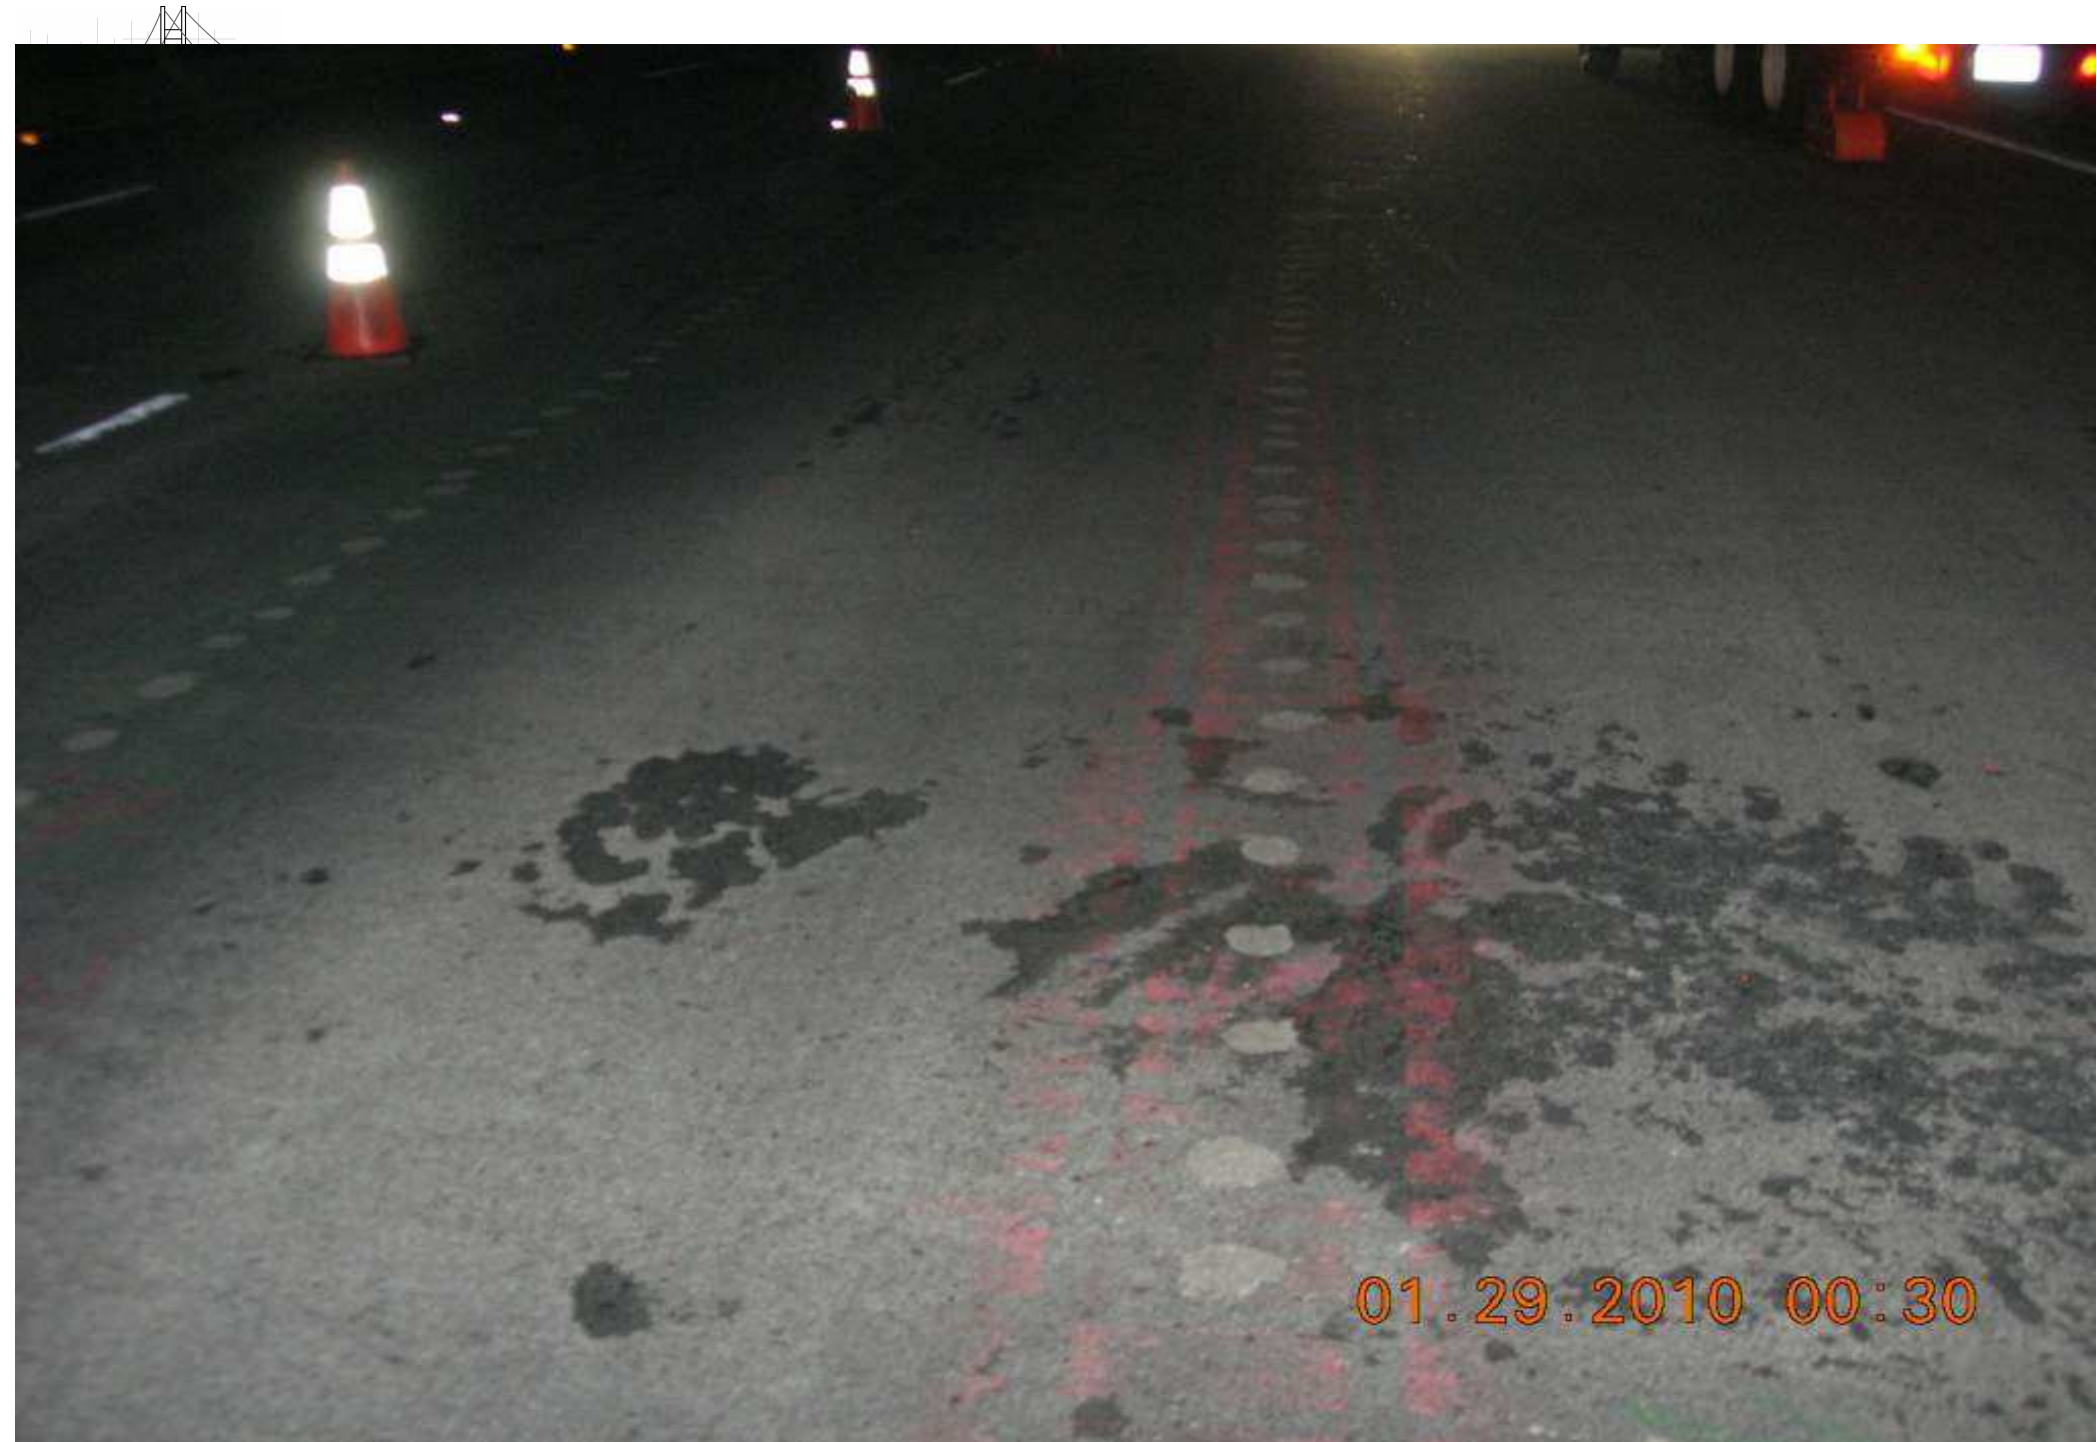
DECK CRACKING NOVATO CREEK

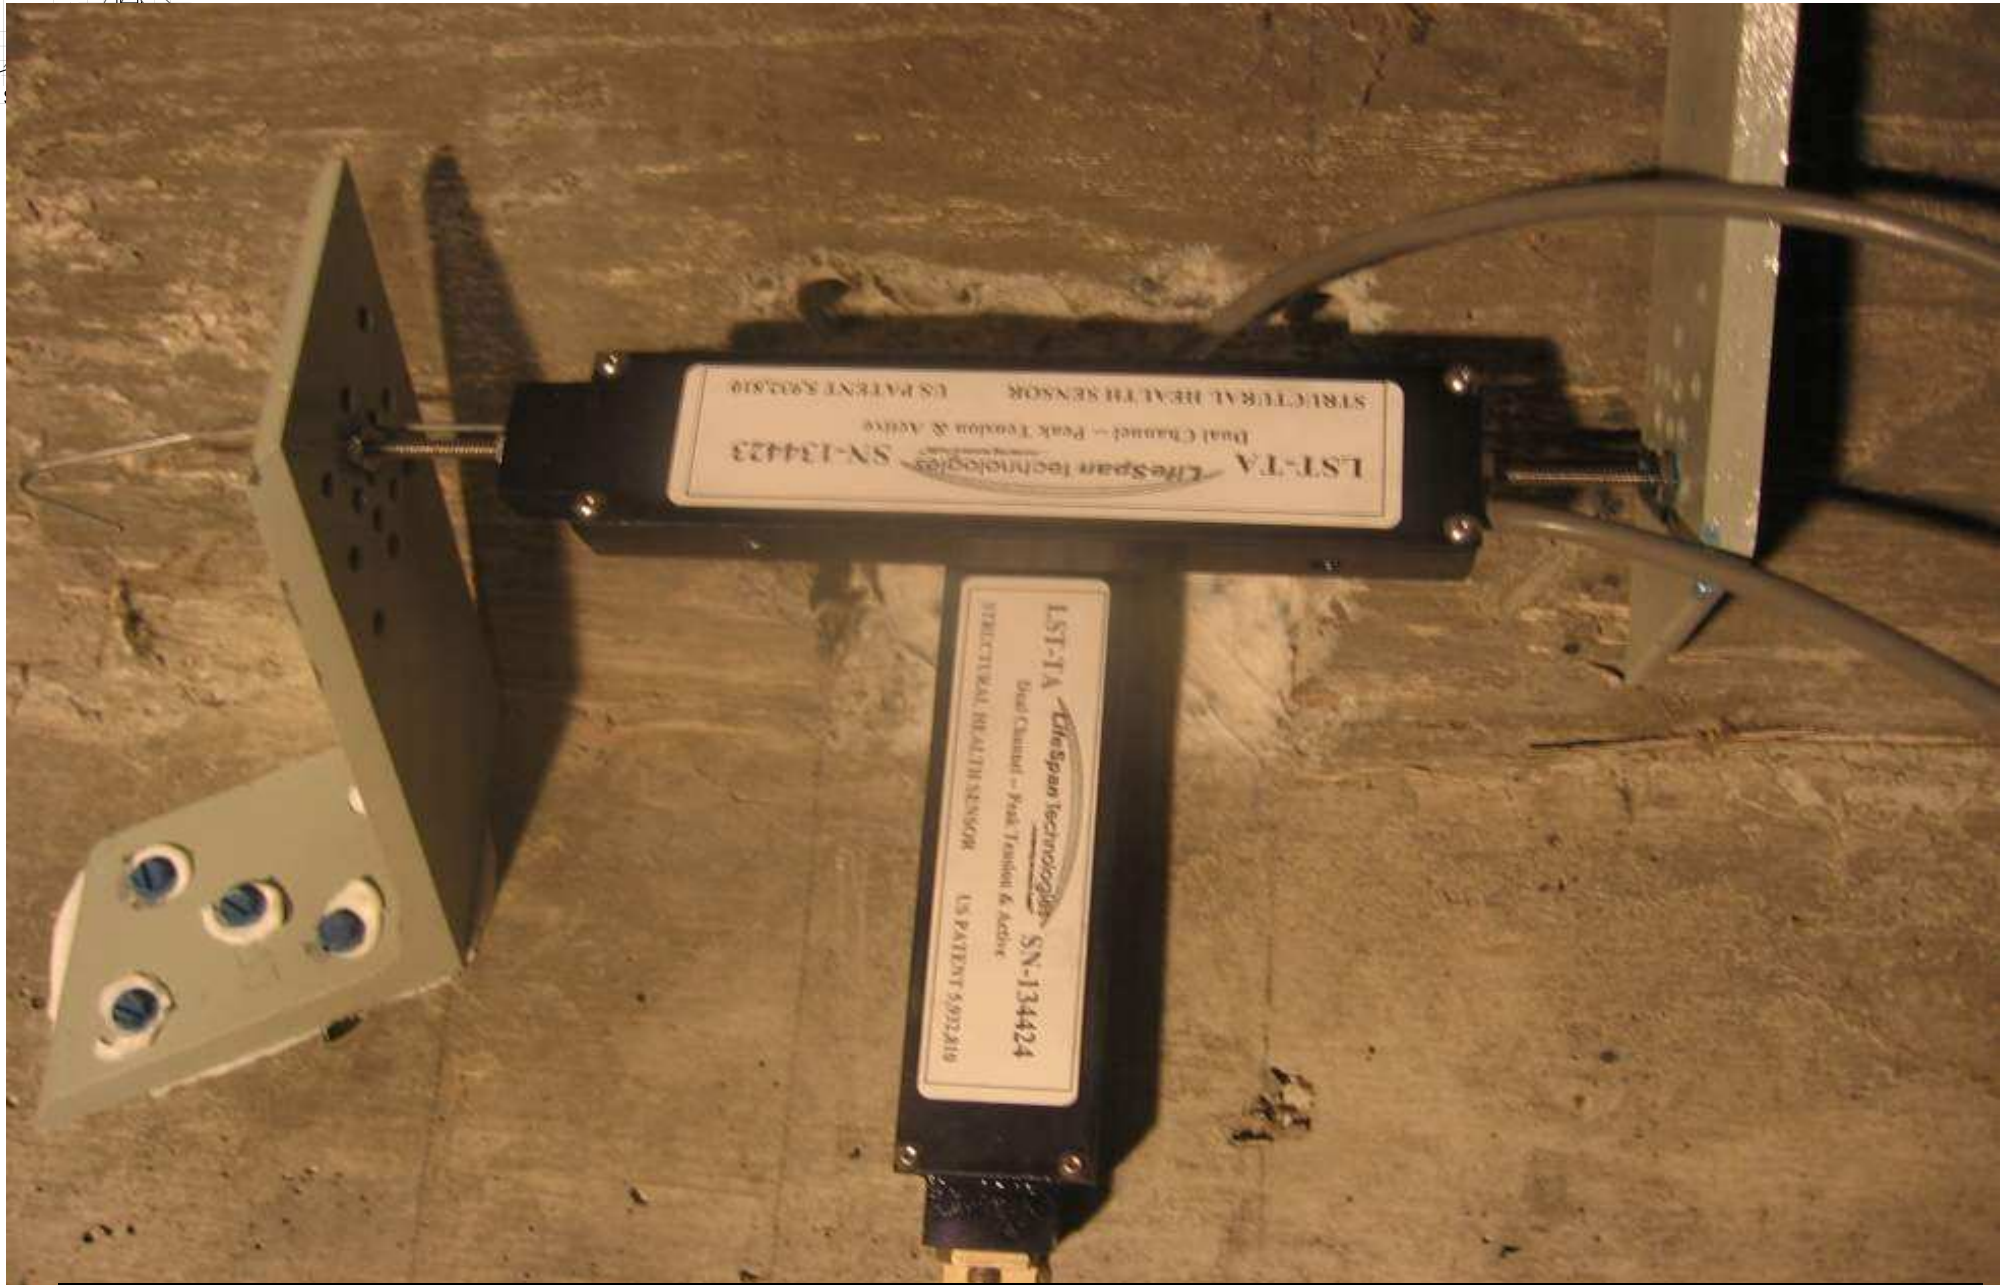
Instrumentation measure displacements in 3 directions

So far repairs have been effective. Dowels have significantly reduced and maintained relative displacement between girder and deck.
