Taking Opportunities as they Come

Deck Preservation Work During the
I-40 Rockslide Closure

Chris Lee, PE

NCDOT Bridge Maintenance Engineer, Division 14

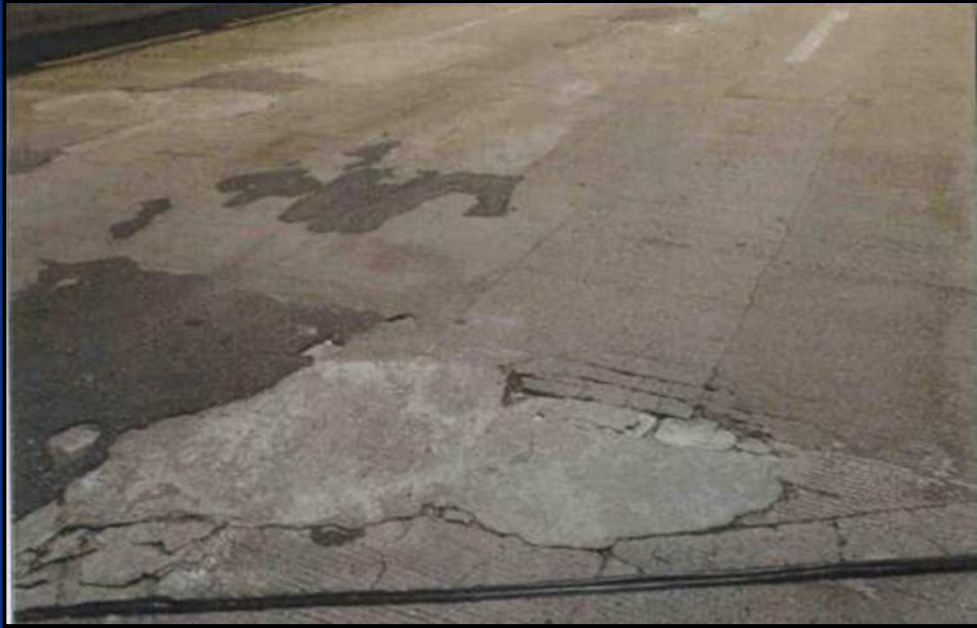
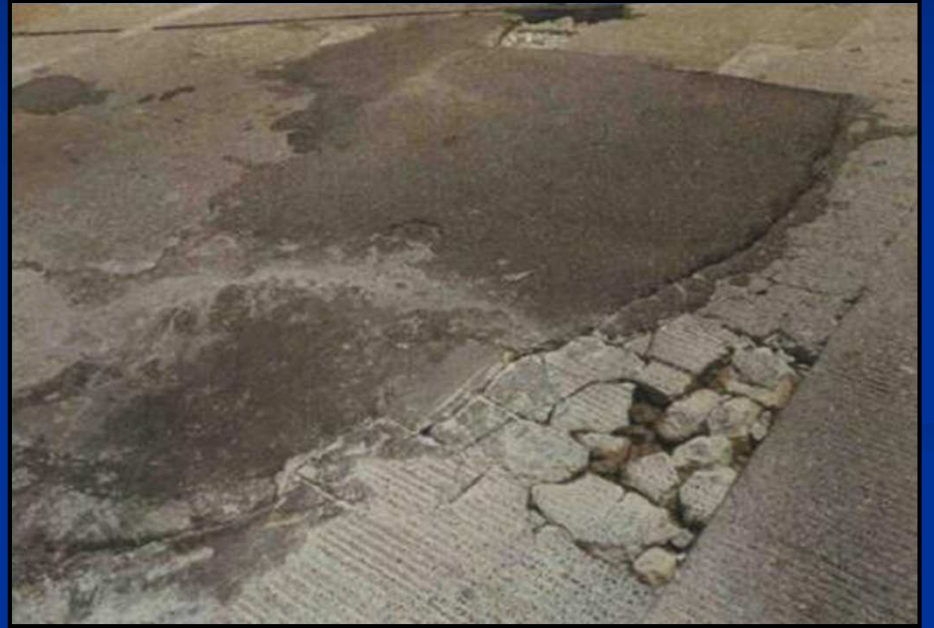
Bridge Deck Condition

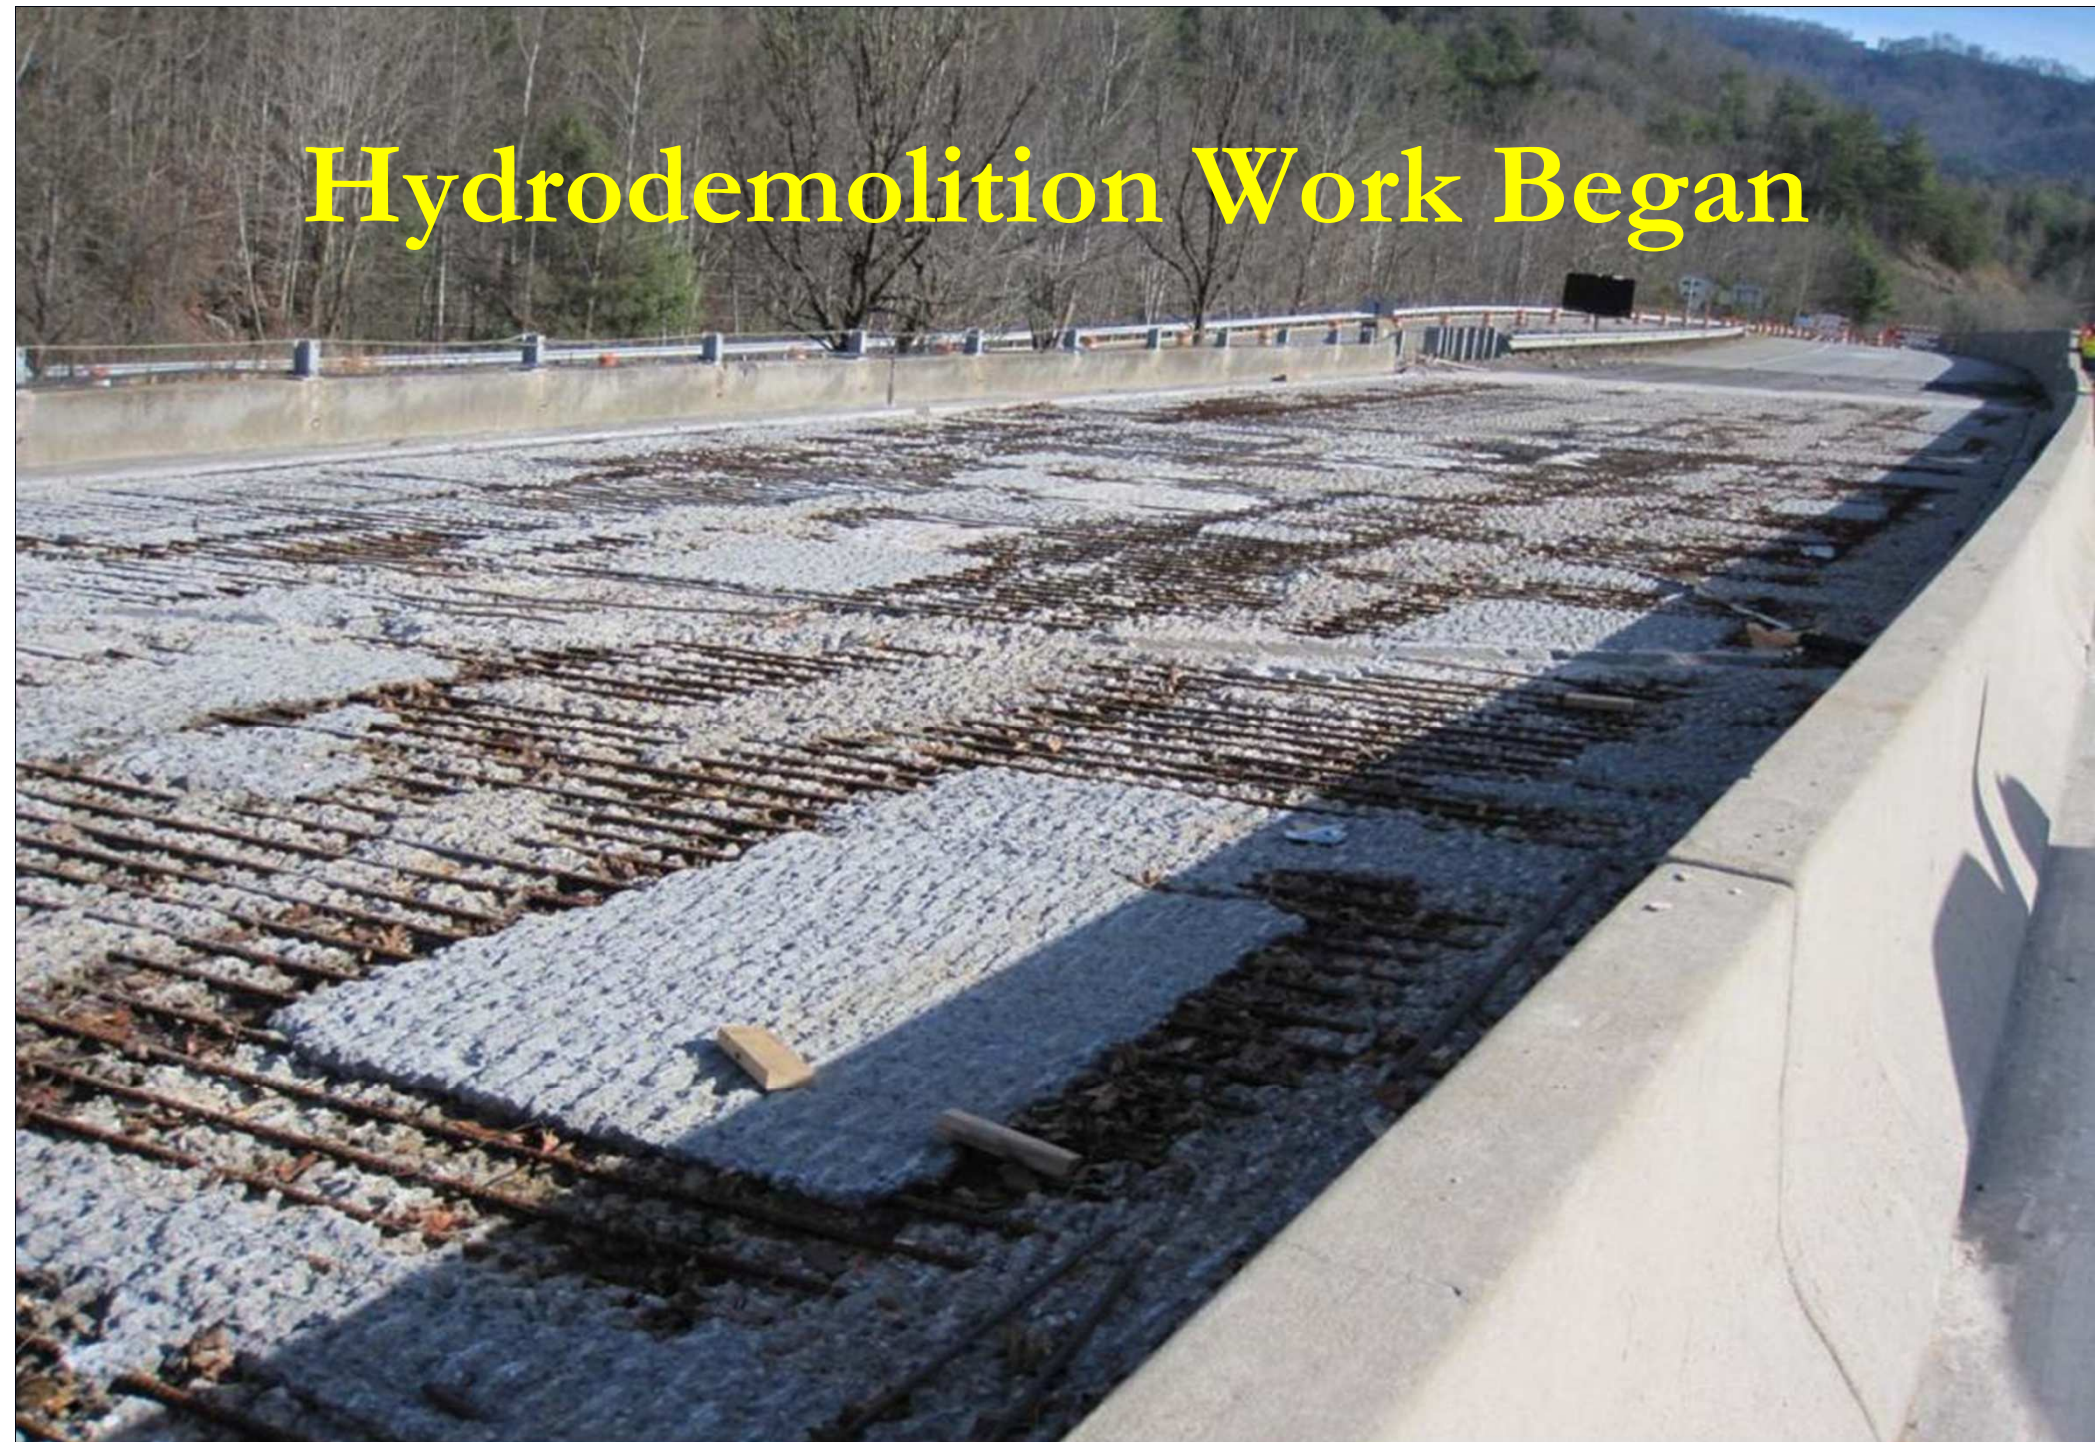
Hydrodemolition Work Began

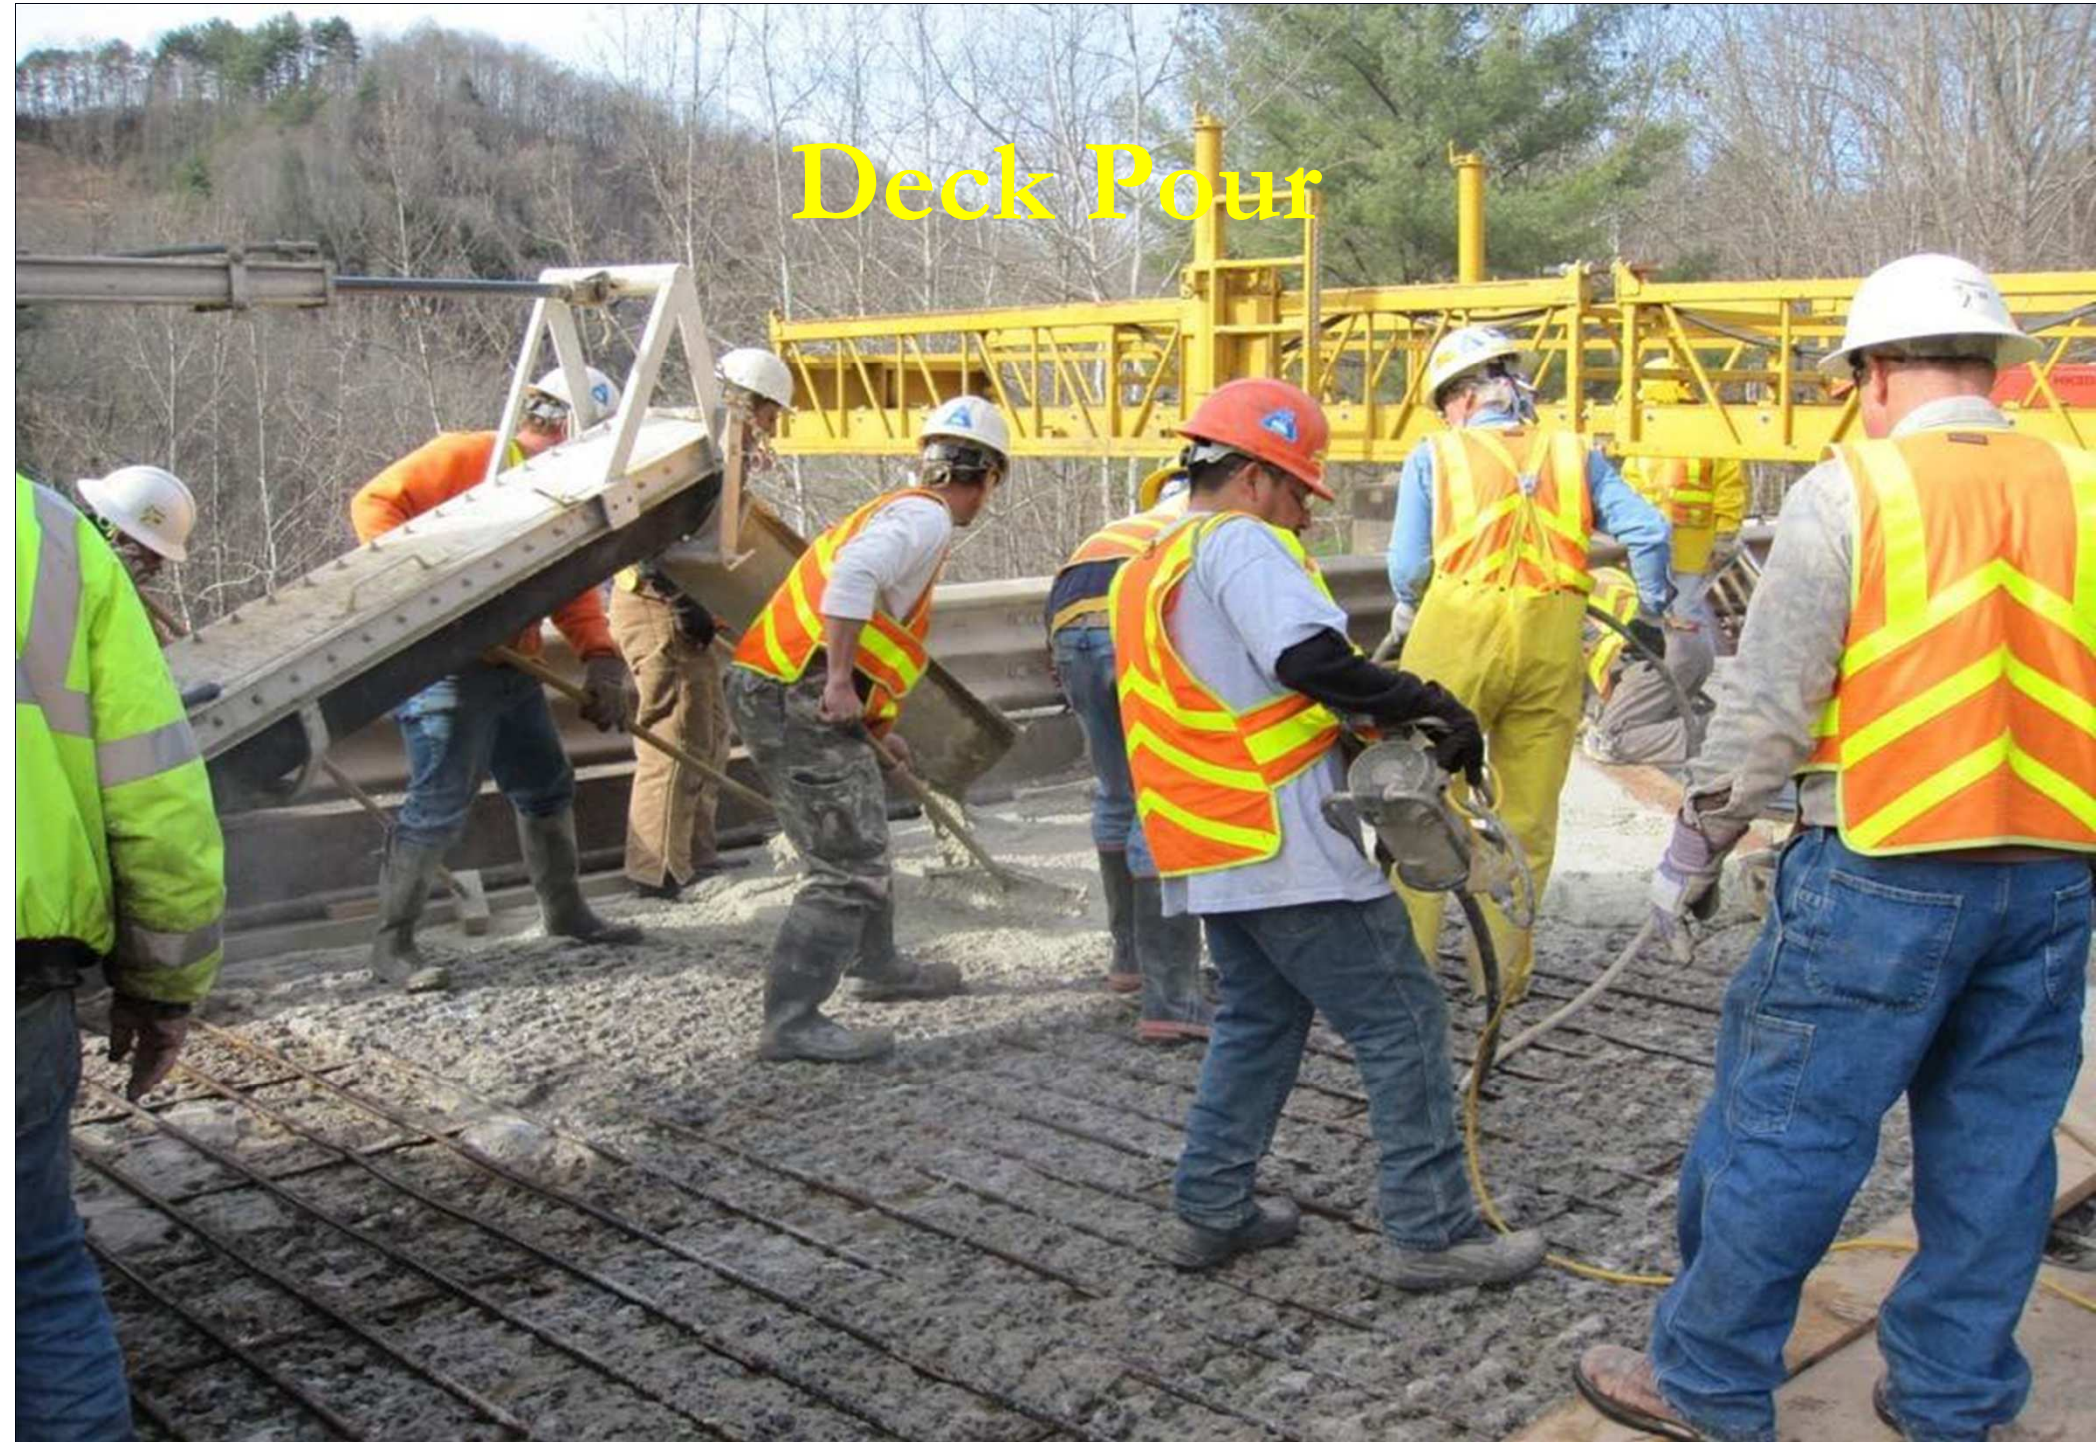
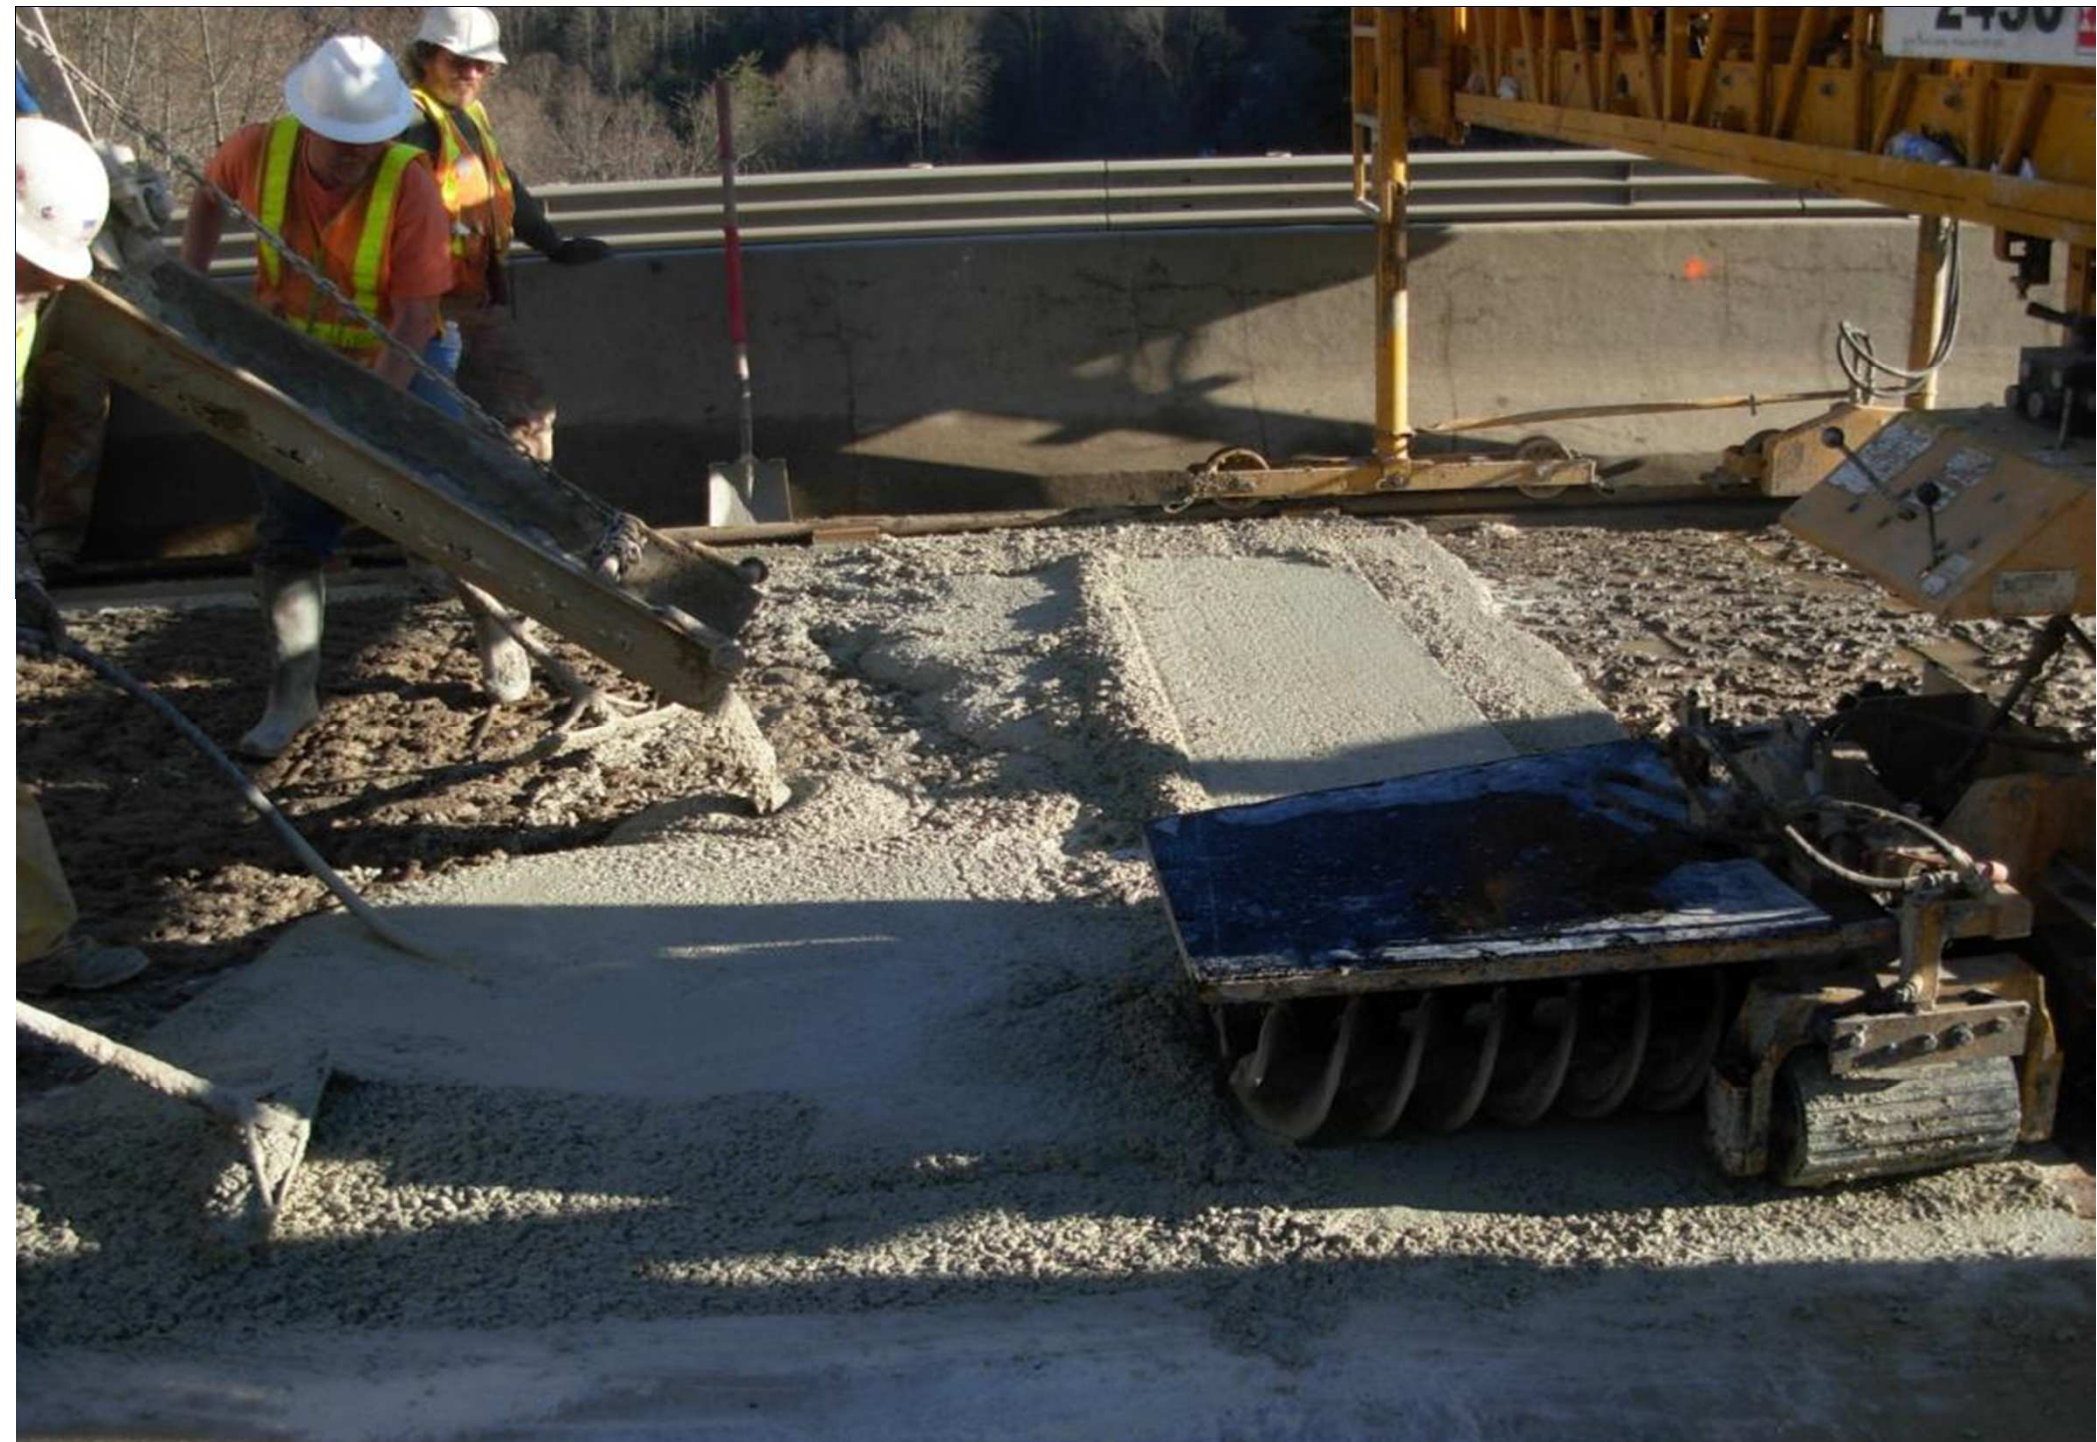
Deck Pour

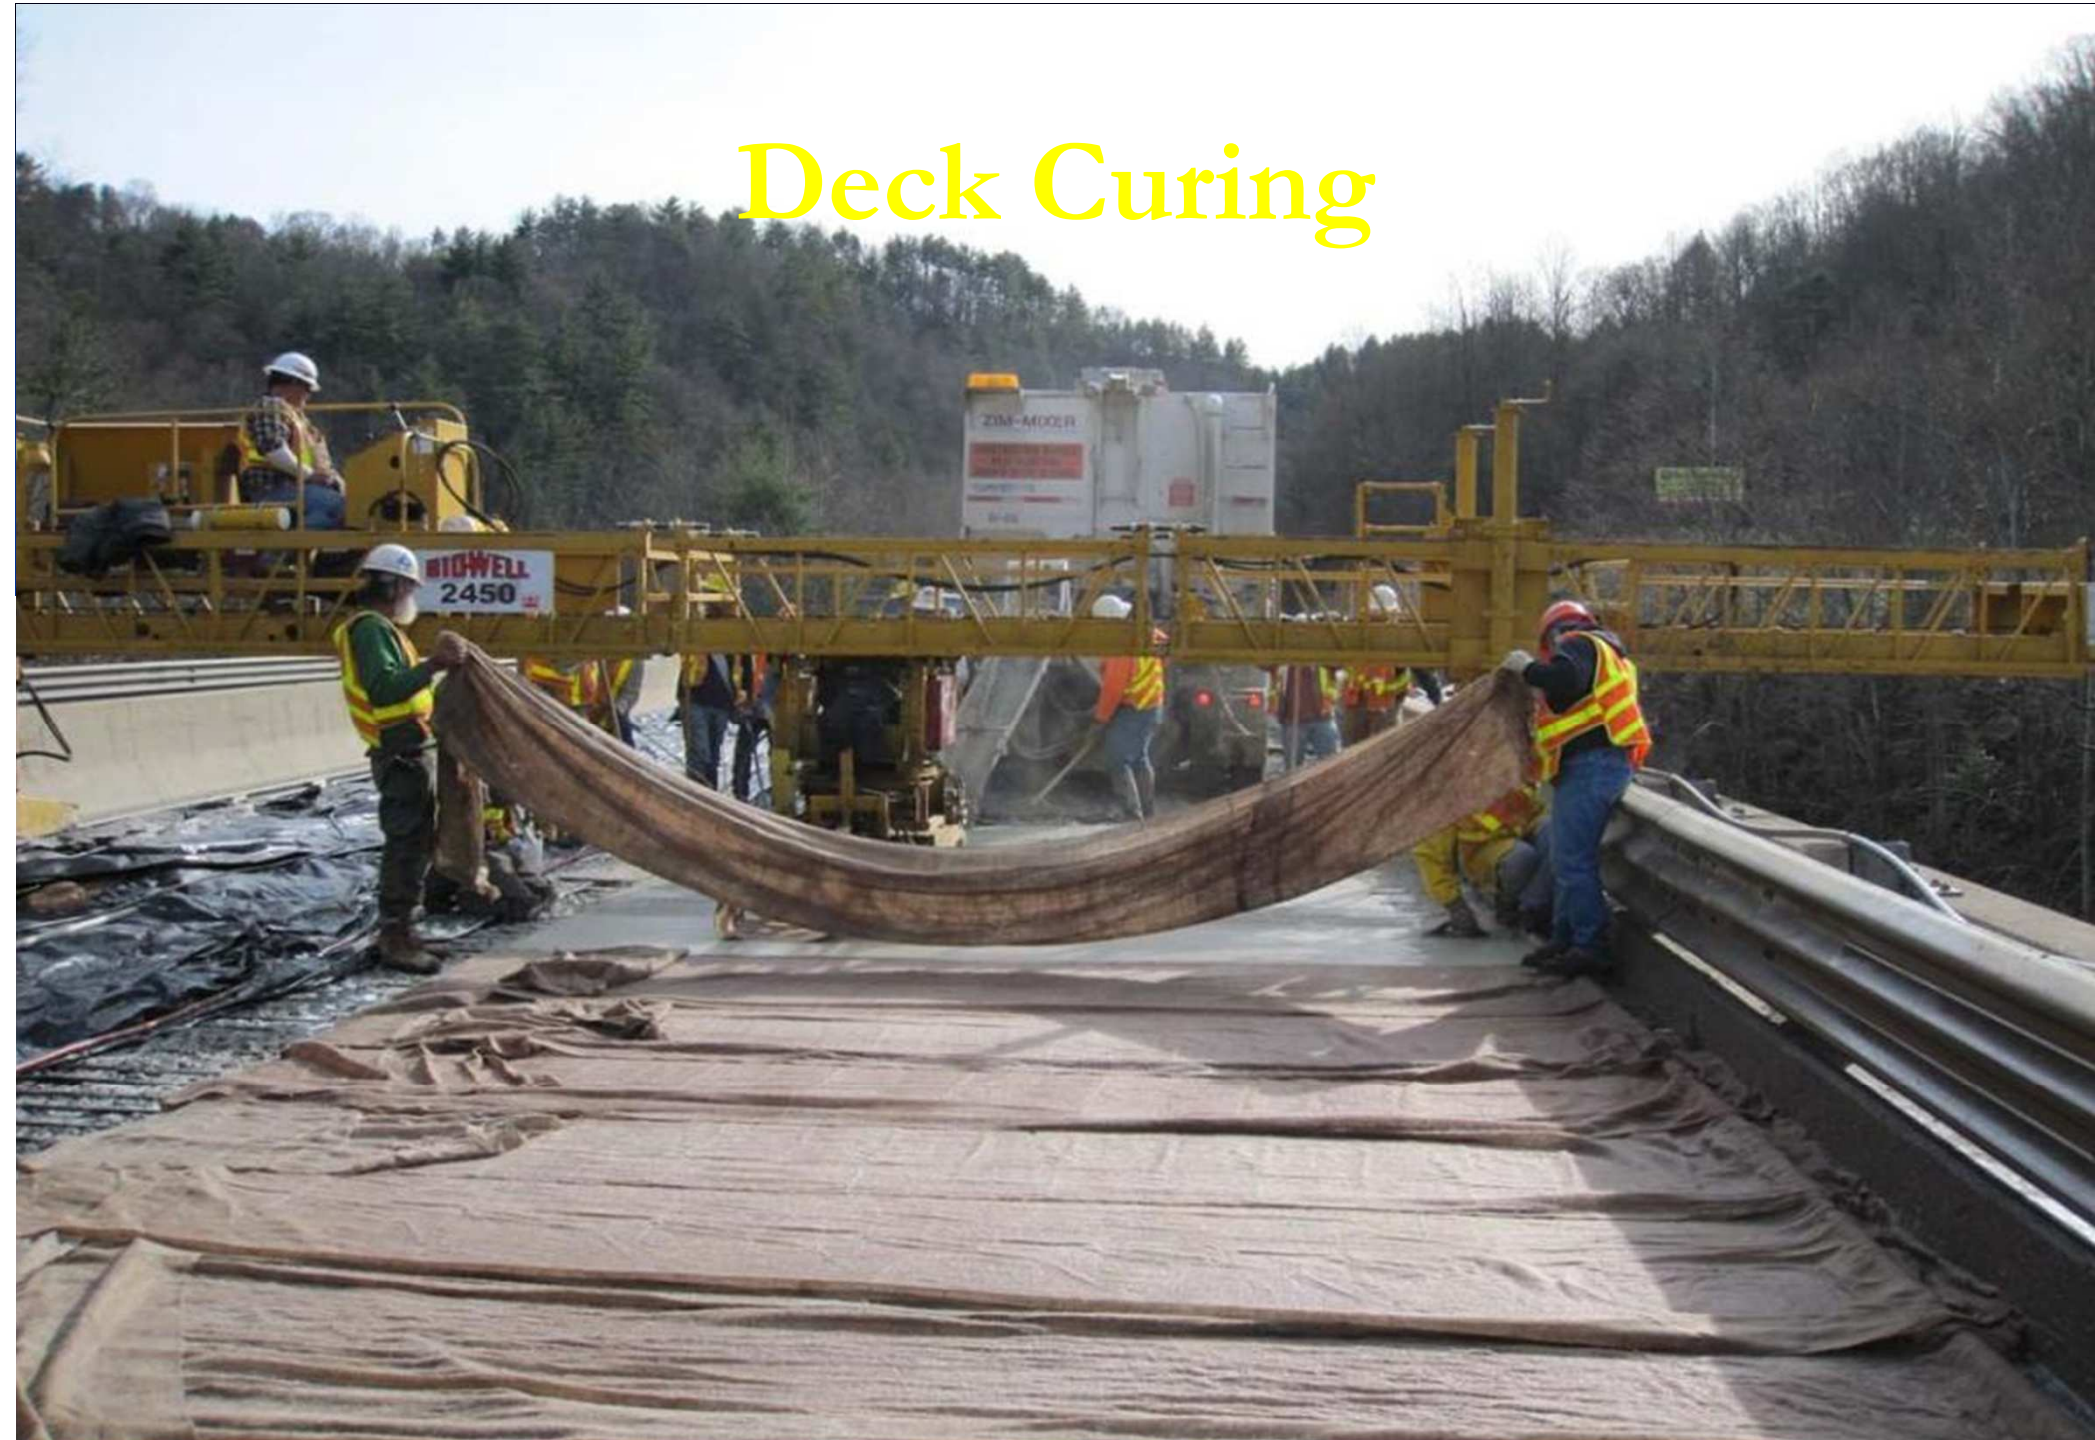
Deck Curing

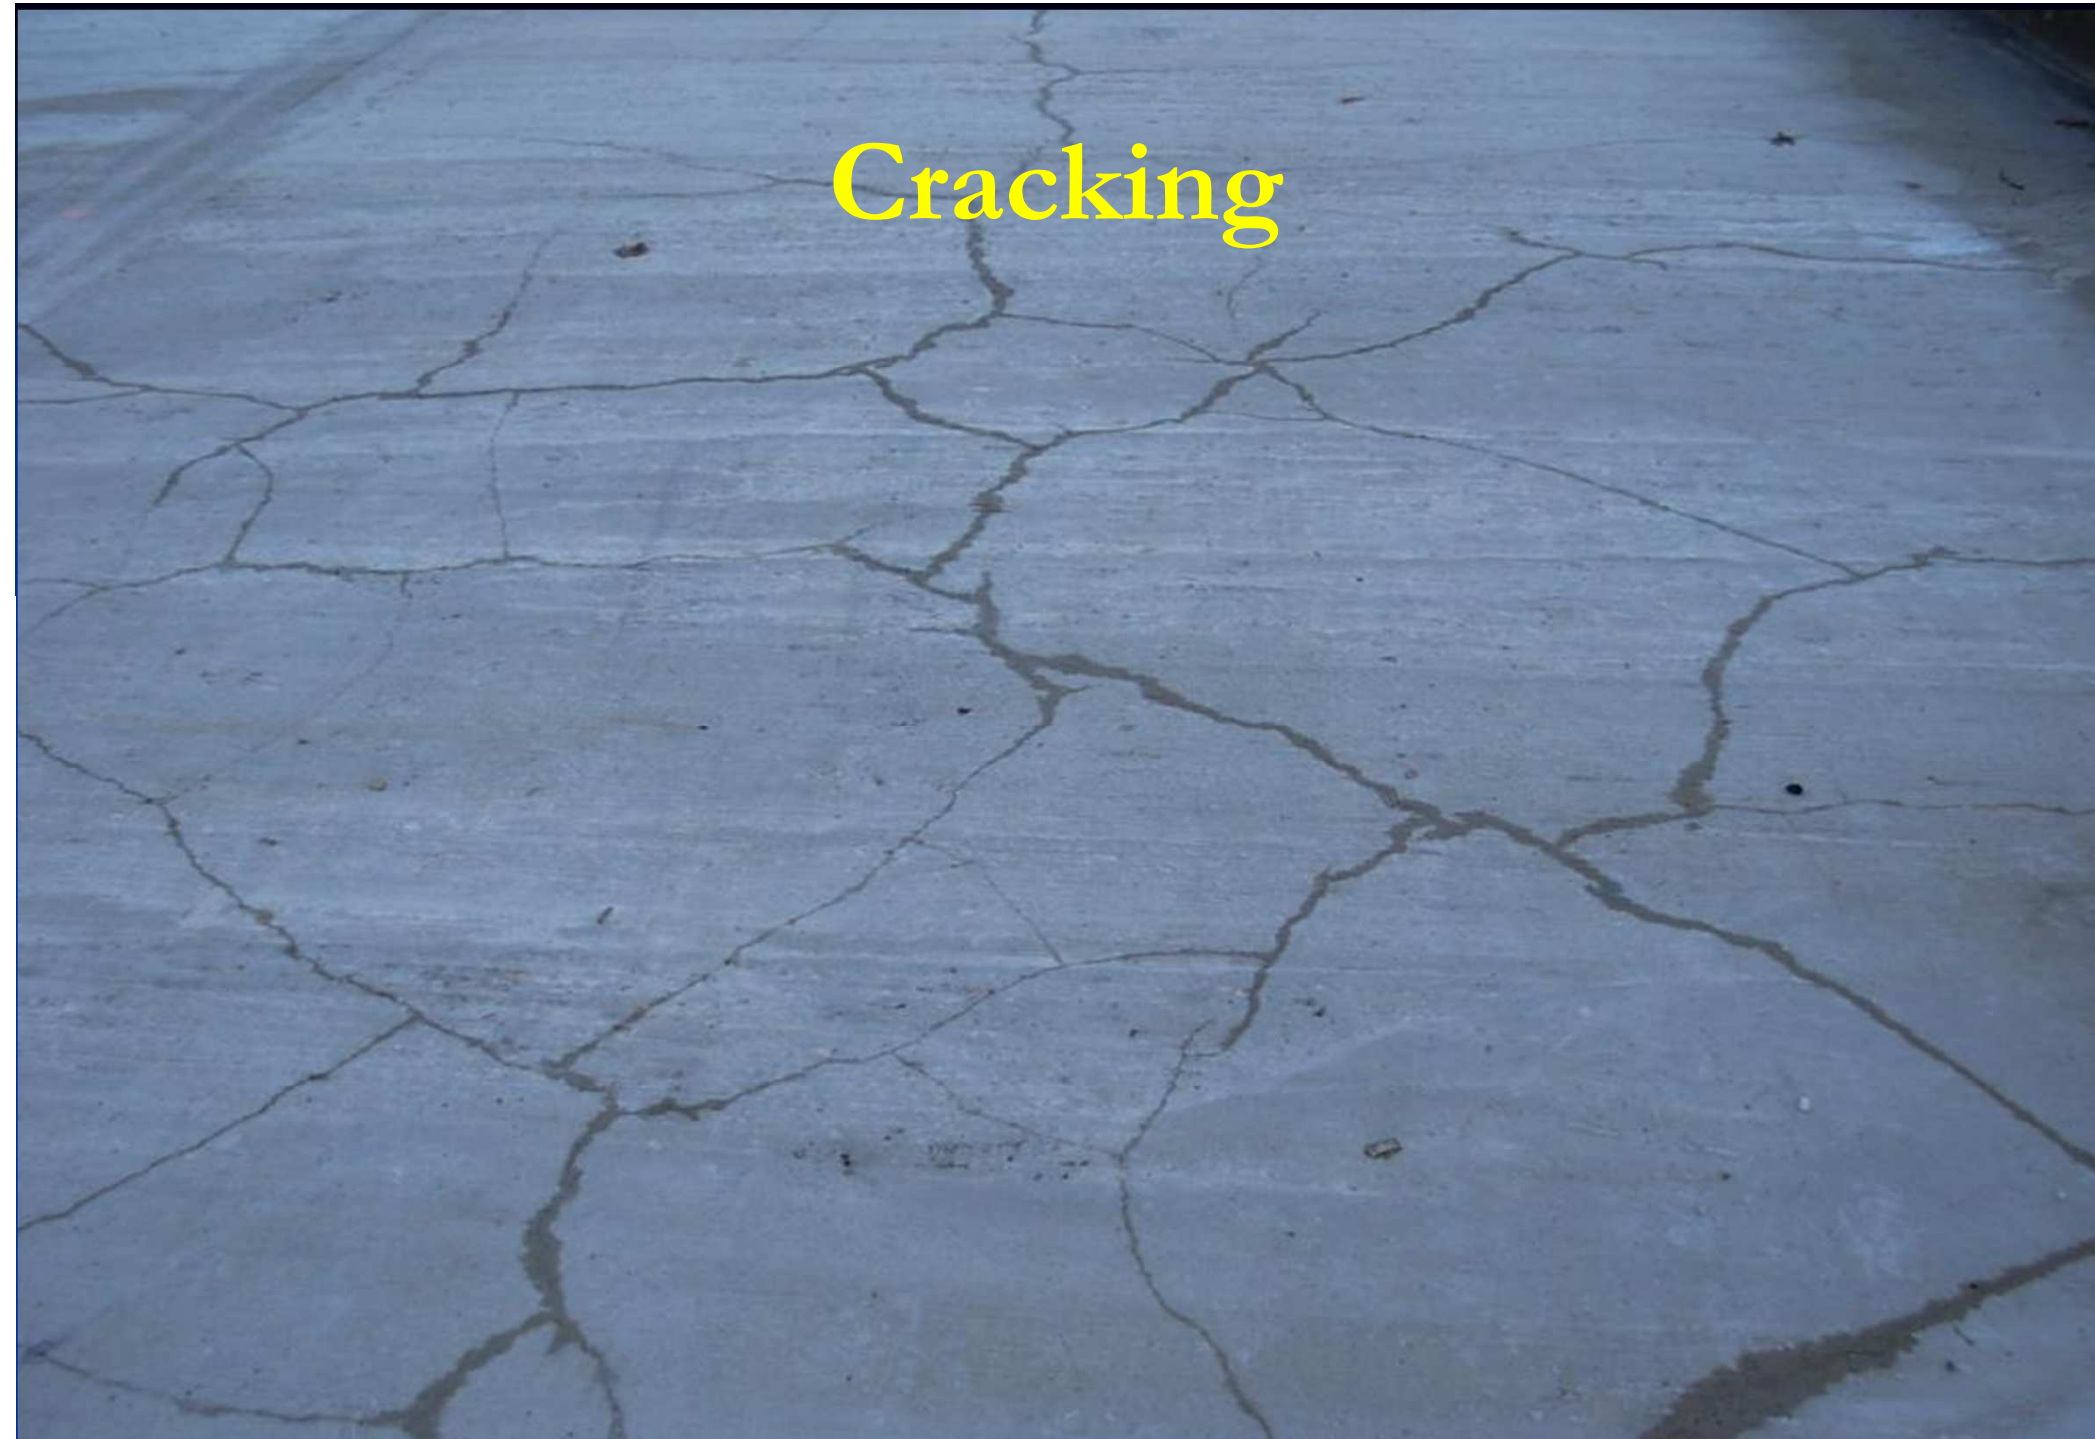
Cracking

Ambient Air Temperature – 47 F – 50 F

Humidity – avg. 18-20%

Deck Temp. – 51 F

Concrete Mix Temp. – 60 F

Wind Speed – Sustained 10 mph, gusts to 25+

Concrete Mix Air Content – Avg. 5%

3 Hr. Cylinder Break – 4200 PSI

- Consultation with FHWA, VDOT, Contractor, and NCDOT staff
- Remove and replace?
- Deck sealing

- BASF Methacrylate Sealant
- Light sand over top for skid resistance
- Sealants were placed in February 2010 (approx. 2 months after construction began)

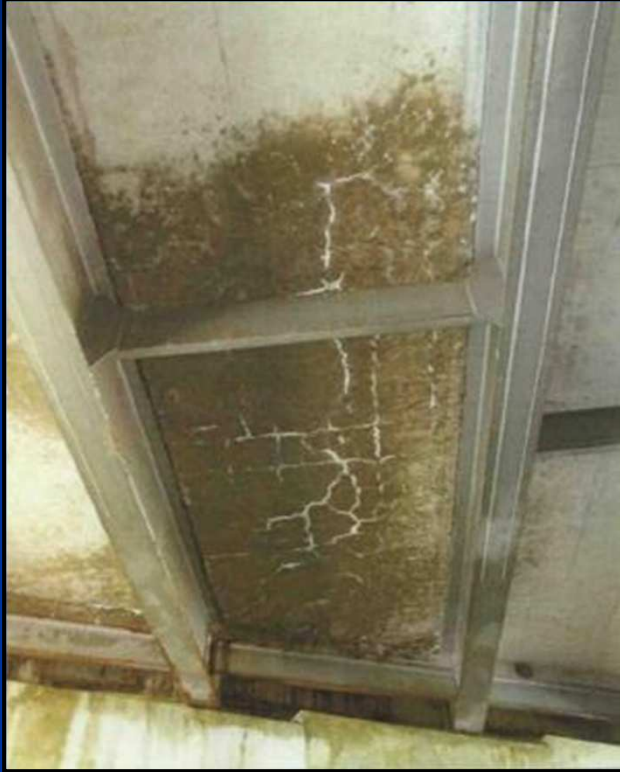
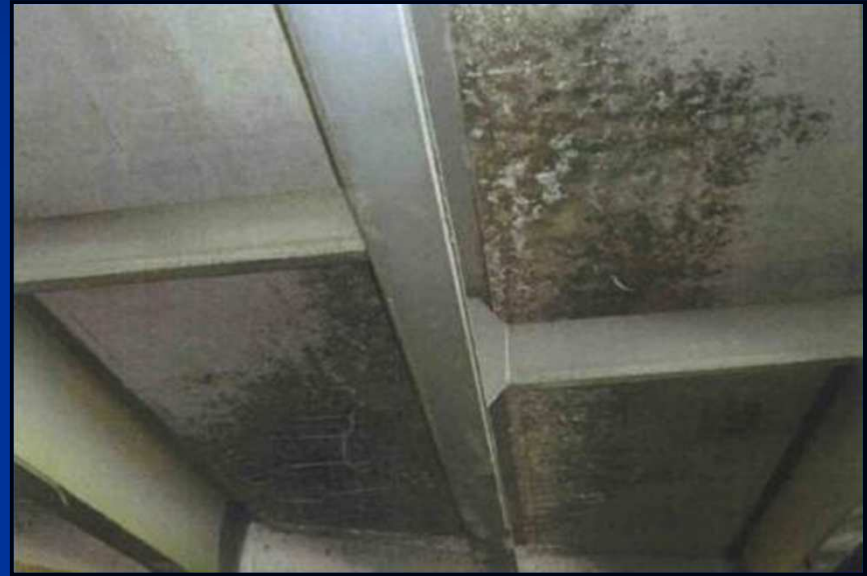
Underside

Full Depth Cracking is apparent

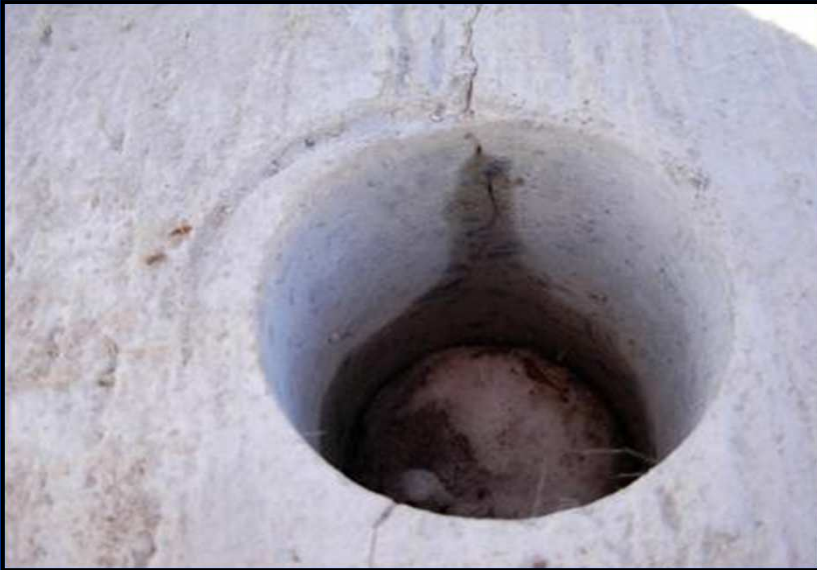
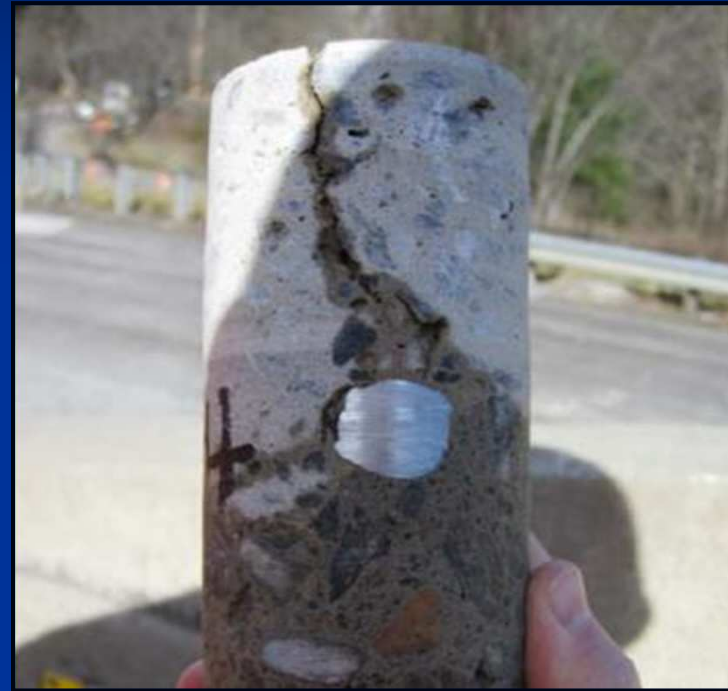
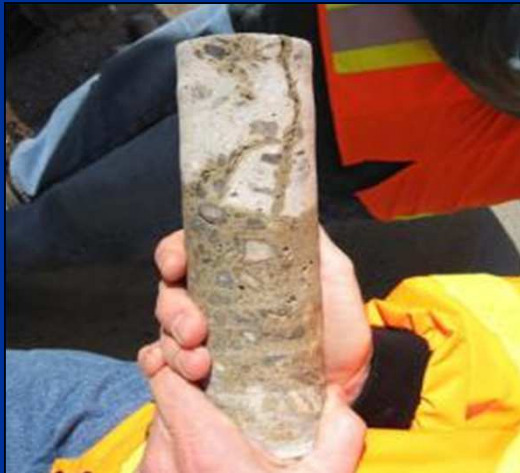
Core Samples

Avg. Cracking – 0.006 – 0.010 in.

Some as large as 0.014 in.

Within 2- 3 SF areas
