**SR 19 OVER LITTLE LAKE HARRIS
BRIDGE I 10026 SUBSTRUCTURE REPAIR
LAKE COUNTY, FL**

Little Lake Harris Bridge

GEOTECHNICAL ENGINEERING EVALUATION

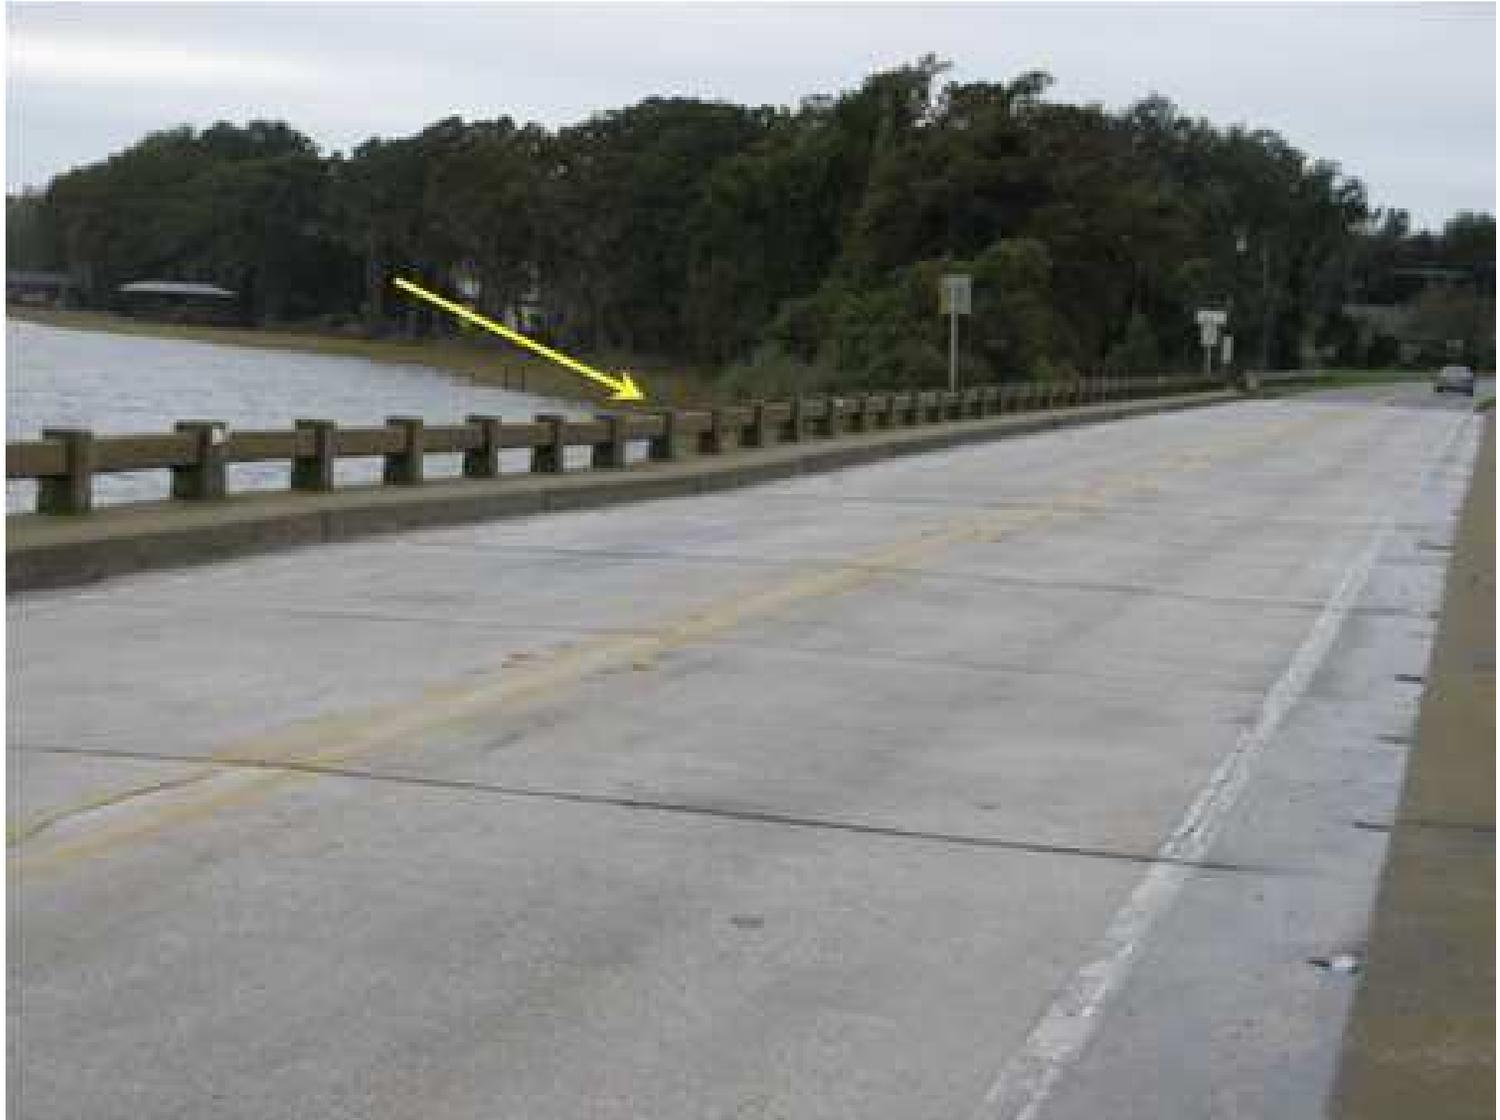
Areas of Settlement

- SR 19 over Little Lake Harris construction was completed in 1951
- In the late 1980's slight settlement was noted in several bents.
- In 1990, the FDOT initiated annual survey of deck elevations during bridge inspections to monitor settlement of the bridge.

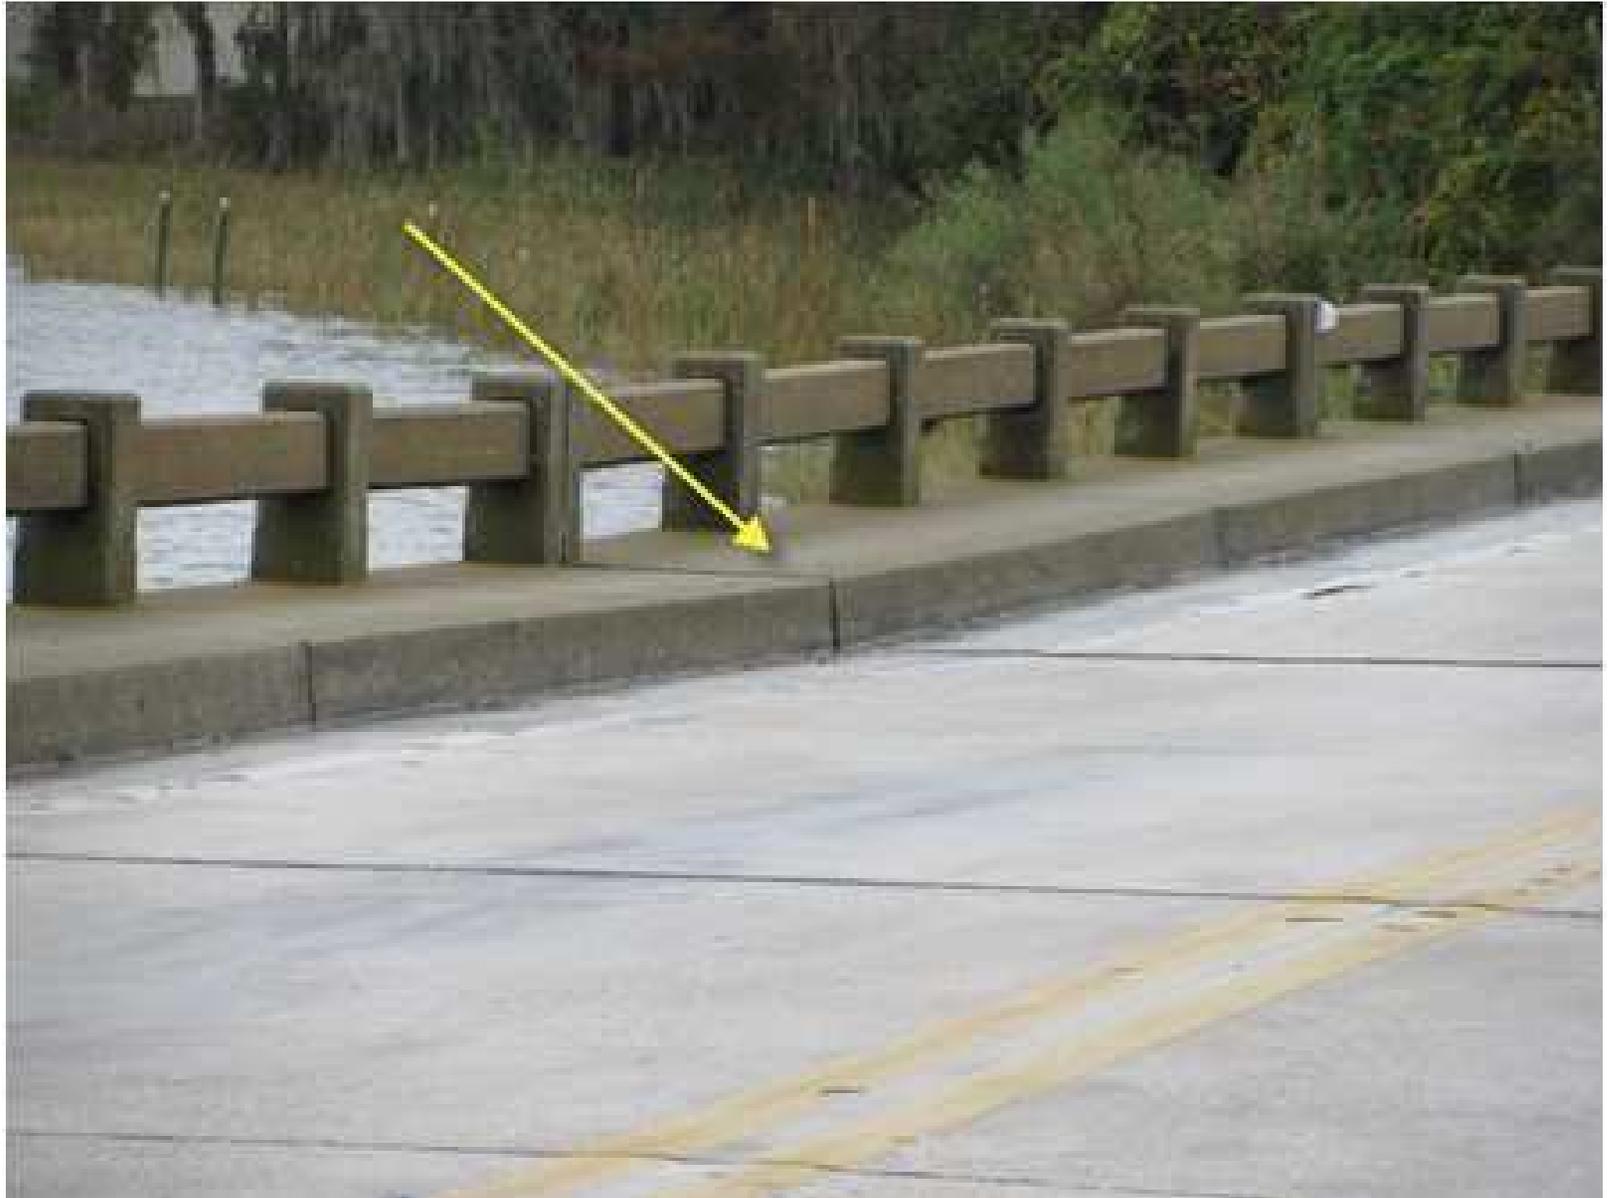
Areas of Settlement

- Settlement was noted to be gradual
- Due to the slow nature of the settlement substructure stability was not a major concern. However public concern over the settlement and increasing rough ride was noticed though complaints to the locals, state representatives and the department.
- Bridge was studied for replacement with a future widening project however initial estimate was over \$53,000,000 due to length of structure.
- Funding for the replacement project was unavailable in the department's 20 year work program.
- FDOT District 5 tasked KCA to provide a design for crutch bent remediation of the settled areas.

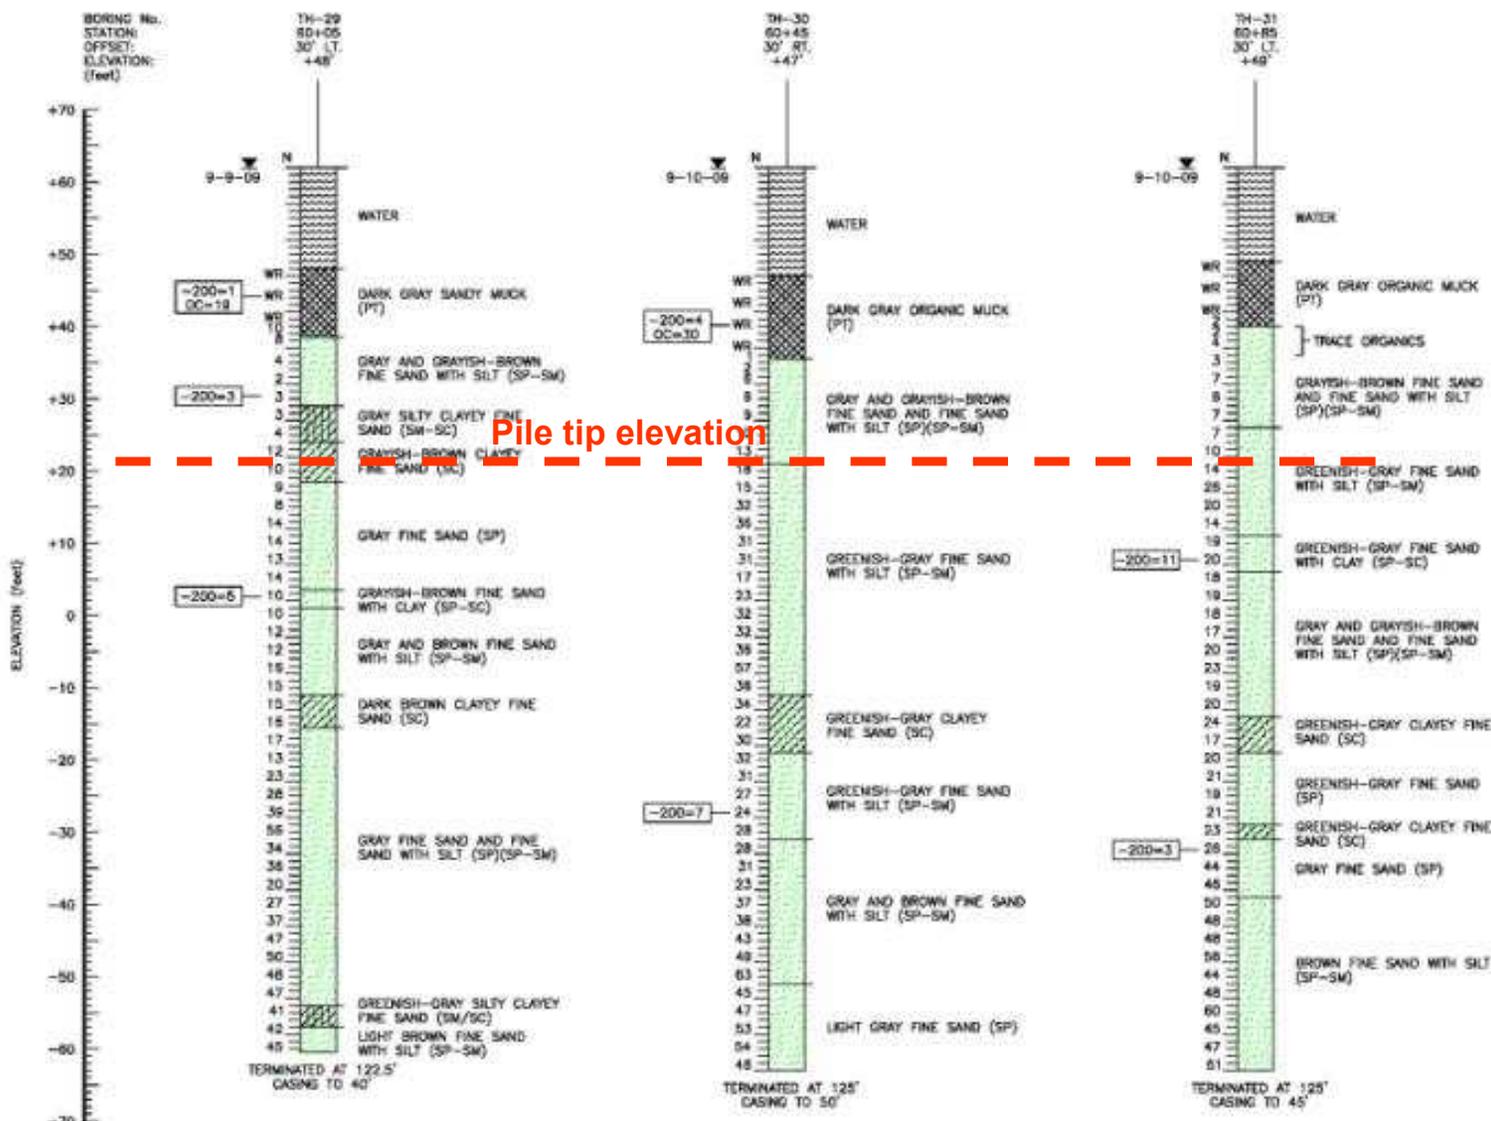
Pile tip elevation

- TH-7** DETAIL BORING PROFILES SHOWN ON FIGURE 2.
- 31 AVERAGE PILE TIP ELEVATION AS PER DRIVING RECORDS.
 - 12 AVERAGE PILE TIP ELEVATION TO ACHIEVE 40 TONS (Meyerhof)
 - 11 AVERAGE PILE TIP ELEVATION TO ACHIEVE 40 TONS (PBD eep)

- The un-even settlement/heave across some of the studied bents may be attributed to substantial difference in subsoil conditions at both ends of the cap, which was not explored
- The main reason for the observed settlement is the relatively weak/loose subsoil conditions at specific bent locations
- This resulted in initial settlement of the pile foundations causing a small dip
