# Cost-Effectively Extending Service Lives of Severely Deteriorated Concrete

**Substructures**  
NE Bridge Preservation Partnership  
September 29, 2010

***Siva Venugopalan***  
*Principal Engineer*  
*Siva Corrosion Services (SCS)*  
[Siva@SivaCorrosion.com](mailto:Siva@SivaCorrosion.com)  
[www.SivaCorrosion.com](http://www.SivaCorrosion.com)

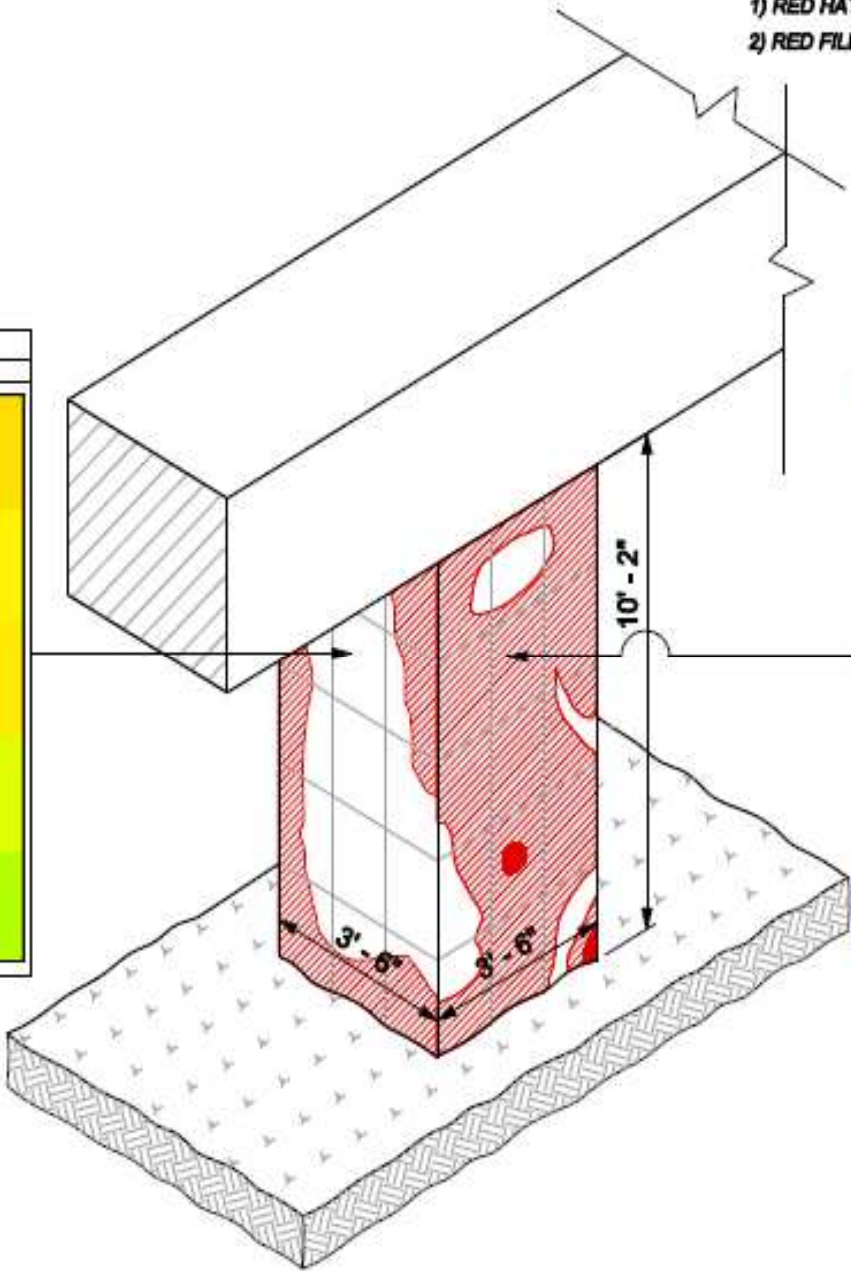
**PIER 1 COLUMN 2  
EAST/NORTH ELEVATION  
N.T.S.**

COVER			HALF-CELL		
1.30	2.10	2.30	-333	-375	-390
2.30	2.15	1.85	-325	-307	-305
1.30	1.75	1.75	-391	-228	-342
2.60	1.65	2.00	-382	-178	-300
2.10	1.90	2.30	-255	-226	-268

COVER			HALF-CELL		
2.10	1.90	2.20	-370	-375	-347
2.15	1.90	2.35	-344	-258	-264
2.15	1.90	1.85	-328	-222	-240
2.15	1.90	1.90	-288	-233	-288
2.20	1.75	2.15	-300	-301	-248

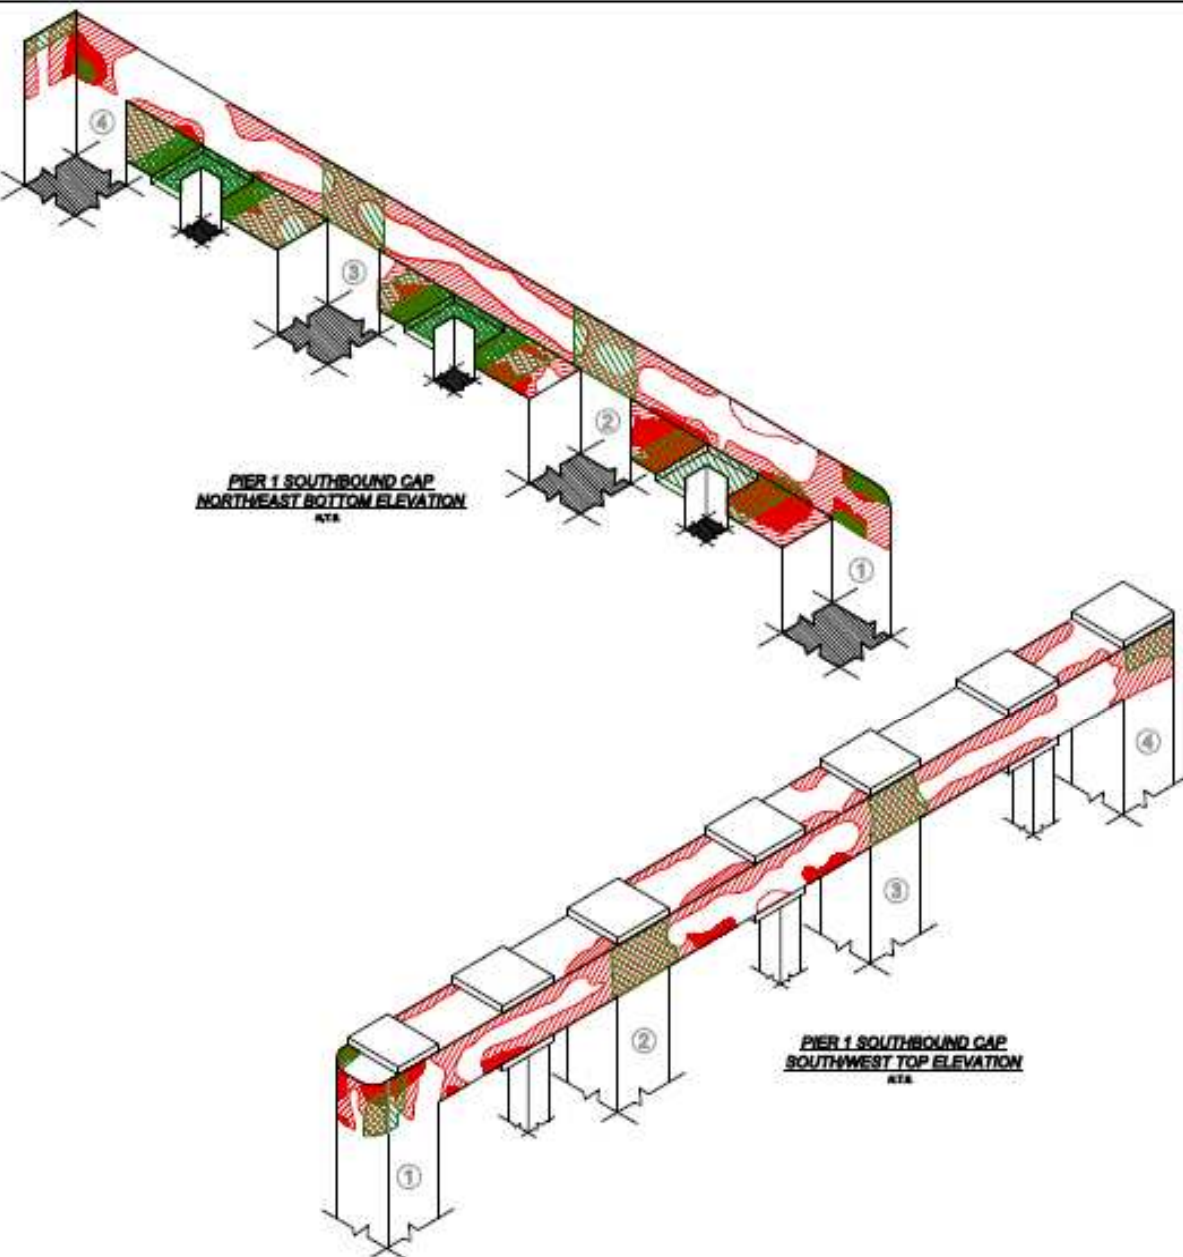
<b>PIER 1 SOUTHBOUND CAP DELAM &amp; SPALL COMPARISON</b>	
DESIGNED: _____	CHECKED: M.M.
CHECKED: C.C.	CHECKED: M.M.

**Spall and Delamination Comparison over Boulevard  
2009 Siva Corrosion Services and 1997 Alpha Corporation**

Bridge Member	1997 Structure Damage (ft <sup>2</sup> )	2009 Structure Damage (ft <sup>2</sup> )	Damage Increase Percentage (1997-2009)
<b>Pier 1</b>			
Pier 1 - Southbound Cap - North Face	52	120	131%
Pier 1 - Southbound Cap - South Face	42	122	190%
Pier 1 - Southbound Cap - West Face	2	11	450%
Pier 1 - Southbound Cap - East Face	5	9	80%
Pier 1 - Southbound Cap - Top Face	3	18	500%
* Pier 1 - Southbound Cap - Bottom Face	127	99	-
<b>Total: Pier 1 - Southbound Cap</b>	<b>231</b>	<b>379</b>	<b>64%</b>
* Patch work for steel columns has caused a decrease in damaged concrete. Patches constitute 25% of bottom surface area. Patches are included in total surface area.			
<b>Total: Pier 1 - Column 1-4</b>	<b>168</b>	<b>302</b>	<b>80%</b>
<b>Total: Pier 1 - SB Cap &amp; Column 1-4</b>	<b>399</b>	<b>681</b>	<b>71%</b>

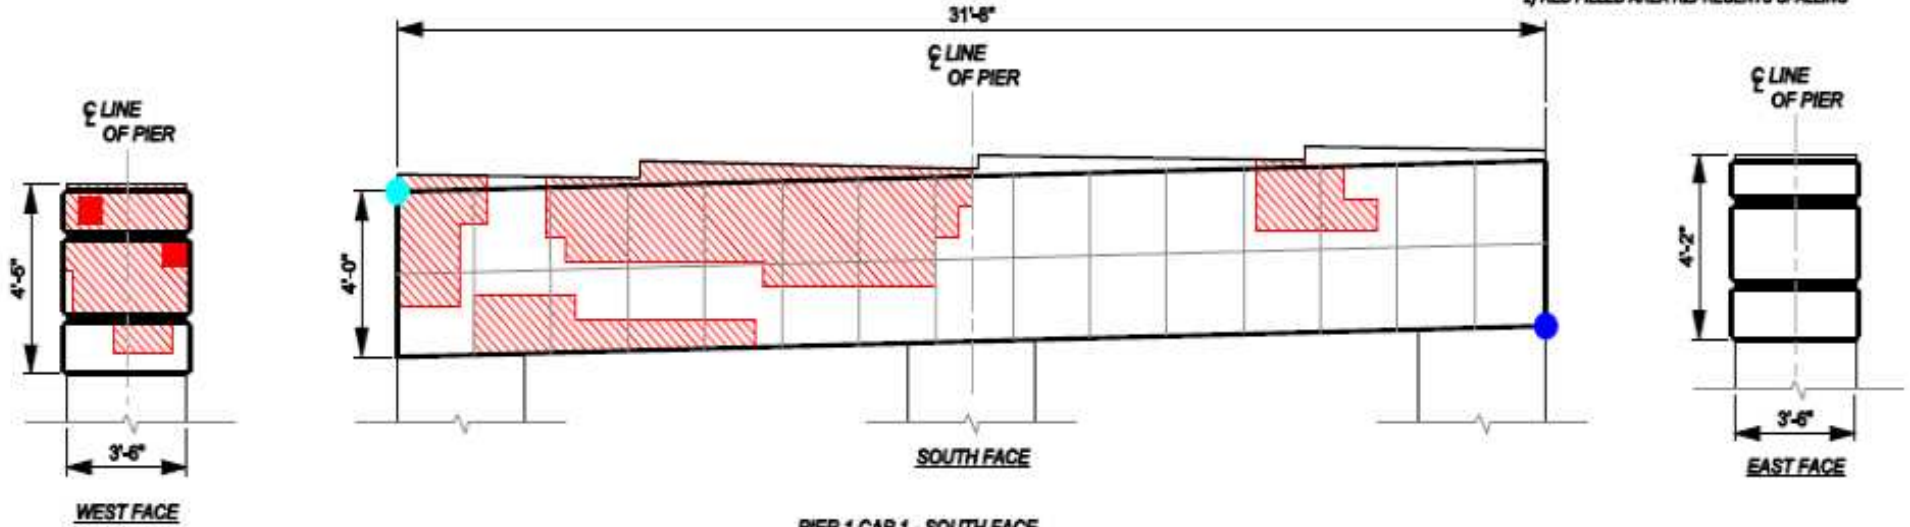
**PIER 1 CAP 1 - SOUTH FACE  
RAMP A OVER GARDEN STATE PARKWAY  
N.T.S.**

PIER 1 CAP 1 - RAMP A OVER GARDEN STATE PARKWAY														
COVER														
2.70	3.05	3.30	3.15	3.35	3.35	3.95	2.95	2.95	2.75	2.60	2.80	2.55	2.90	2.95
2.76	3.00	3.25	3.25	3.50	3.40	4.45	3.15	3.20	3.10	2.95	3.15	3.15	3.55	3.75
POTENTIAL														
-622	-386	-466	-432	-430	-433	-284	-249	-232	-223	-277	-517	-263	-82	-96
-541	-340	-450	-435	-305	-275	-206	-383	-298	-232	-218	-265	-130	-27	-109

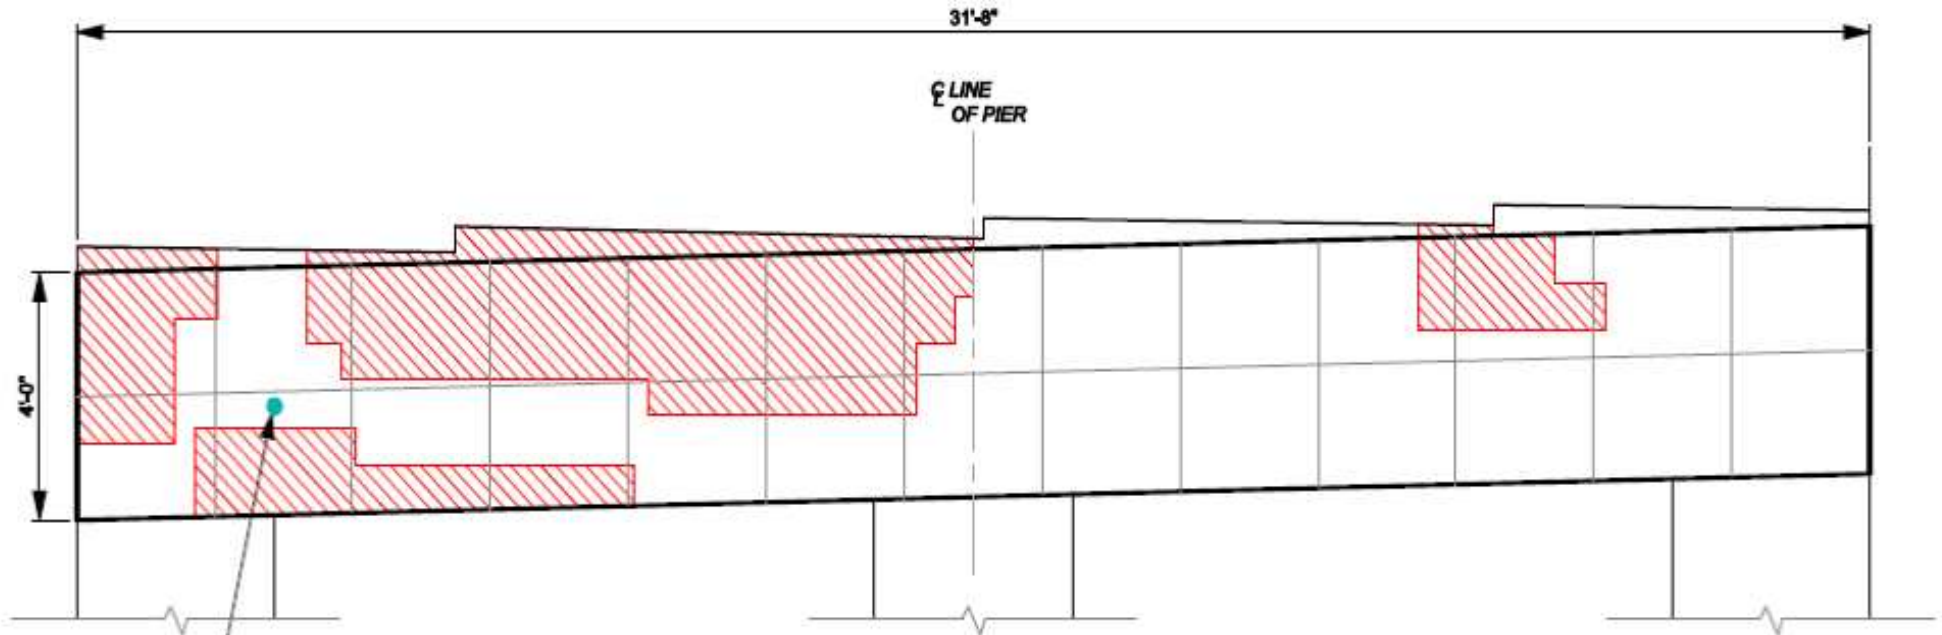
**PIER 1 CAP 1 - SOUTH FACE -  
RAMP A OVER GARDEN STATE PARKWAY**  
N.T.S.

**CHLORIDE TESTING LOCATIONS AND RESULTS**

LOCATION	DEPTH	Cl, WT % POWDER
SOUTH FACE - B2 - 1	0" - 1"	0.103
SOUTH FACE - B2 - 2	1" - 2"	0.038
SOUTH FACE - B2 - 3	2" - 3"	0.028
SOUTH FACE - B2 - 4	3" - 4"	0.011
SOUTH FACE - B2 - 5	4" - 5"	0.008
SOUTH FACE - B2 - 6	5" - 6"	0.007

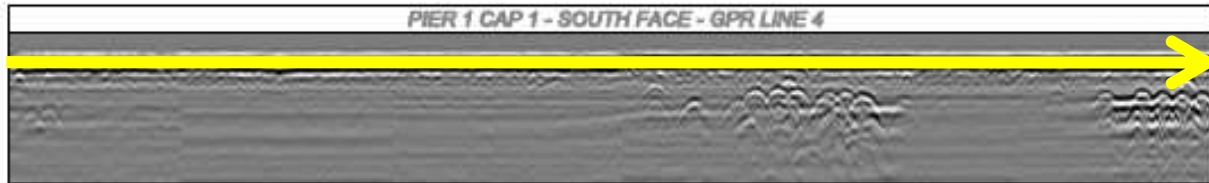
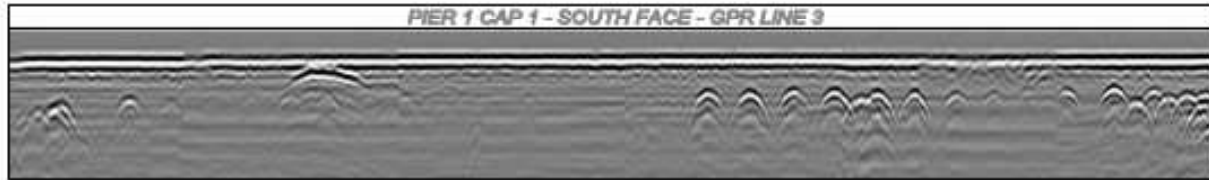
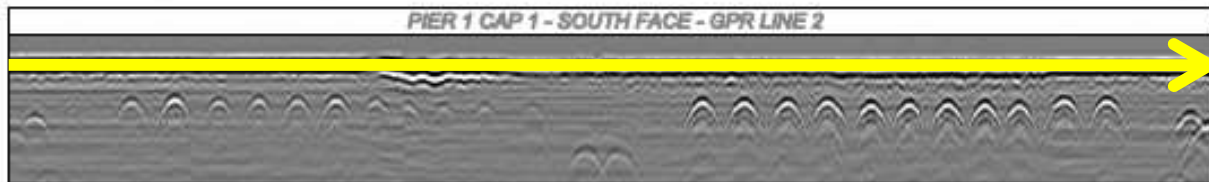
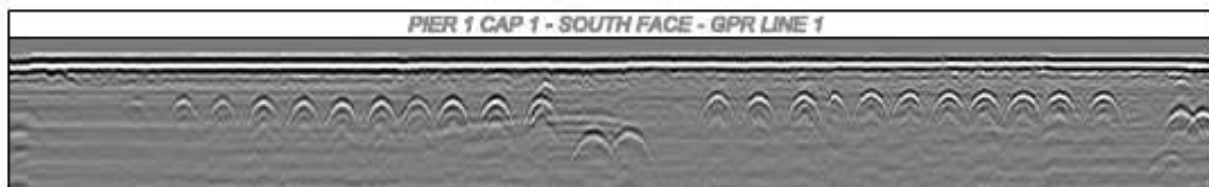
**PIER 1 CAP 1 - SOUTH FACE**  
**RAMP A OVER GARDEN STATE PARKWAY**  
 N.T.S.

\* NOTE: GPR READINGS TAKEN FROM CENTER LINE OF COLUMN 1 TO CENTER LINE OF COLUMN 3.
