Condition Assessment Guide for Bridge Coatings

Glenn A. Washer, Ph.D.

Midwest Bridge Preservation Partnership 2010

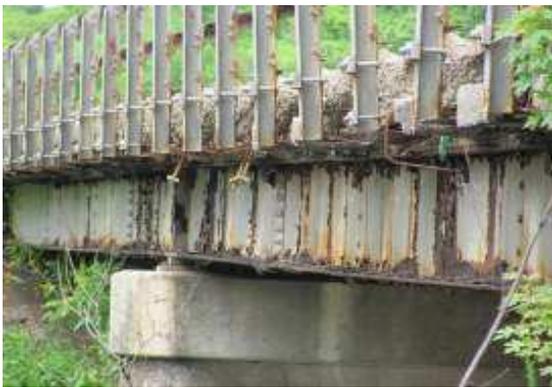
Very Poor

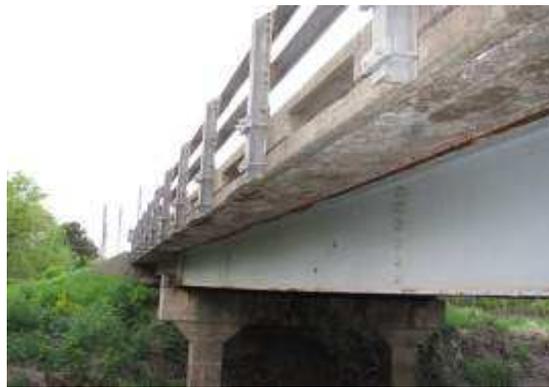
Poor

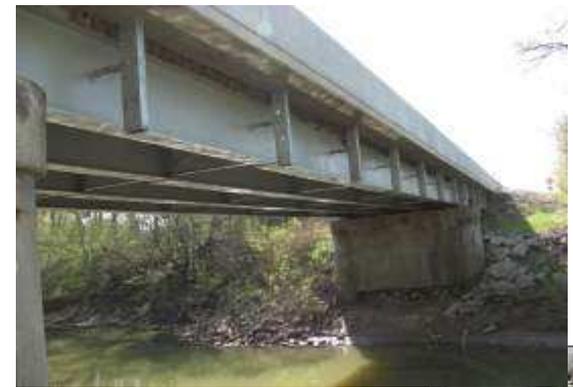
Good

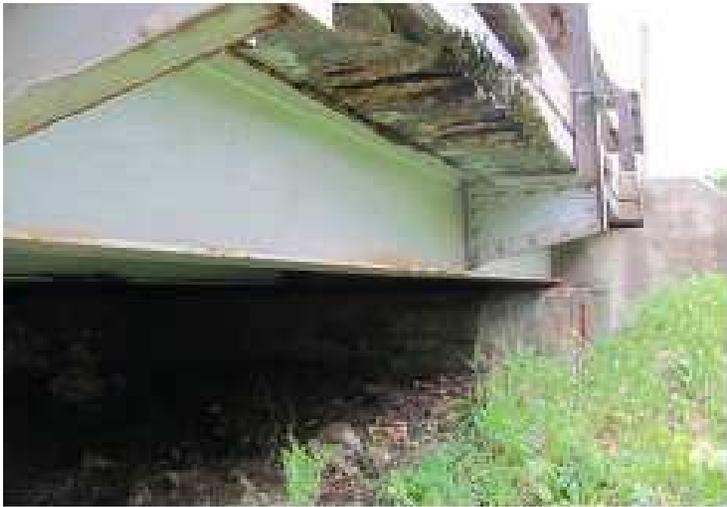
Poor Condition – Exterior Beam End-Span

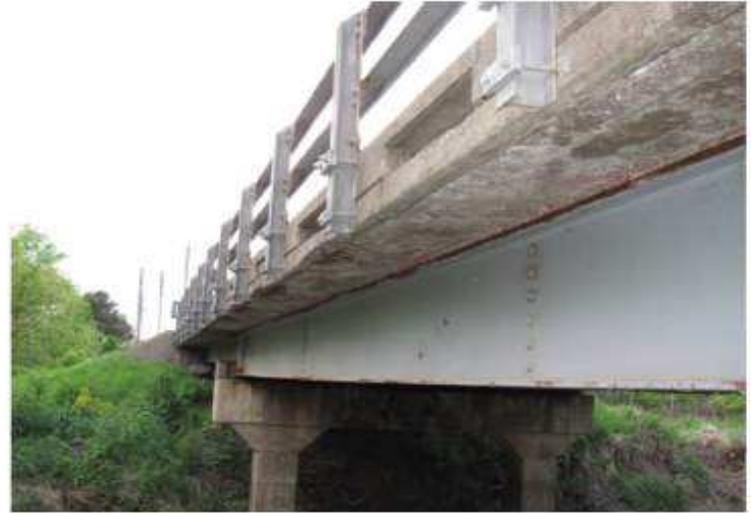
Poor Condition – Fascia Girder Mid-Span

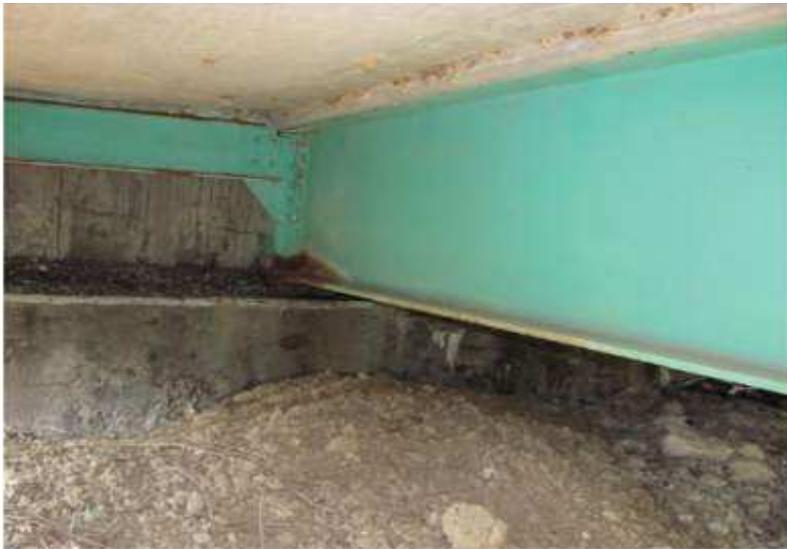
Poor Condition – Interior Beam End-Span

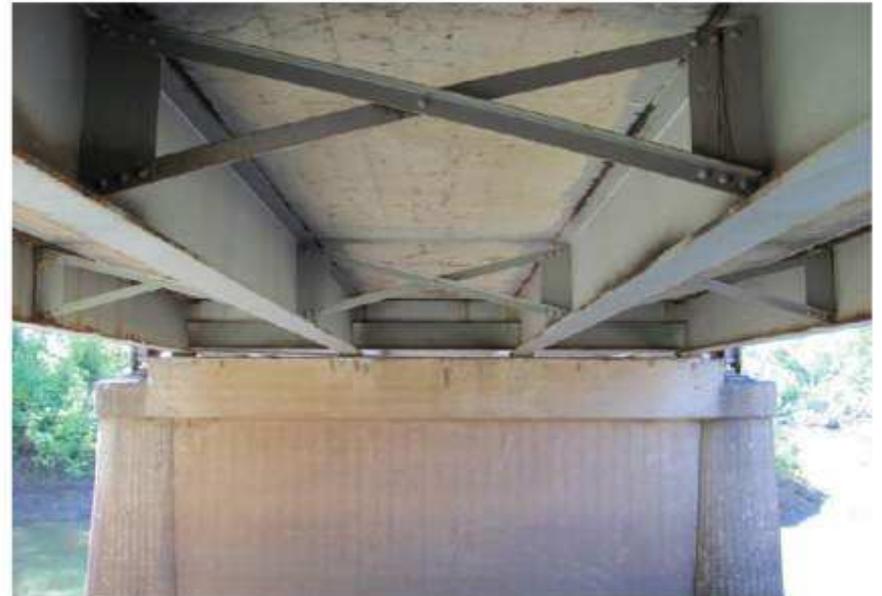
Poor Condition – Interior Beam Mid-Span

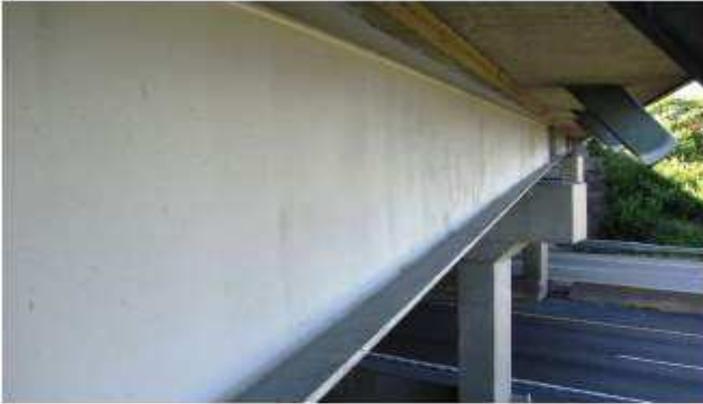
GOOD

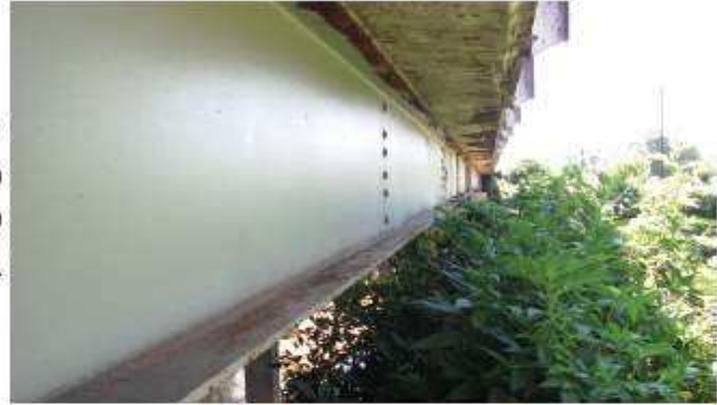
POOR

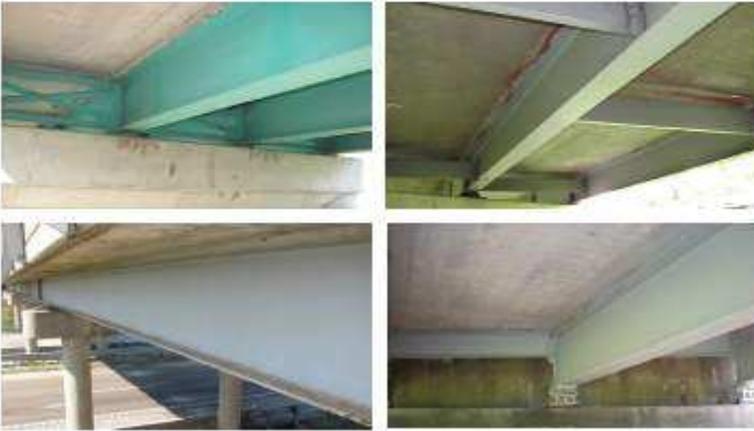
GOOD

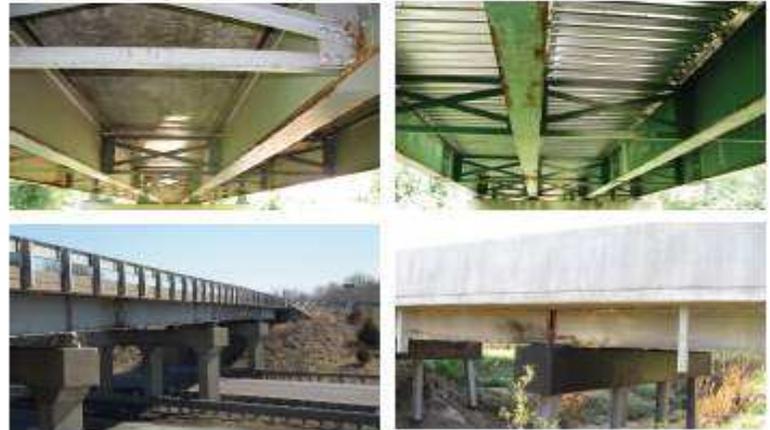
POOR
