#### **Scour Monitoring & Prediction** *From Simple to Sophisticated Schemes*

**2010** Western Bridge Preservation Partnership Sacramento, California

#### **Kevin Flora**

Caltrans Structure Maintenance & Investigation Hydraulics Branch

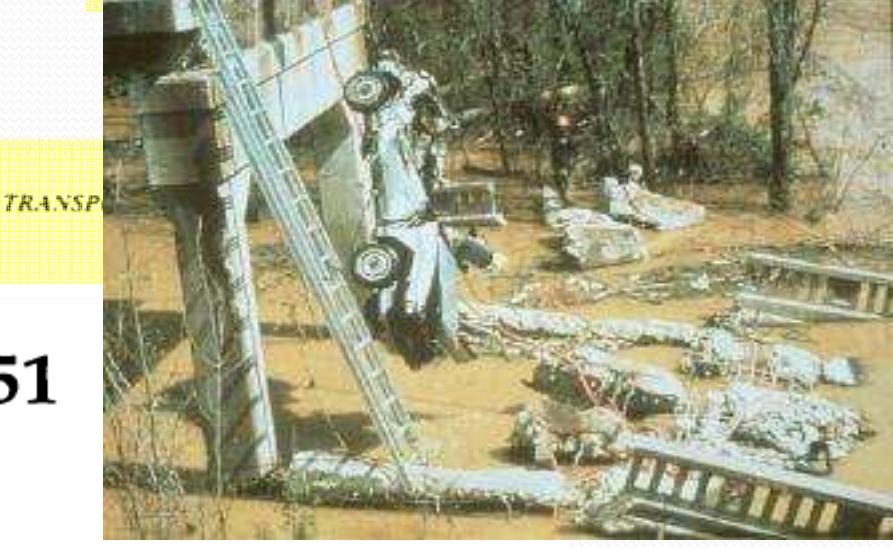
#### April 1989 Hatchie River US-51 **Bridge Failure**

3 Spans Collapsed 5 Vehicles in the River

8 Lives Lost

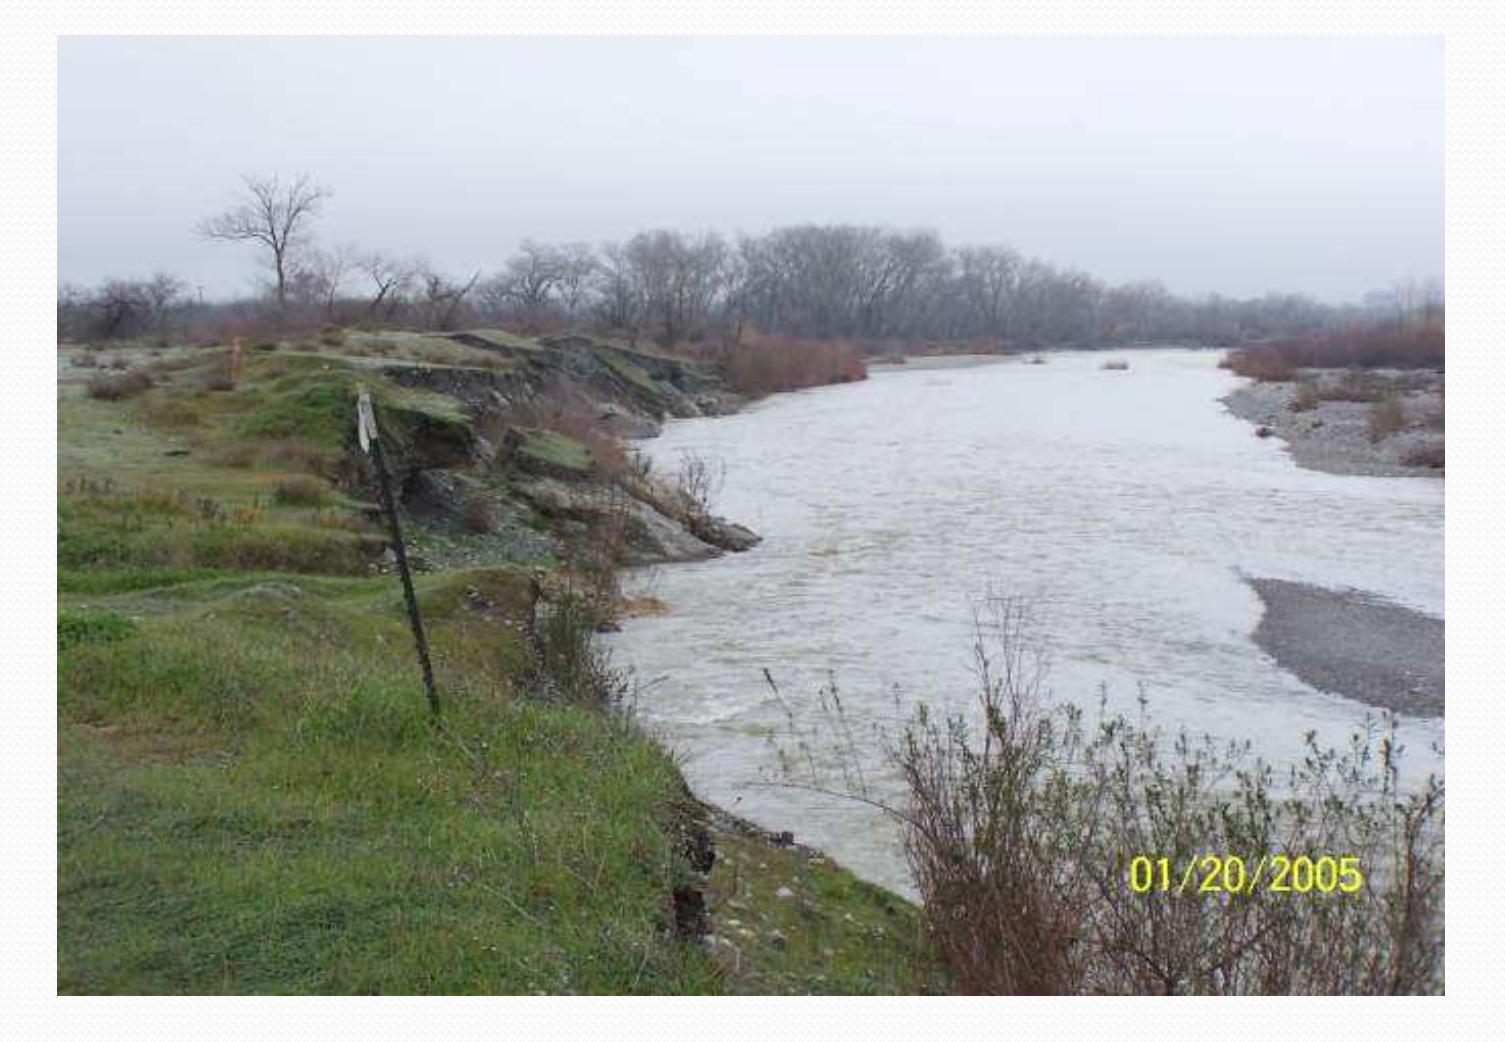
#### **Ongoing Bank Erosion Downstream**

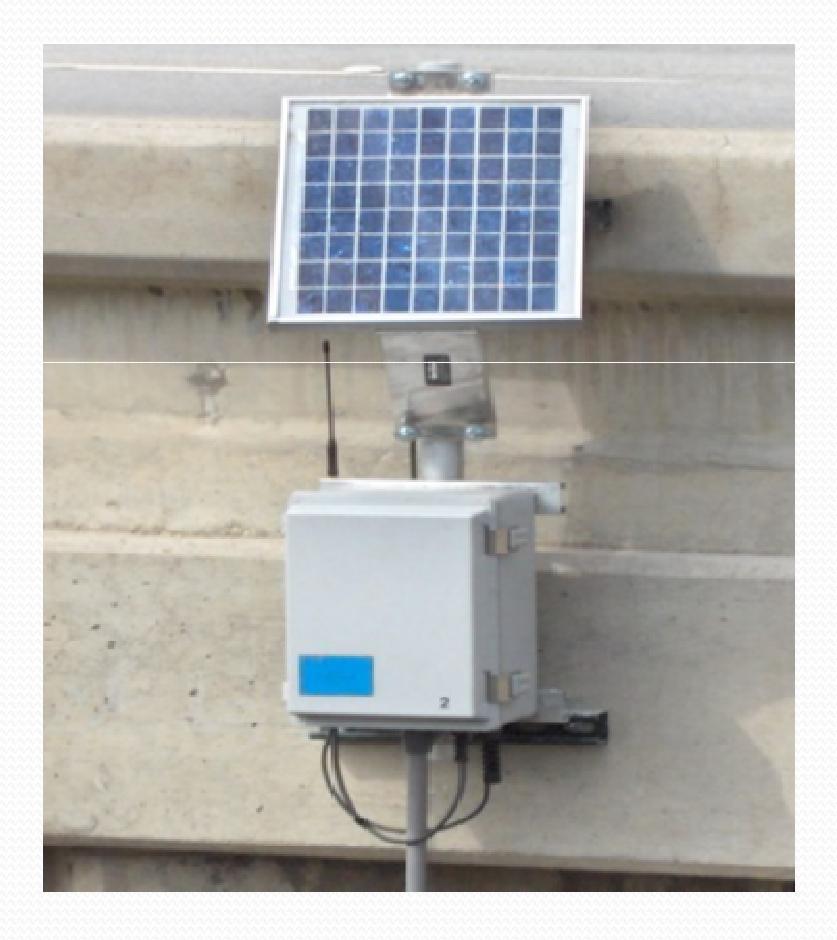
TILT SENSOR

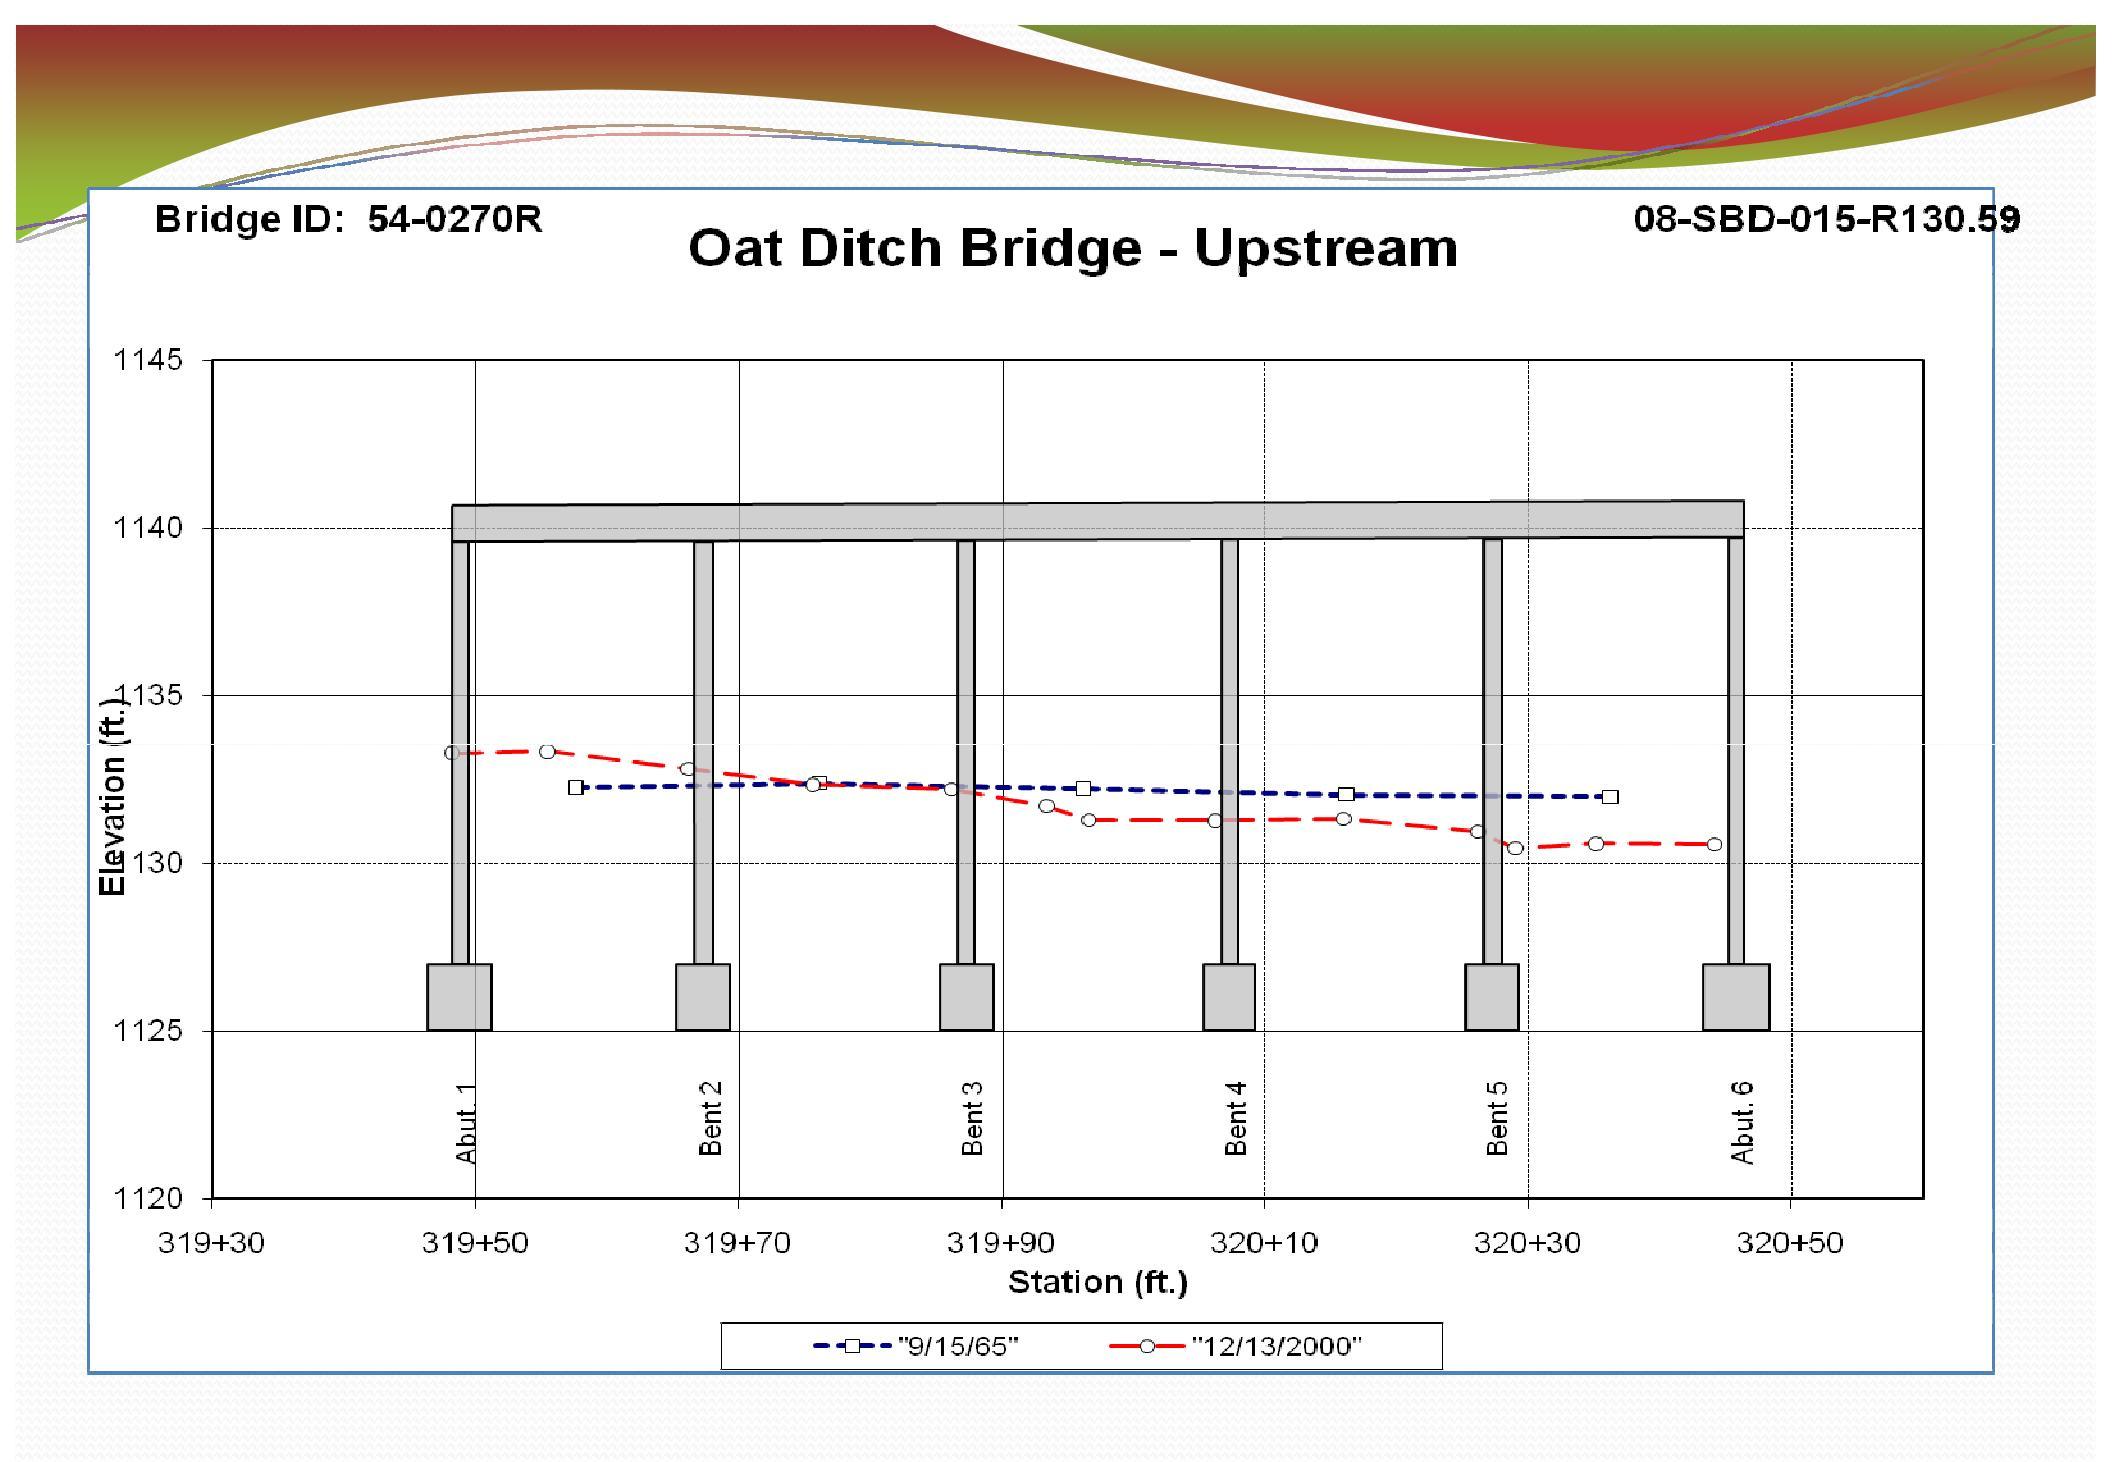
Bridge creates a contraction and is located at a bend in the channel

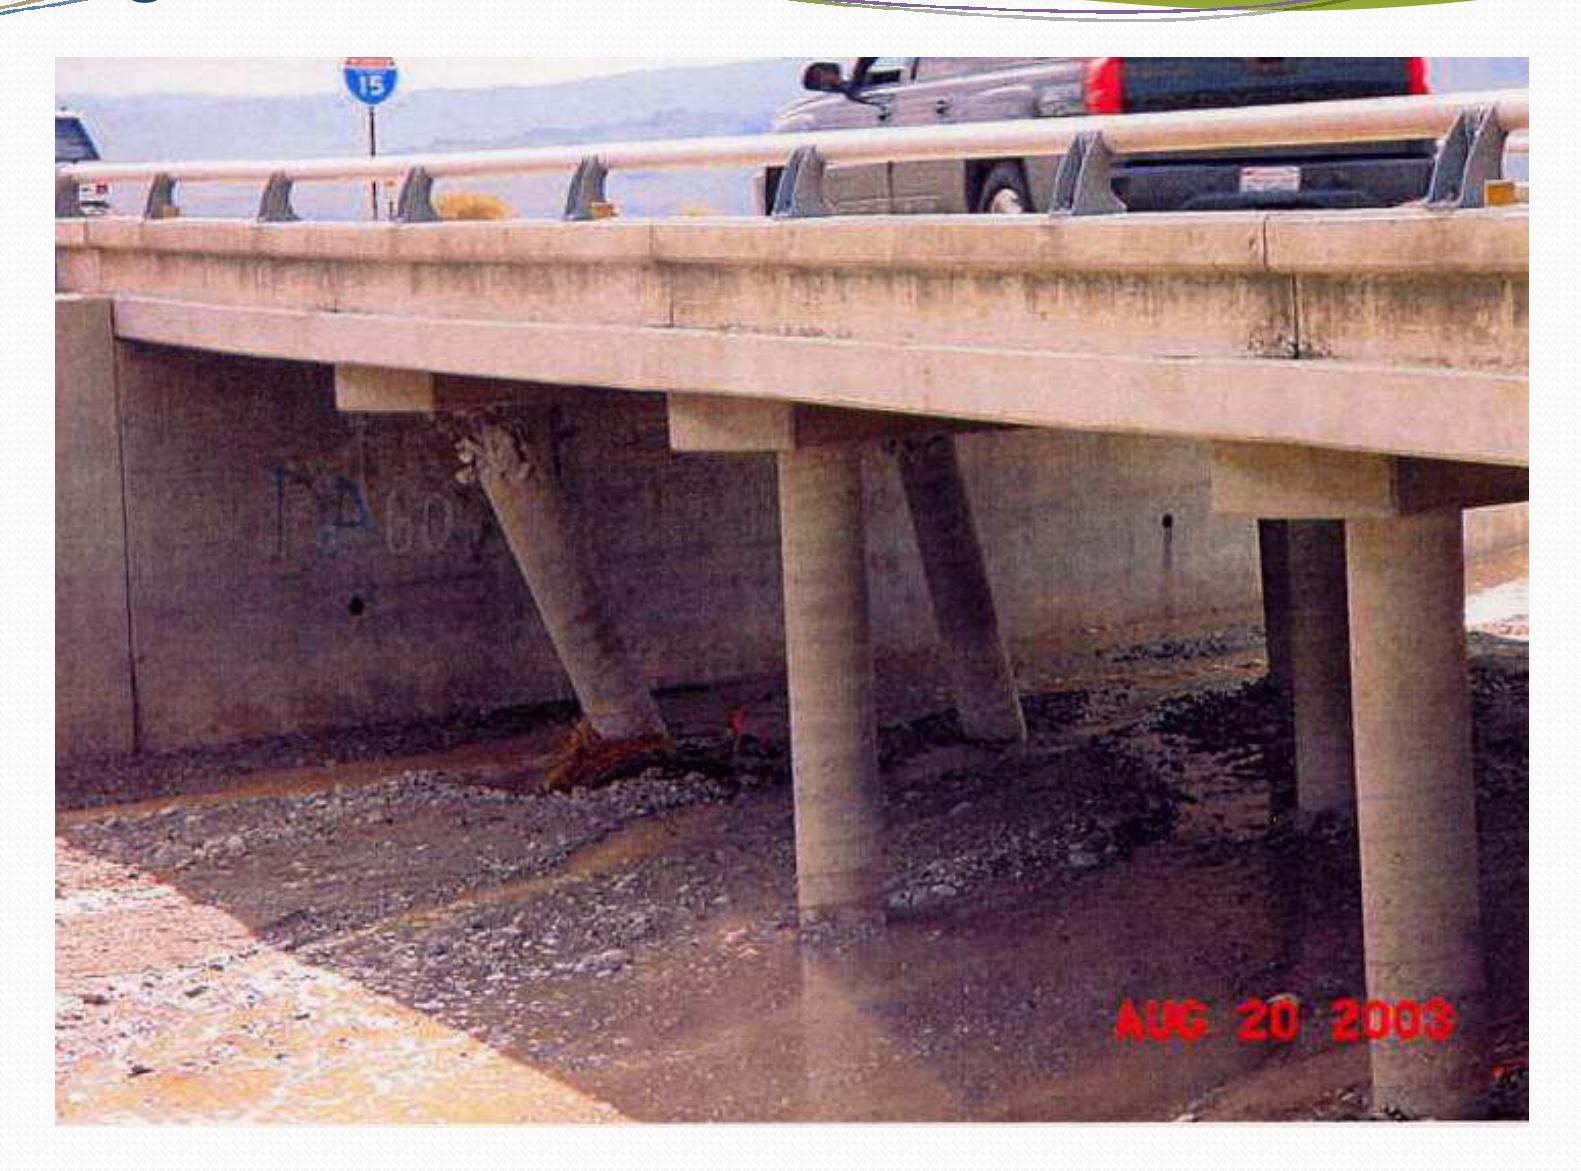
- •Late evening 08/19/03 & early morning hours on 08/20/03, 2 inches of rain poured down on the Oat Ditch basin in approx. 40 minutes by some estimates
- •Bent 5 Right Bridge, columns 1 thru 3 failed at bent cap joint

### First Signs of Failure

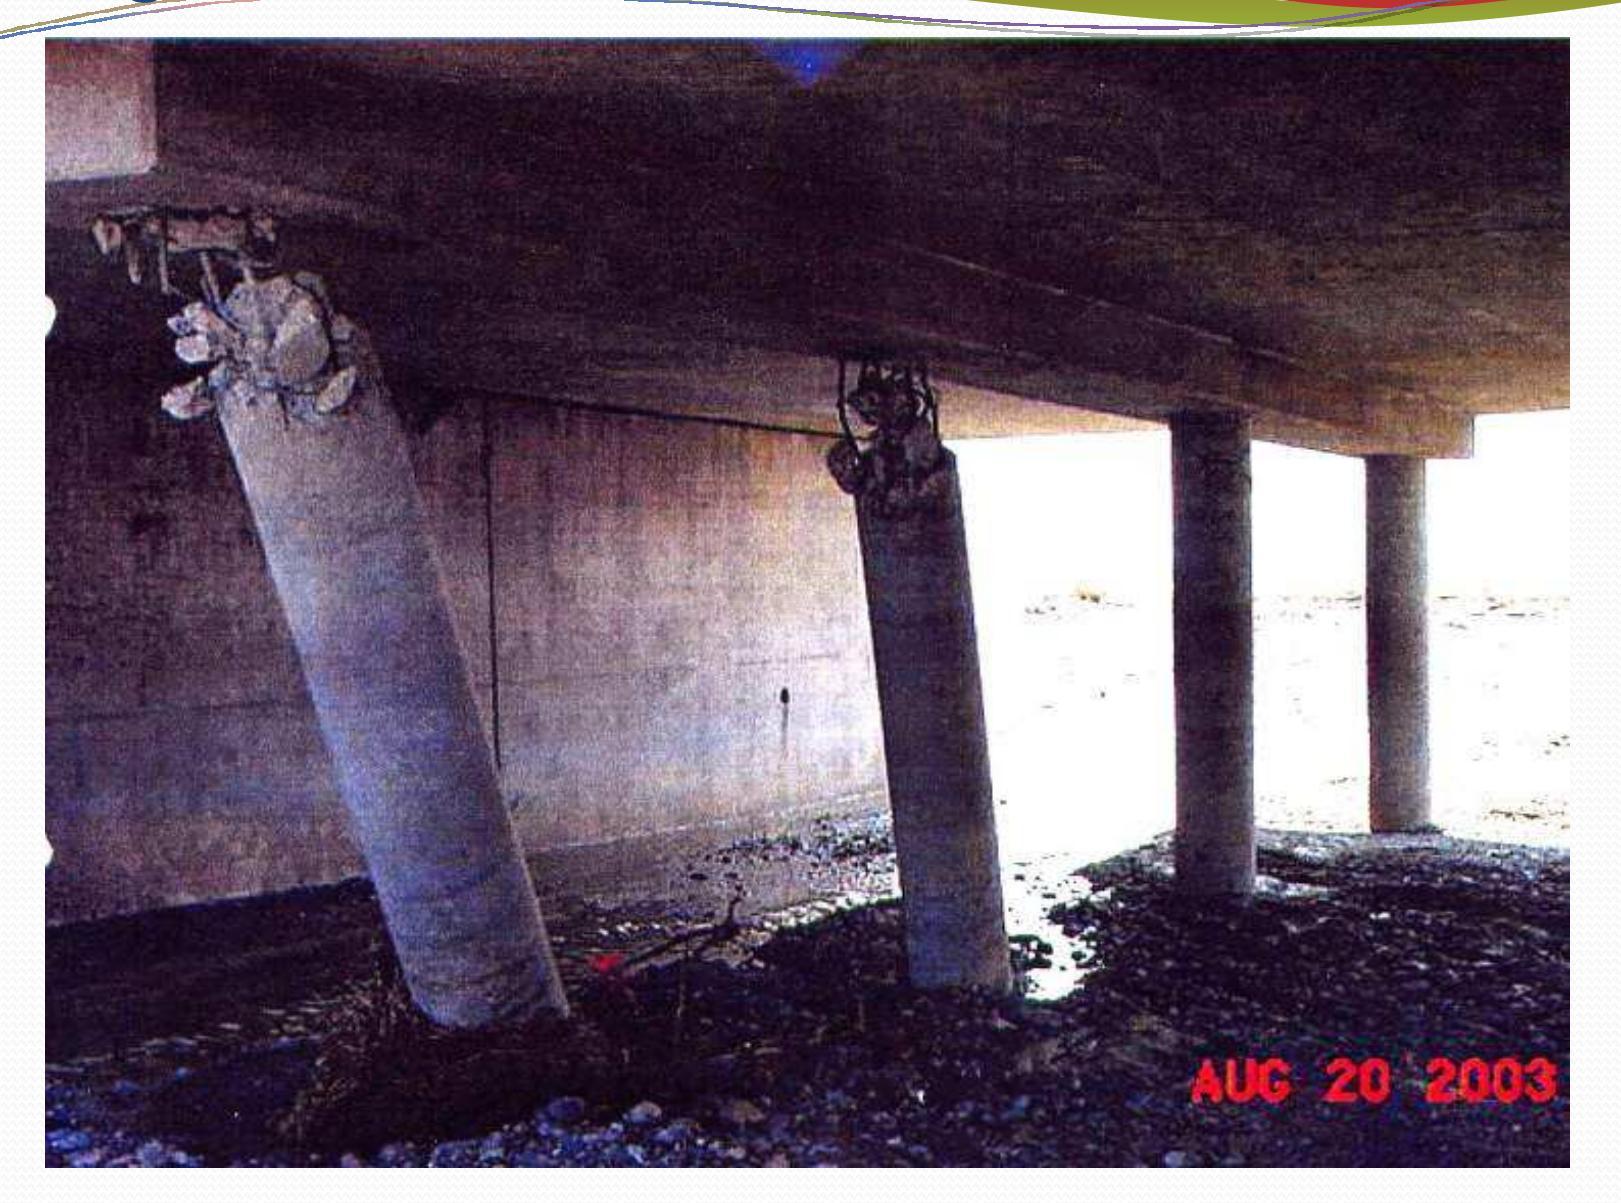
### Damaged Bents

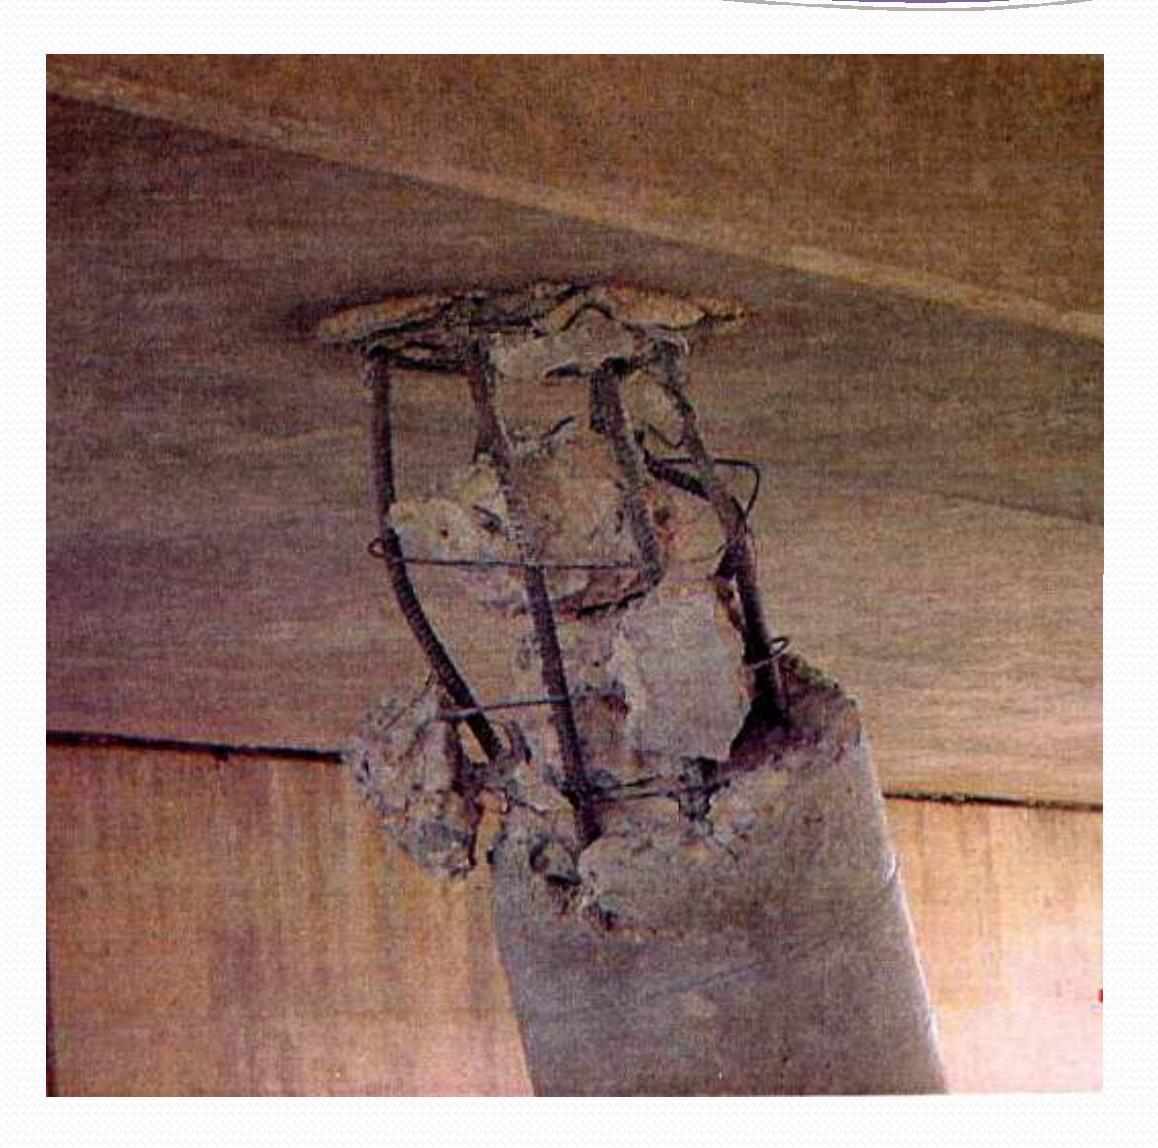
#### **Column Failure**

Column 2 bent cap joint failure - typical

•Scour Predictions were not conservative due to the flash flood nature of the dessert wash

•Channel is located at a bend in the wash

- •Channel creates a contracted Opening
- •Possibly the Soil may have Fluidized

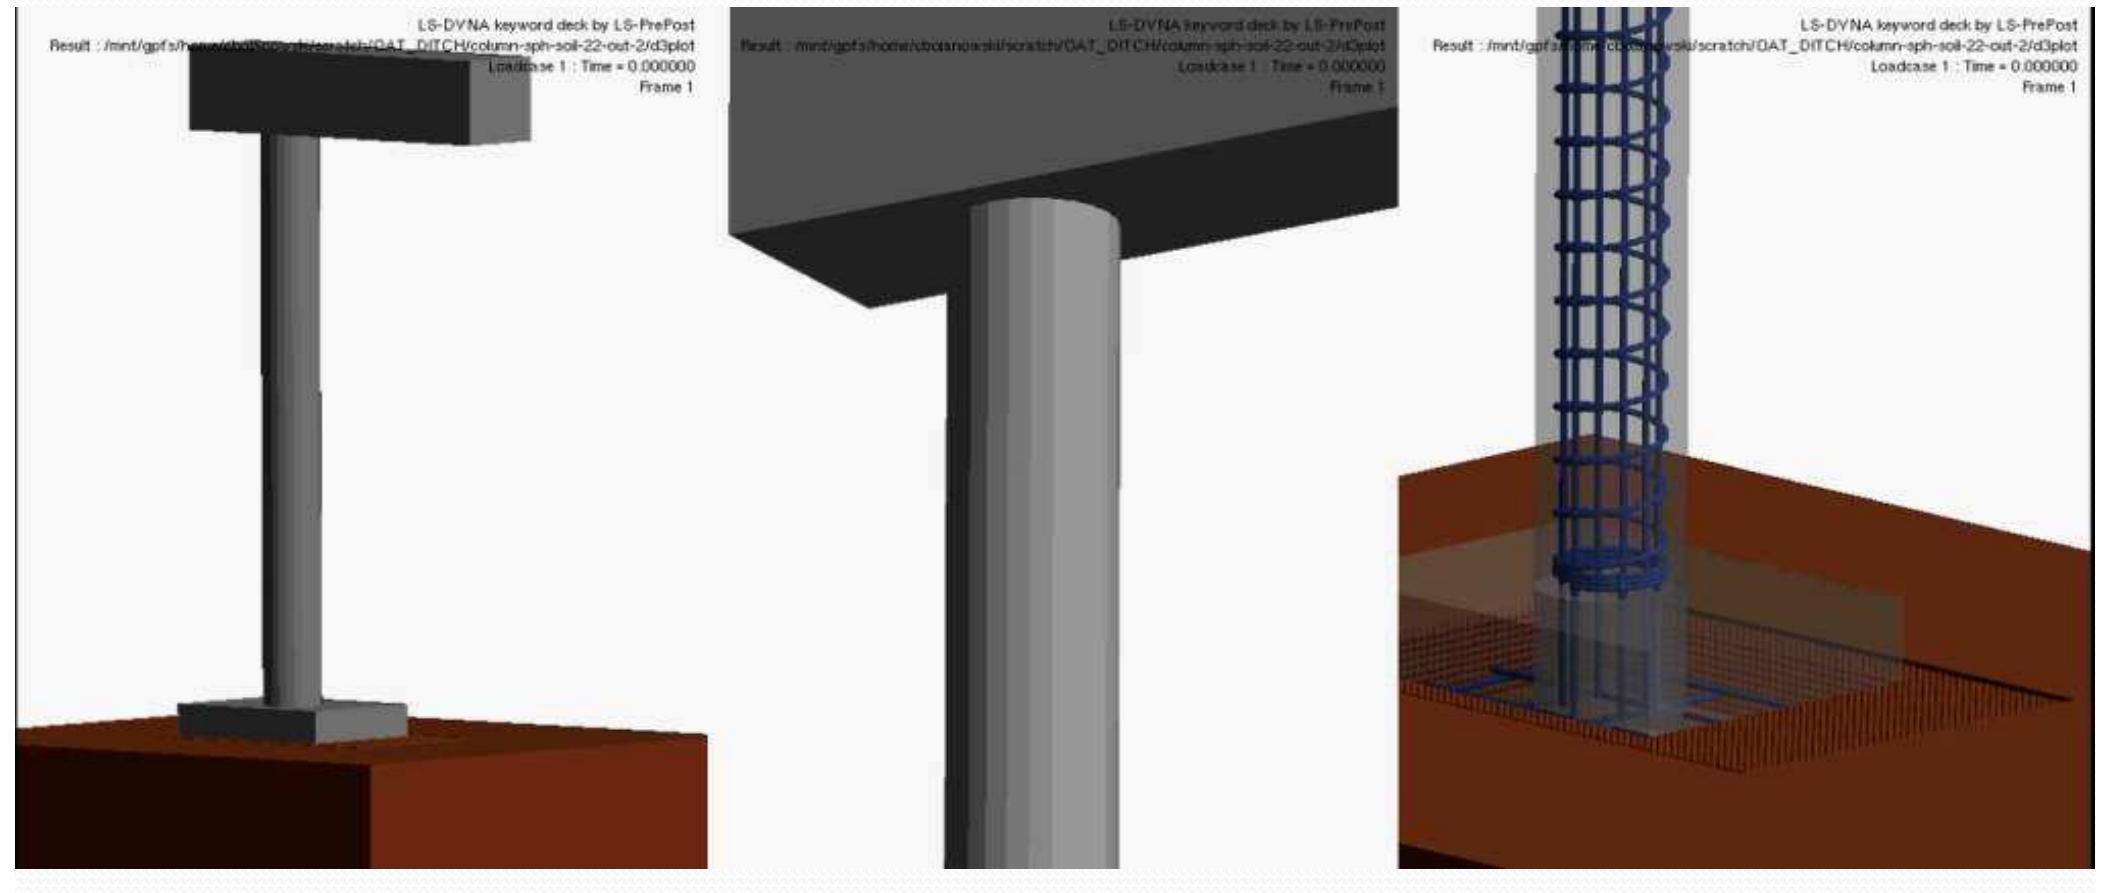
The Oat Ditch Bridge on I15 in California failed from hydraulic loading on support piers during a flood in 2003. Large deformation soil-structural interaction failure analysis was able to capture the failure mode.

### FSSI Simulation Shows Oat Ditch Bridge Failure Mode

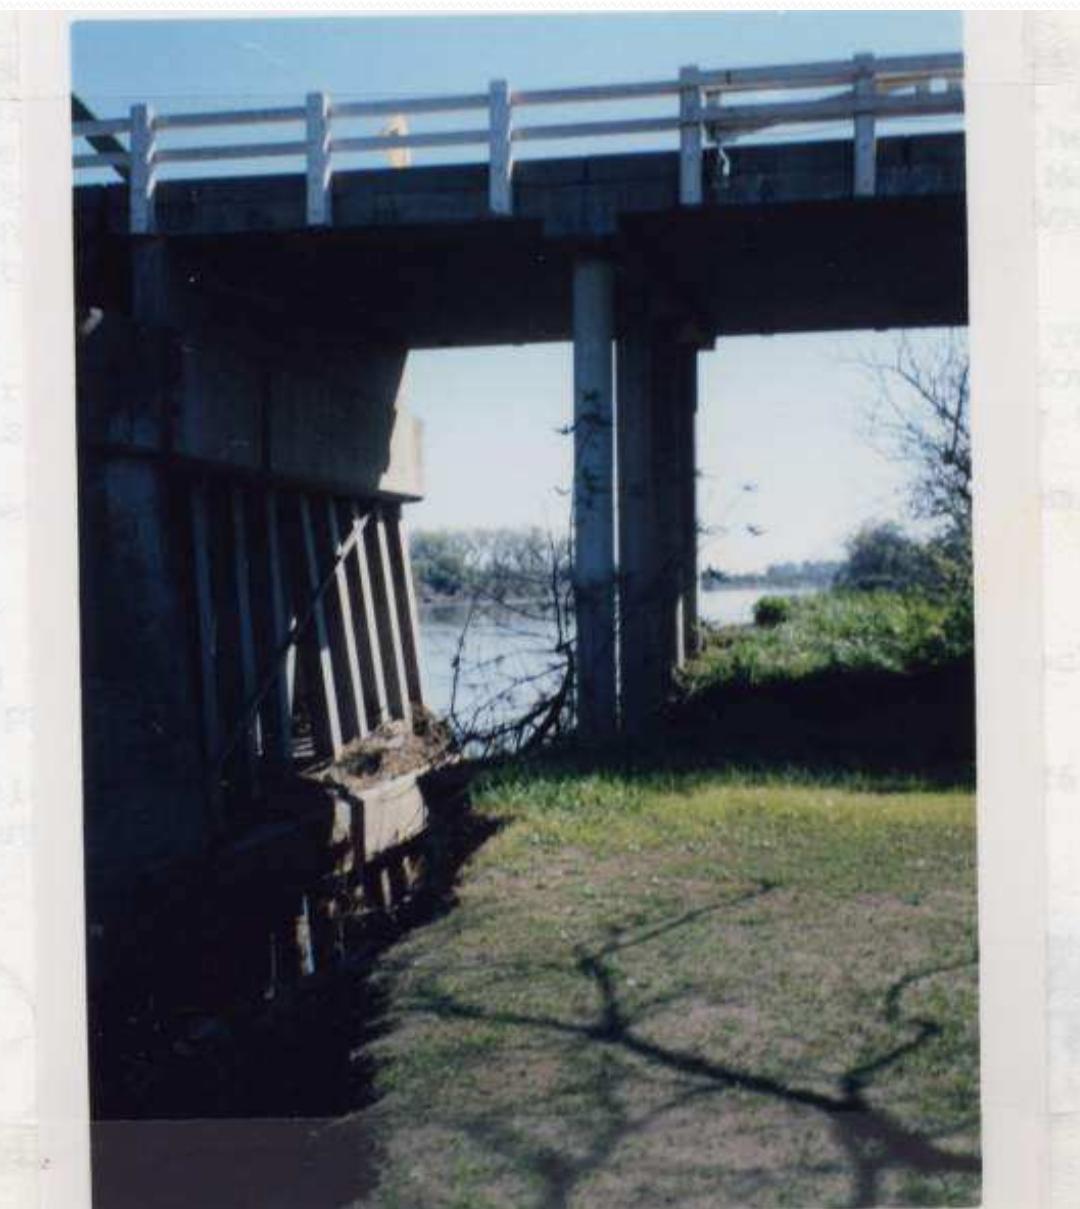
## 1997 Bank Erosion

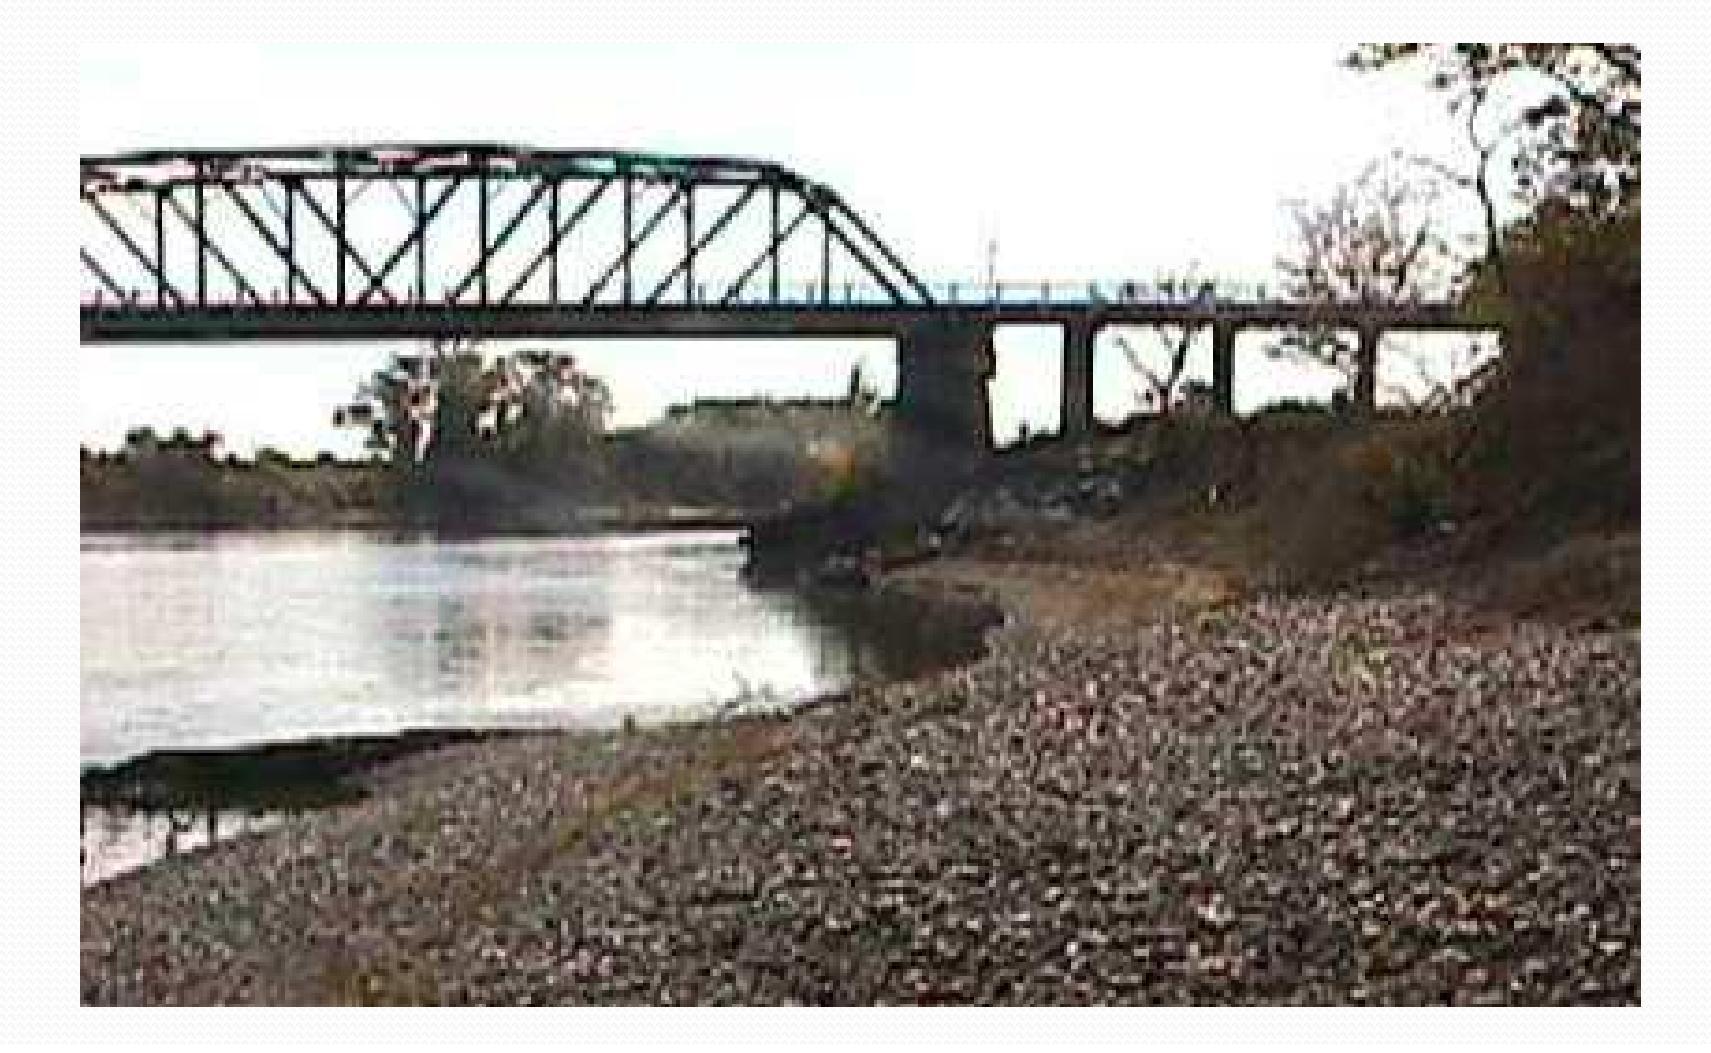
## **Bank Continued to Erode**

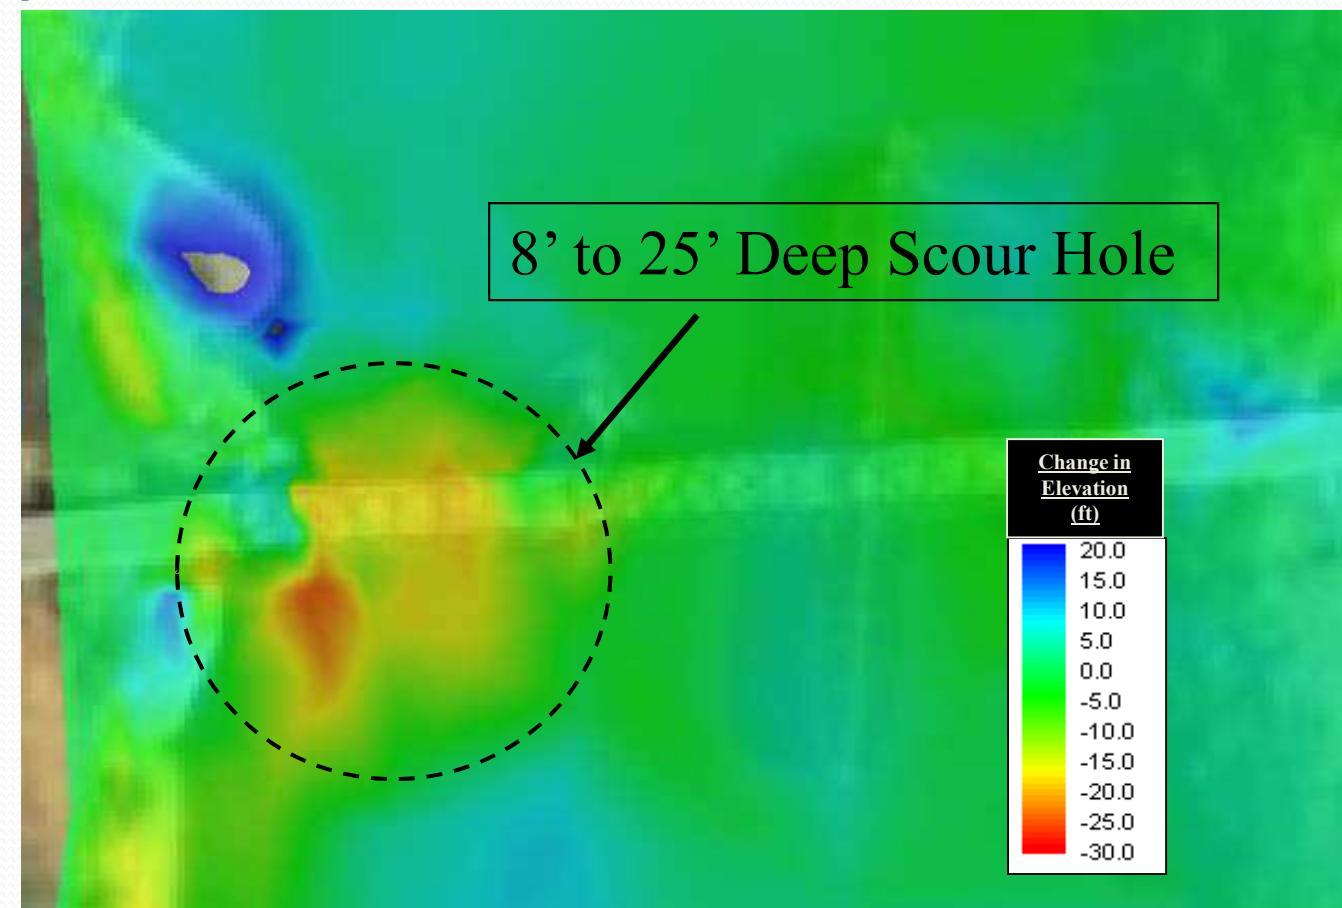
### **Unexpected Scour**

Bridge is currently being analyzed for potential instability of the main channel piers

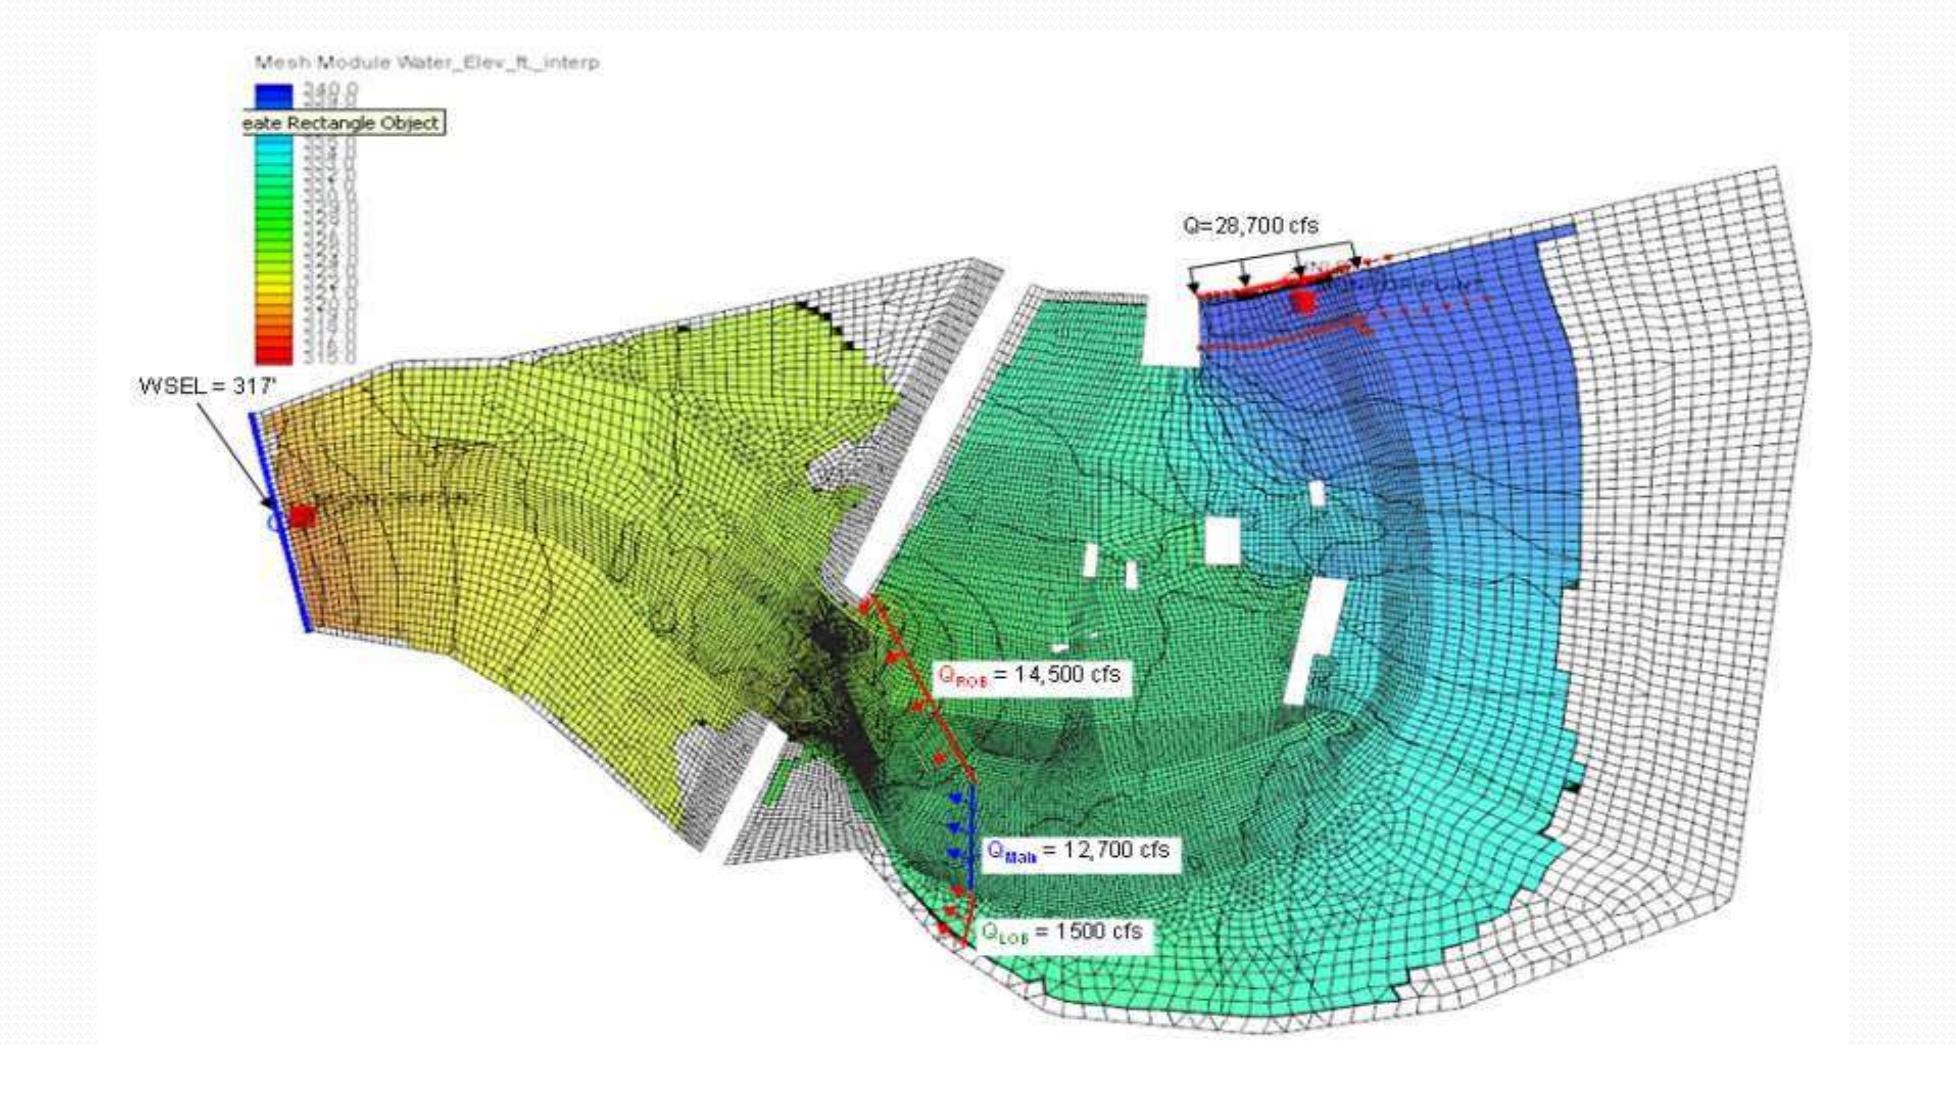
# More than 50% of Flow is in the floodplain 12 feet of Contraction Scour
