CHECKERED HOUSE BRIDGE

July 2012

Under blue skies, bridge truss is successfully moved

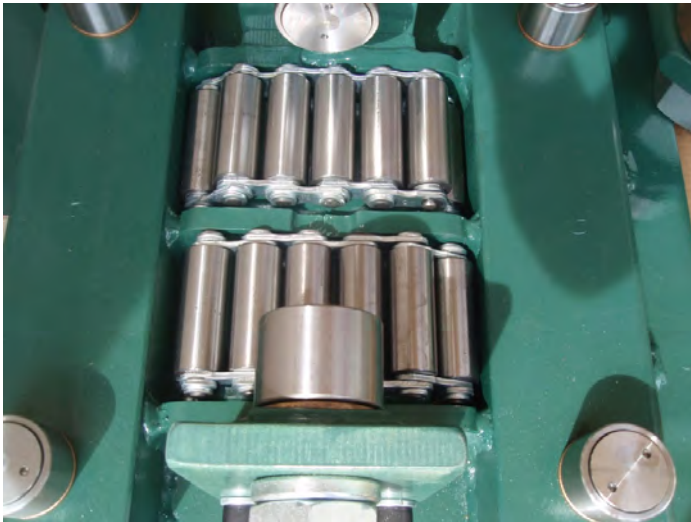
Rollers specially made to fit under the truss allowed the truss to glide when pushed.

Hydraulic jacks were placed on the deck level of the bridge as well as where the beam connected to the top chord. Hydraulic pressure was counter-balanced, i.e., while the bridge was pushed out at each end of the bridge, the other eight jacks, positioned in the opposite direction, pulled so the truss's vertical beams would remain upright throughout the move.

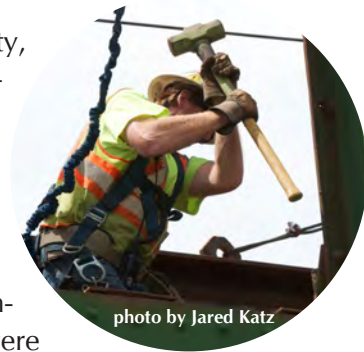
Even for a job of such complexity, simple tools found in most households had a key role in ensuring safety and success. Ten teams of construction workers holding handheld measuring tapes measured bridge movement and reported regularly to the Superintendent at the controls. Levels were attached to the beams to monitor their position so the crew could quickly note any leaning, should it occur. In between moving operations, wrenches tightened and untightened bolts used to stabilize the tension rods that secured the bridge.

And, when rust initially kept the truss from moving, it was cut away using a blow torch, a hand-held sledgehammer and some "elbow grease."

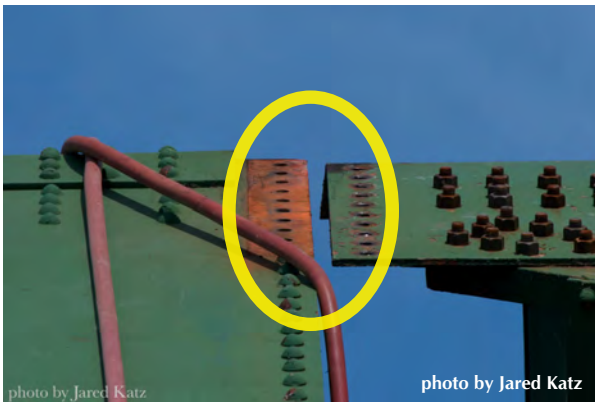
On the move: the first two inches were the most time-consuming.

As expected, the first two inches of the move were the most difficult. By the end of the day, the truss had been moved 2.5 feet. The remaining 10 feet of the move went quickly and was completed by early afternoon the next day.

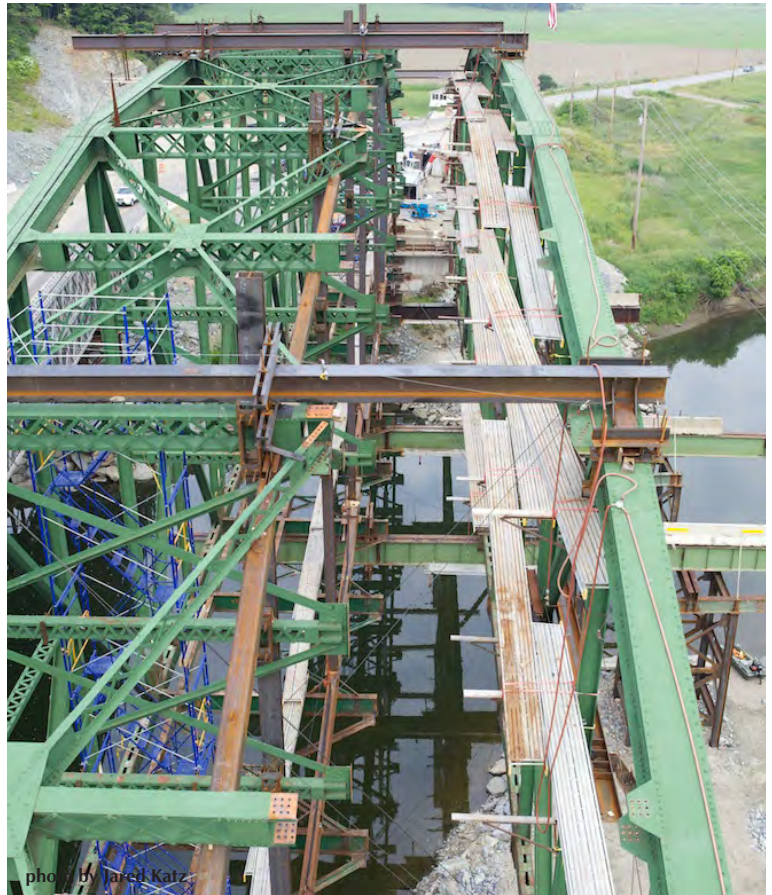
The day after: truss has been moved and the bridge is now 12.5 feet wider.

As soon as the north truss was successfully moved 12.5 feet, new beams were installed to reconnect it in its new position to the remainder of the 1928 bridge. The new pieces are now gray but will blend into the existing bridge once the entire bridge gets a fresh coat of green paint.

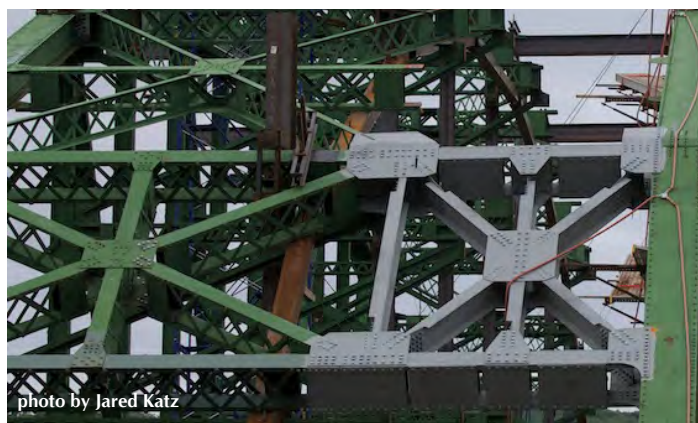
Do you remember reading in our previous newsletter that the bracing on the widened section will not look exactly the same as the bracing on the original bridge? Can you see that difference begin to emerge in this photo? In our next newsletter, we will say more about historic preservation requirements that led to this widening plan.

The new gray-colored section, in keeping with historic guidelines, will be green when the entire bridge gets a fresh coat of green paint.
