Final Report No. 605601
Report Date: July 2016

**Development of Delineator Material/Impact Testing Specific to
Managed Lane Use for Optimization of Service Life**

Contract No.: BDR74-977-06
Test Nos.: 605601-1-6

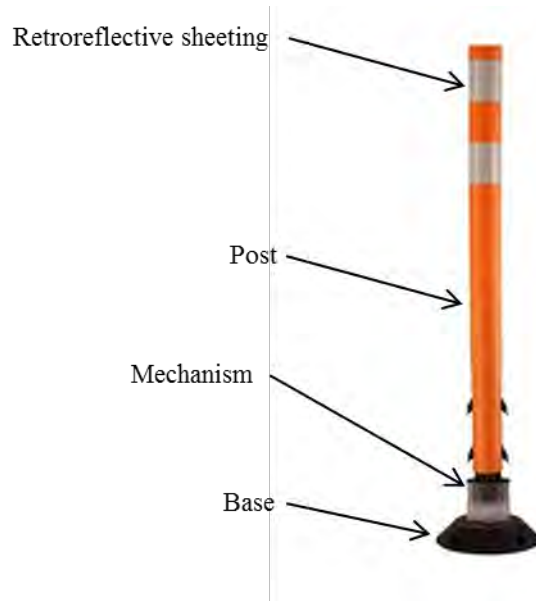
Delineators have four main parts: the retroreflective sheeting (required for nighttime use), the post (can be various colors), the mechanism that connects the post and the base (typically a proprietary component), and the base. Figure 1 shows these parts that compose one delineator.

Figure 1. Delineator Parts

When installed, there are two additional parts to consider: the epoxy (which connects the base to the pavement) and the pavement itself. Any of these parts may fail when the delineator is struck. Based on past efforts, the researchers developed a list of failure modes, which are described below:

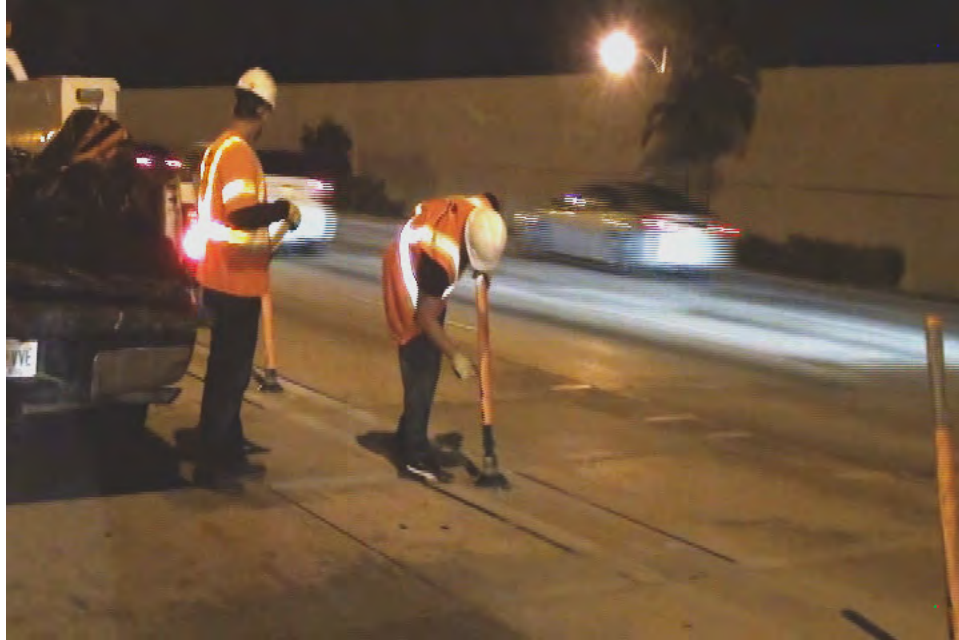
The first three failure modes (sheeting failure, post failure to restore, and post failure at connection) comprised 84 percent of the repair/replace activities witnessed in Phase 1. All of these failures required replacement of the post to correct. The workers used a cutting tool to remove any portions of the failed posts (as shown in Figure 3) and attached the new post by shoving it down onto the connector. Each of these repairs took about 15 seconds for one worker to perform.

Figure 3. Sheeting Failure and Post Failure Replacement.

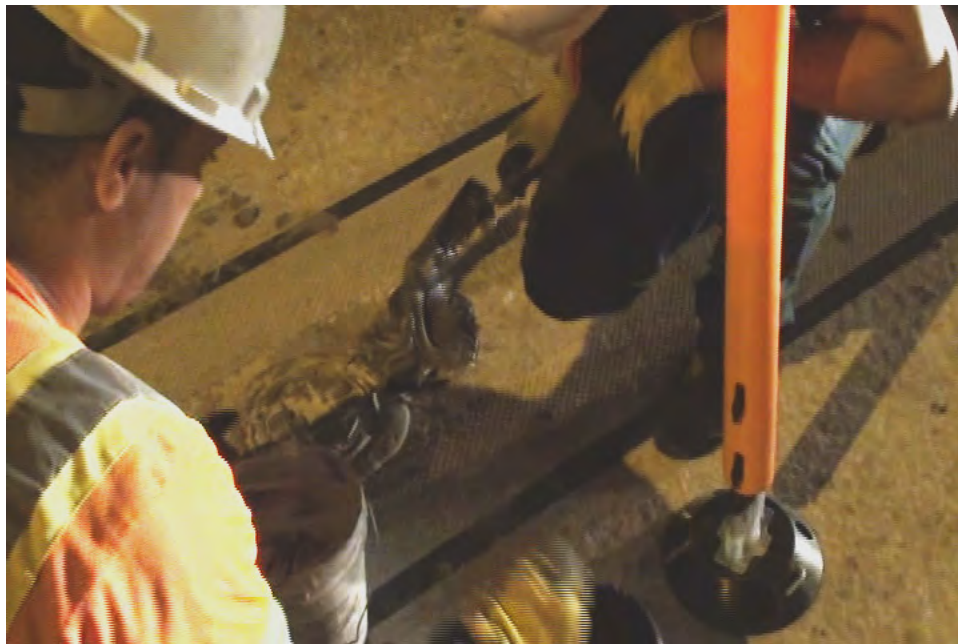
When the epoxy or the pavement has failed, a new delineator was installed. The workers swept a small area of the pavement by hand and mixed a small batch of two-part epoxy directly on the pavement (as shown in Figure 5). A new delineator was placed and the workers set the

delineator by rotating it in the wet epoxy, checking for proper alignment, and stepping on the top of the base to force the epoxy up into the pockets in the bottom of the base. This process took about 4 minutes for two workers to perform.

Figure 5. Epoxy Failure and Pavement Failure Replacement.

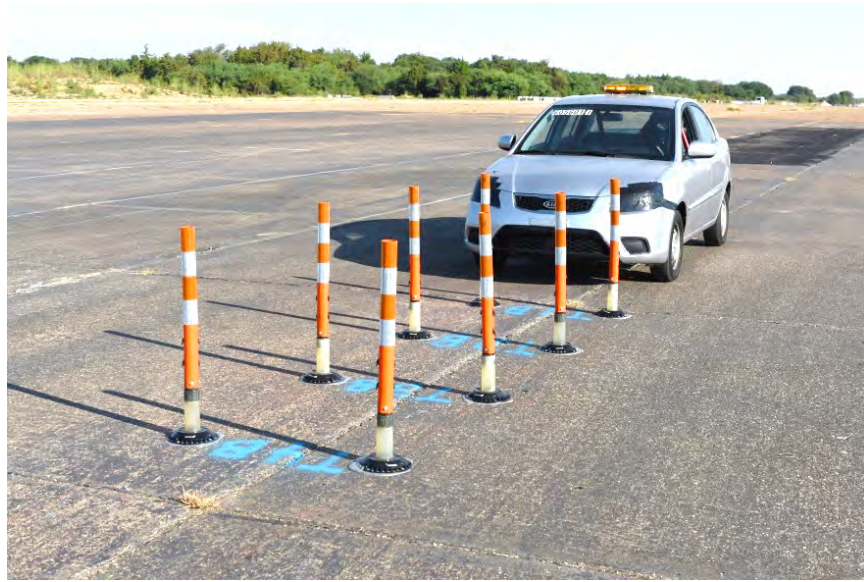
Figure 8. Test Vehicle in Impact Position prior to Testing.

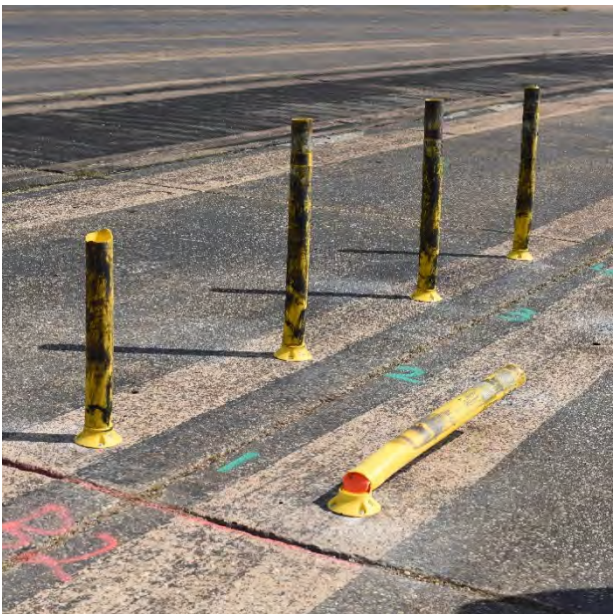
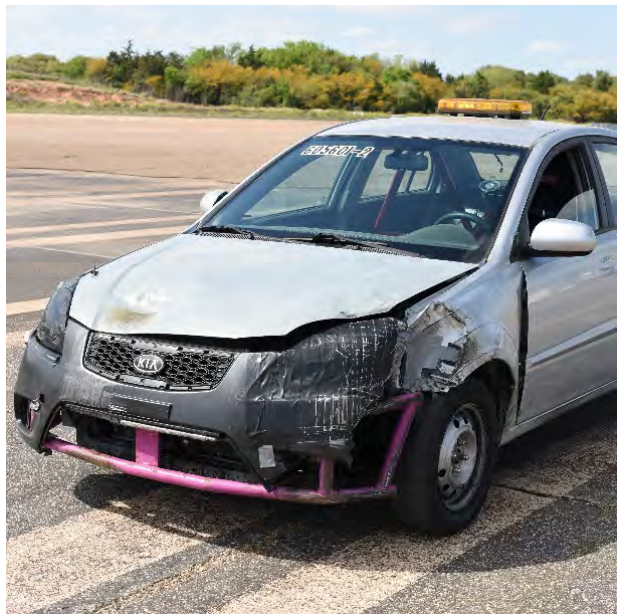
Figure 14. 605601-2 after Testing.

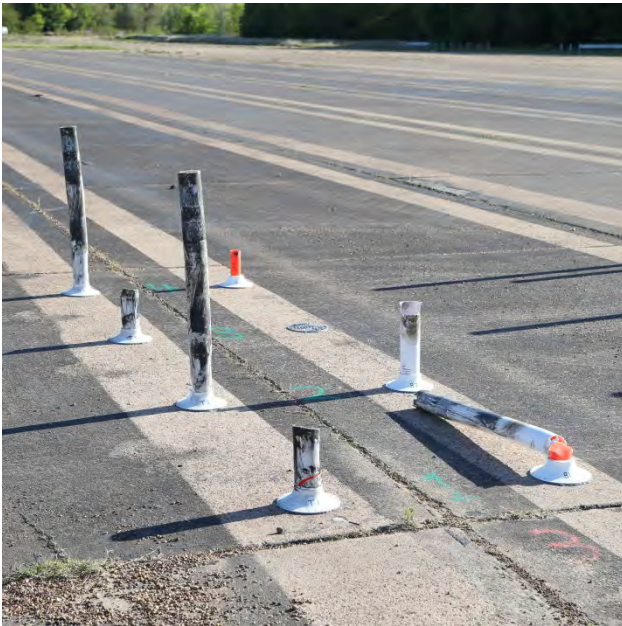
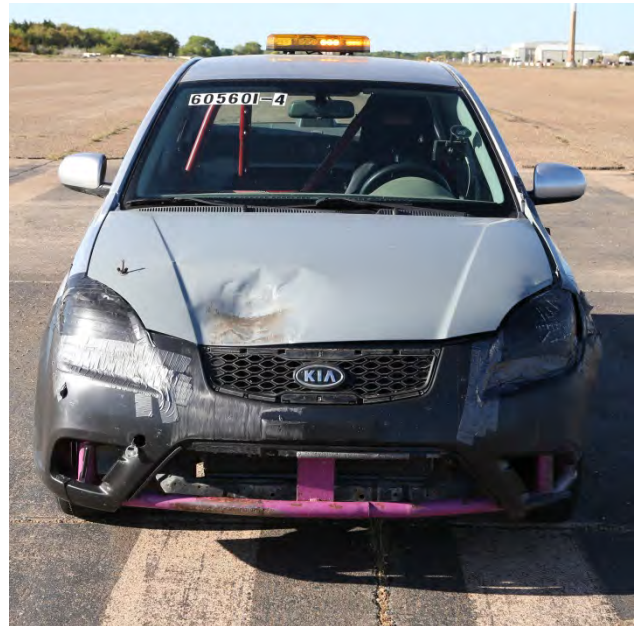
Table 5 documents the list/lean and failure modes witnessed under Test #605601-4. All samples that were impacted by the bumper of the vehicle failed to resist 200 impacts. Fifty percent of samples that were impacted by the tire resisted all 200 impacts. The primary mode of failure was rupturing of the samples at the base. The maximum list recorded prior to failure was 3°, and the maximum lean recorded prior to failure was 4°.

Figure 20. 605601-4 after Testing.

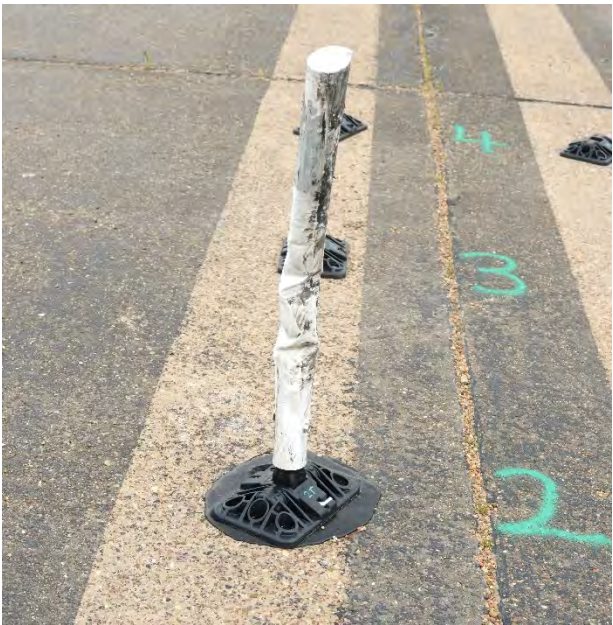
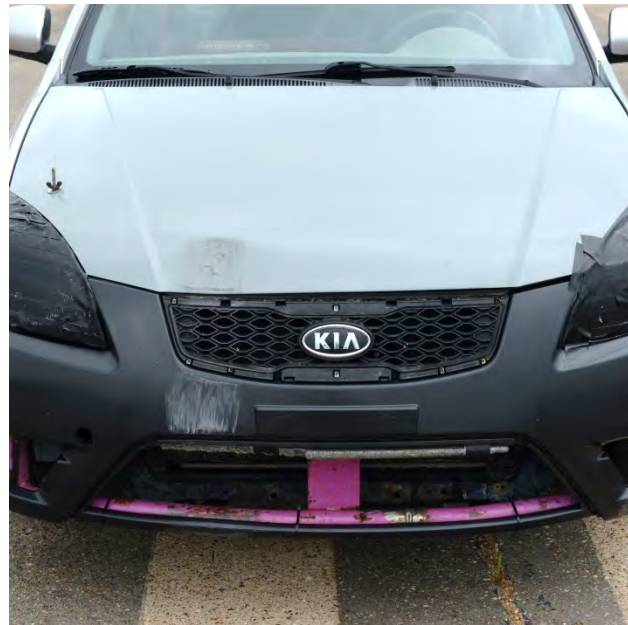
Table 7 documents the list/lean and failure modes witnessed under Test #605601-6. For the Shur-Flex Surface Mount sample, all samples failed to resist 200 impacts. The primary mode of failure was exceeding the maximum allowable degree of lean/lean. The maximum list recorded was 4°, and the maximum lean recorded was 50°.

Figure 26. 605601-6 after Testing.

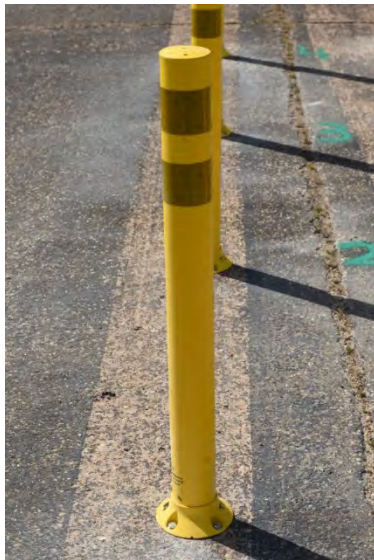
Test #605601-2, performed on March 22, was an impact durability test performed on 36³/₄-inch tall Pexco Surface Mount City Post samples secured with Hilti 3/8 inch HCA Coil Anchor Bolts as shown in Figure 27. The product resisted an average of 180 tire impacts. The product resisted an average of 128 bumper impacts. The product resisted a combined average of 154 tire and bumper impacts. Table 8 shows a summary of the results. The primary failure mode of the sample was anchorage failure.

Figure 27. 605601-2 Product Sample.

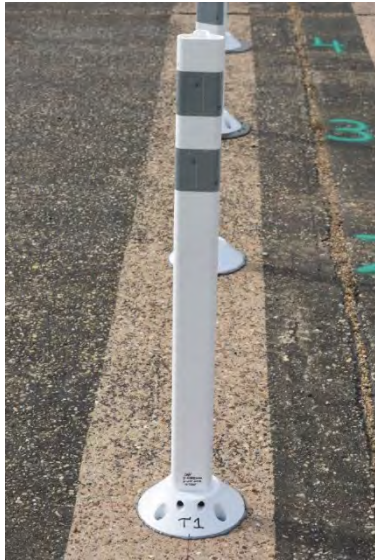
Test #605601-3, performed on March 23, was an impact durability test performed on FG300 samples secured with two different epoxy adhesives as shown in Figure 28. The first four samples were secured with FIRMmarker™ #18M900C20 2-part epoxy adhesive, and the second four samples were secured with Crafcro Hot-Applied Bituminous Marker Adhesive #34269. The product resisted an average of 95 tire impacts. The product resisted an average of 14 bumper impacts. The product resisted a combined average of 54 tire and bumper impacts. Table 9 shows a summary of the results. The primary failure mode of the sample was failure at retention pin holes.

Figure 28. 605601-3 Sample.

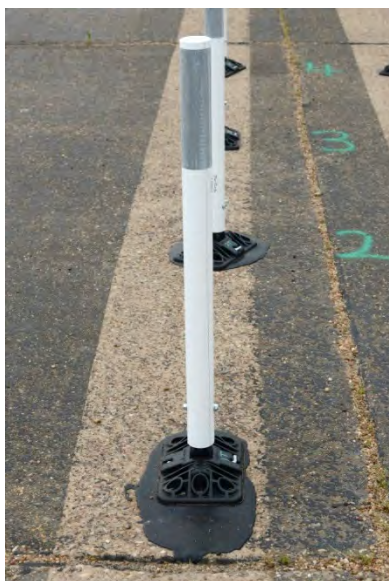
Test #605601-6, performed on March 30, was an impact durability test performed on Shur-Flex Surface Mount samples secured by both adhesive and mechanical methods. The first four samples were secured with Henry HE913 Dot Stick Adhesive, and the second four samples were secured with 1/2-inch × 3-inch Shur-Tite Nylon Plugs and 1/2-inch × 3 1/2-inch lag screws (with USS flat washers) in four corner holes as shown in Figure 31. The product resisted an average of 53 tire impacts. The product resisted an average of 26 bumper impacts. The product resisted a combined average of 39 tire and bumper impacts. Table 12 shows a summary of the results. The primary failure mode of the sample was exceeding the maximum allowable degree of lean.

Figure 31. 605601-6 Sample.

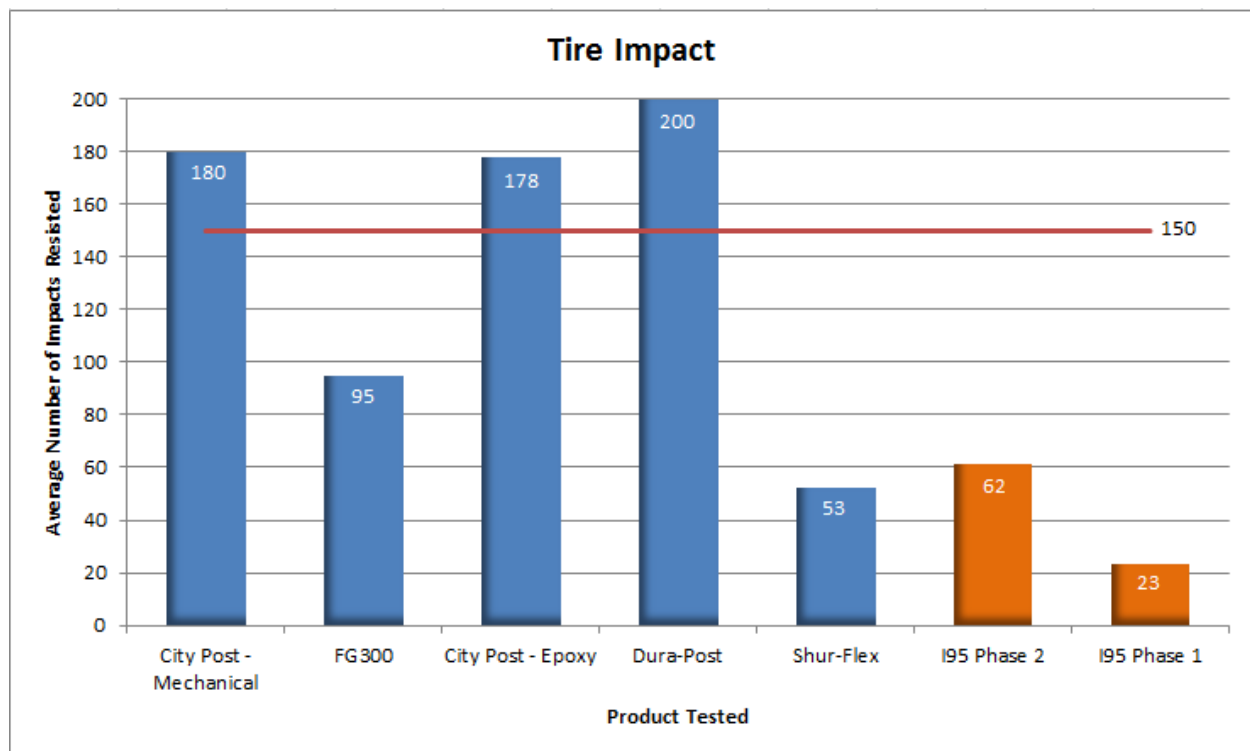
When determining the minimum average number of tire impacts, the researchers looked at the performance of the test samples under Task 1 and Task 3. After looking at the data, there was a large gap between product performances. This created a reasonable and scientific reason to set a minimum performance level for tire impacts that separates the two performance levels. The researchers recommend that a minimum value of 150 impacts be used as a minimum average number of impacts to be resisted by an impacting vehicle tire. Figure 34 shows the average number of tire impacts resisted for each delineator compared to the recommended minimum value. The City Post (mechanically anchored), City Post (epoxy anchored), and Dura-Post (epoxy and mechanically anchored) samples all meet the minimum. The FG300, Shur-Flex, I95 Phase 1, and I95 Phase 2 products do not meet the minimum requirement.

Figure 34. Average Number of Tire Impacts Resisted.

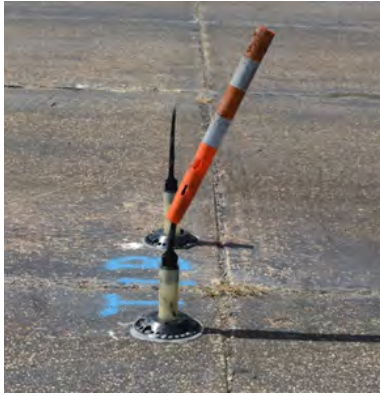
Figure A-1. Sample 1T Failure at 53 Impacts.

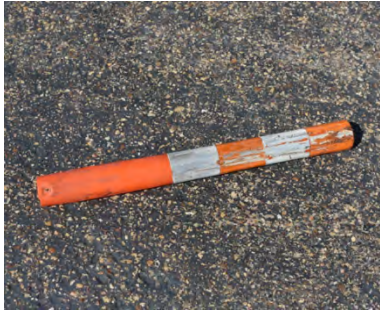
Figure A-2. Sample 1B Failure at 27 Impacts.

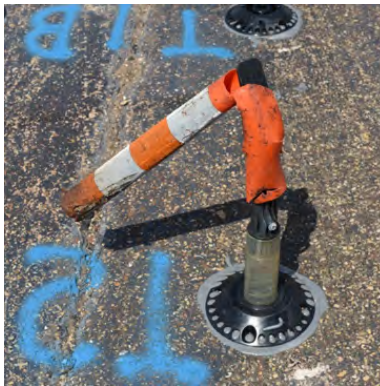
Figure A-3. Sample 2T Failure at 66 Impacts.

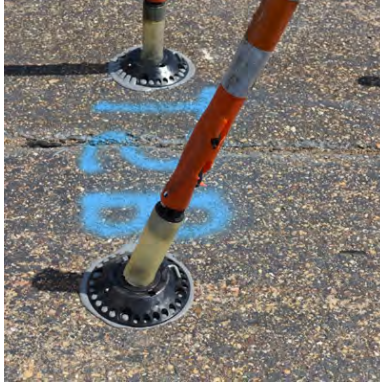
Figure A-4. Sample 2B Failure at 44 Impacts.

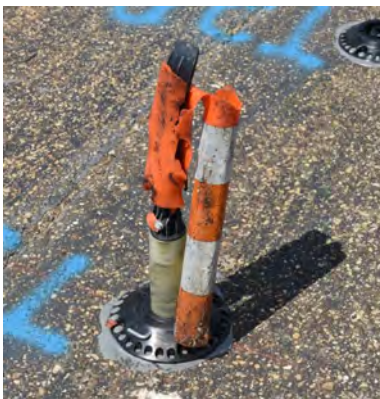
Figure A-5. Sample 3T Failure at 71 Impacts.

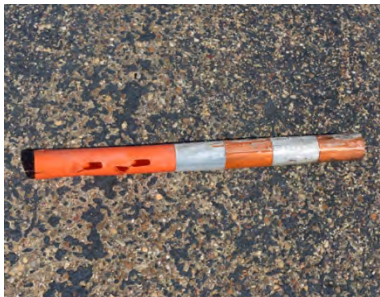
Figure A-6. Sample 3B Failure at 28 Impacts.

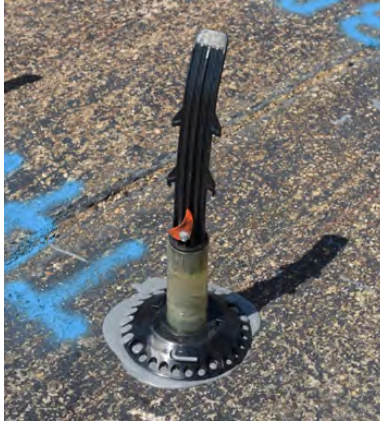
Figure A-7. Sample 4T Failure at 56 Impacts.

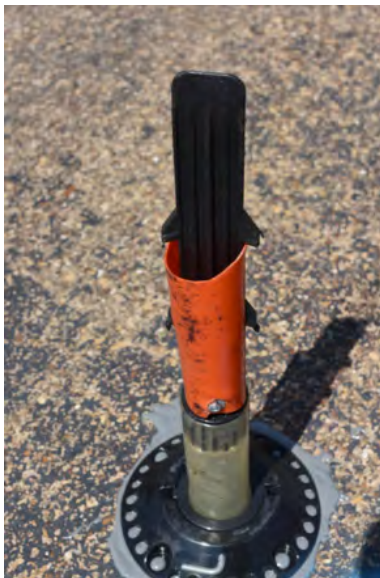
Figure A-8. Sample 4B Failure at 42 Impacts.

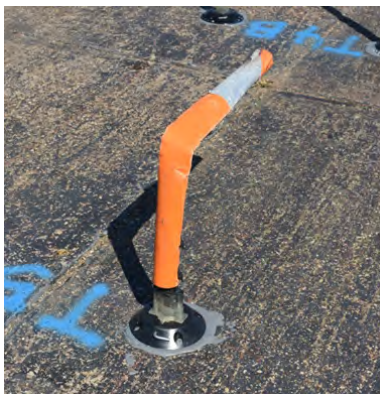
Figure A-9. Sample 5T Failure at 32 Impacts.

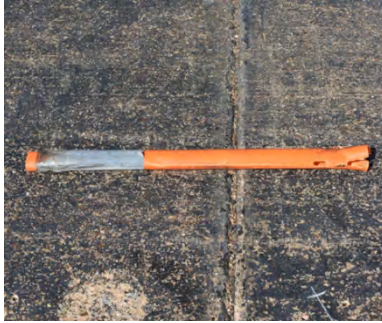
Figure A-10. Sample 5B Failure at 21 Impacts.

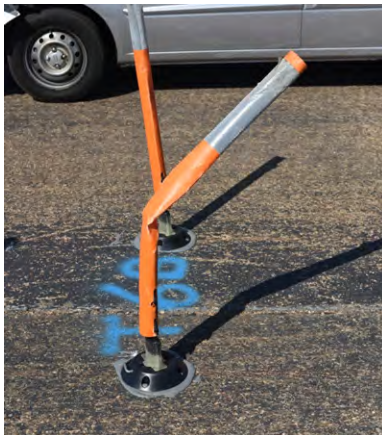
Figure A-11. Sample 6T Failure at 25 Impacts.

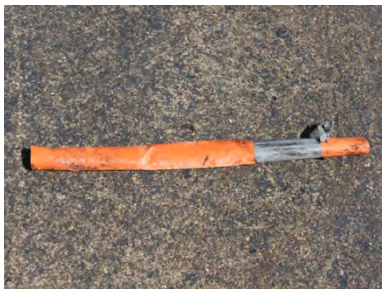
Figure A-12. Sample 6B Failure at 29 Impacts.

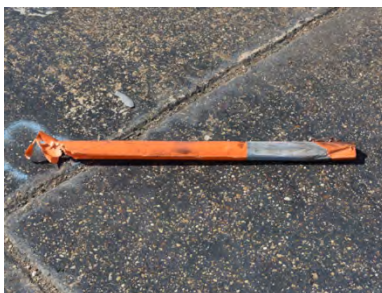
Figure A-13. Sample 7T Failure at 29 Impacts.

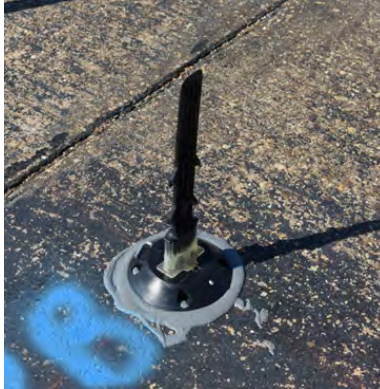
Figure A-14. Sample 7B Failure at 18 Impacts.

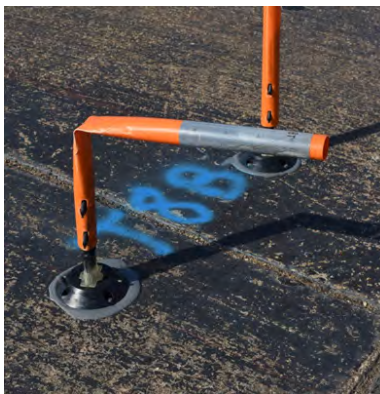
Figure A-15. Sample 8T Failure at 6 Impacts.

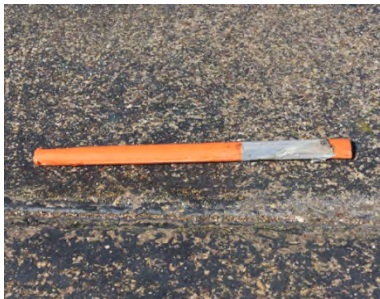
Figure A-16. Sample 8B Failure at 28 Impacts.
