Northeast Bridge Preservation Conference

Rocker Bearing Issues

Franco Balassone, P.E.
Executive Vice President
HAKS Engineers, P.C.

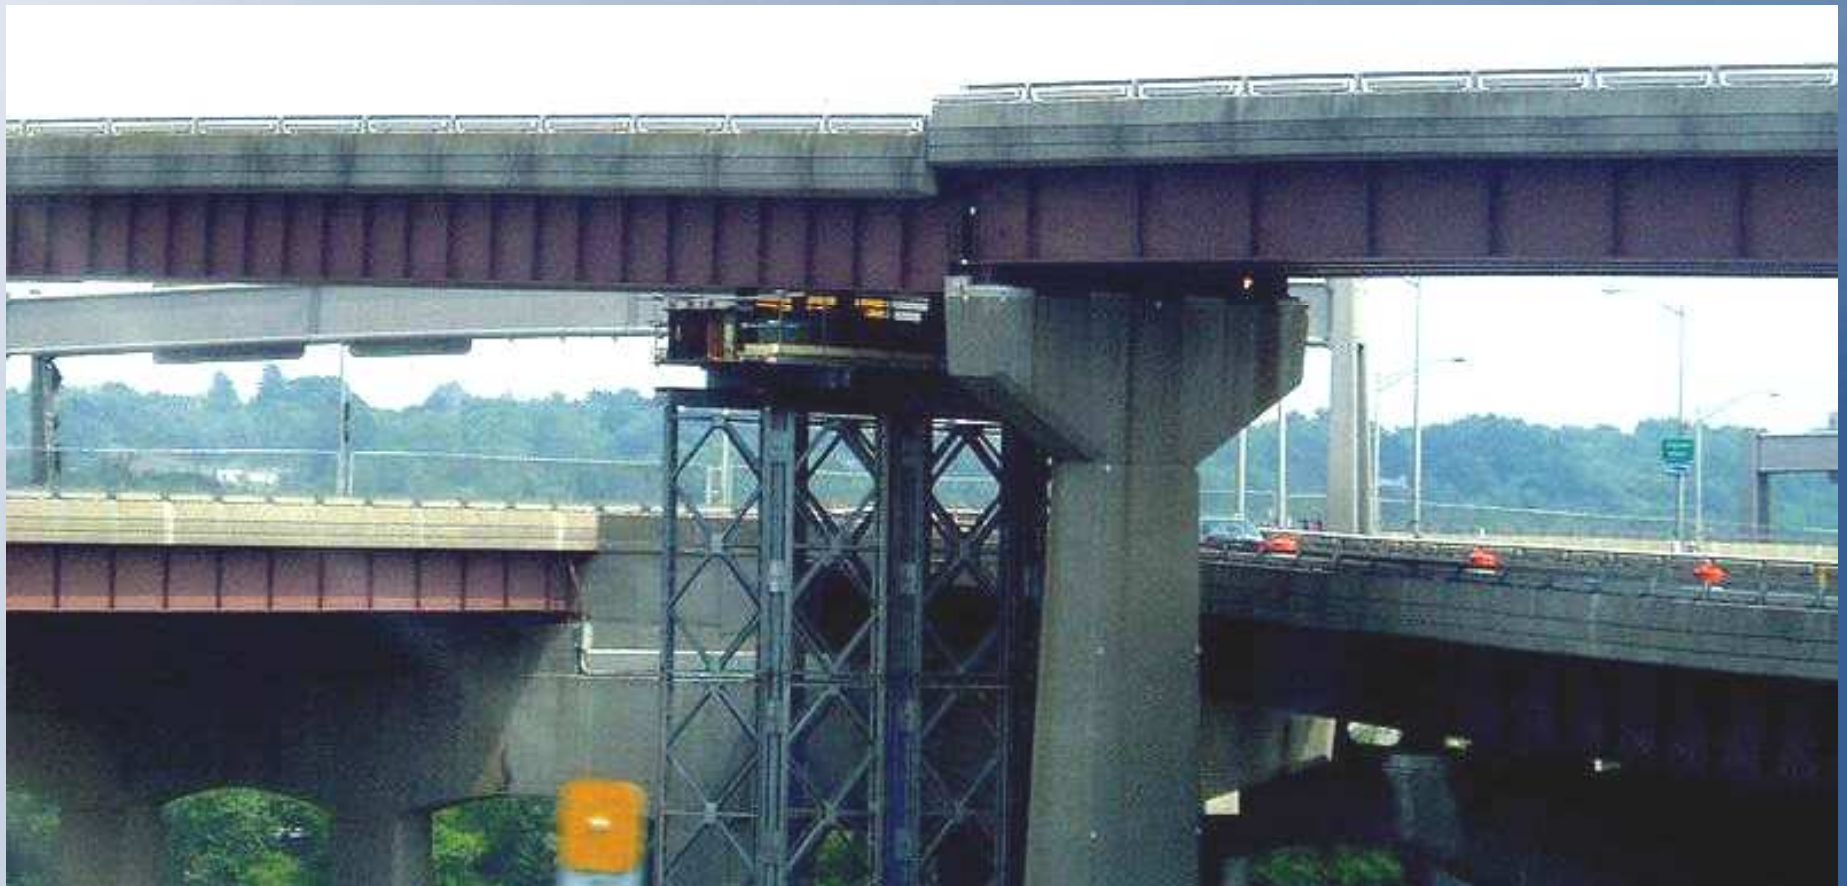
Albany, NY (I-787, Exit 3 NB)
Bridge Closed, July 28, 2005
Rocker Bearing Failure

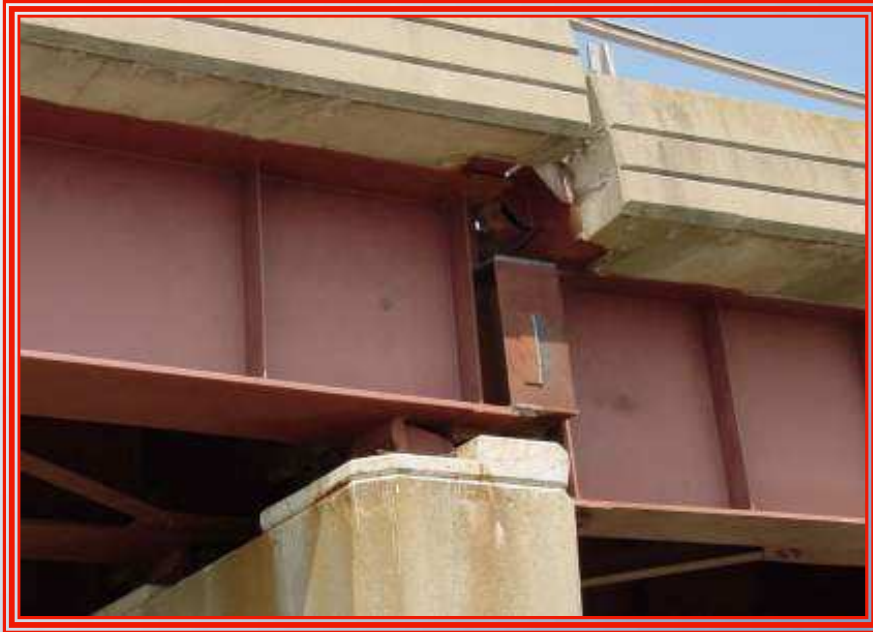
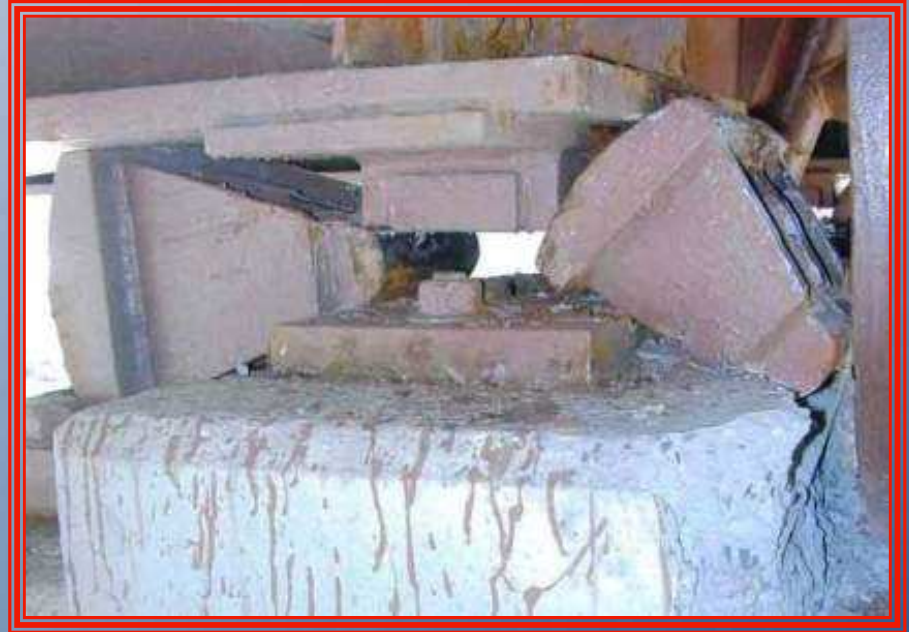
Albany, NY (I-787, Exit 3 NB)

Contributing Factors:

- Misaligned / Over-expanded Bearing
- Overly Flexible Pier

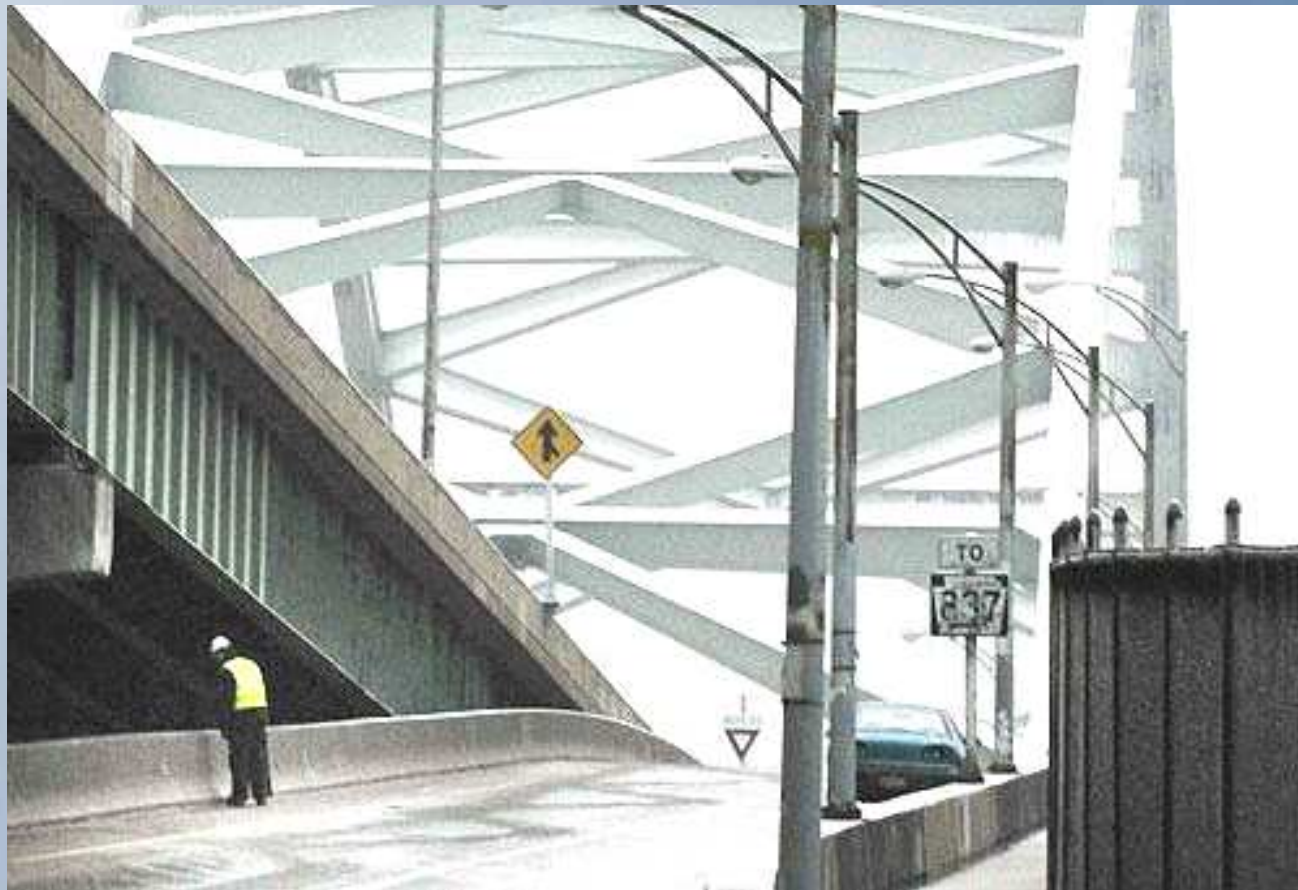
Pittsburgh, PA (Birmingham Bridge)

Bridge Closed February 8, 2008

Rocker Bearing Failure

Contributing Factors:

- Misalignment of Bearing
- Cumulative Bearing Ratcheting
- Horizontal Force – Deflection of Pier

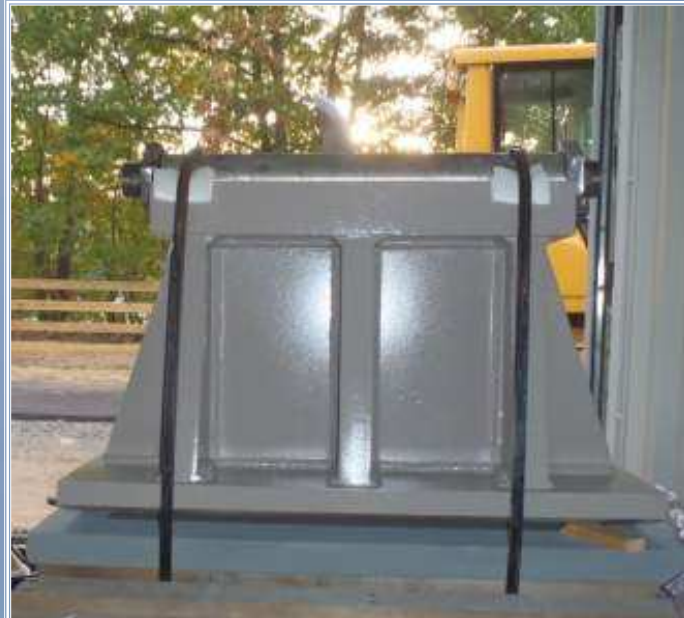
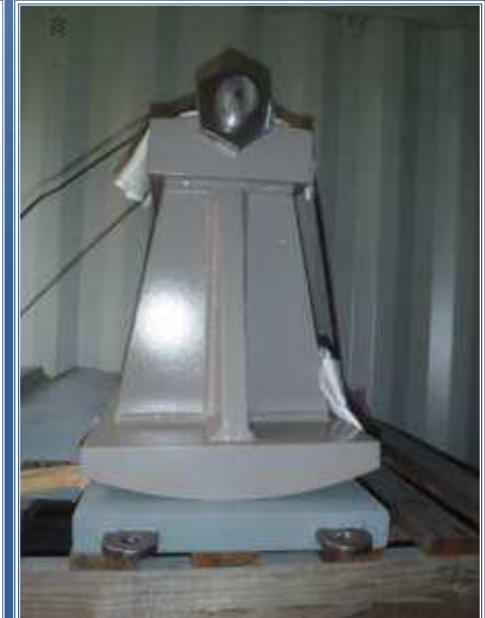
Suffield Bridge, CT (Route 190)

Replacement Recommended

- New Expansion Bearings
 - designed by ConnDOT
 - On-site
- Replacement
 - October 2010

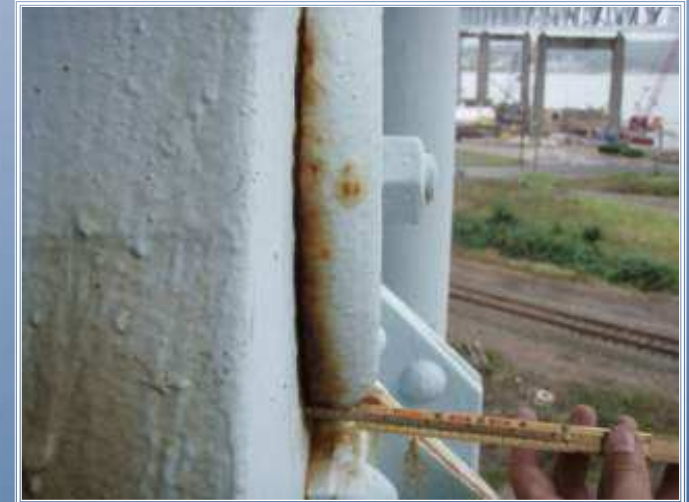
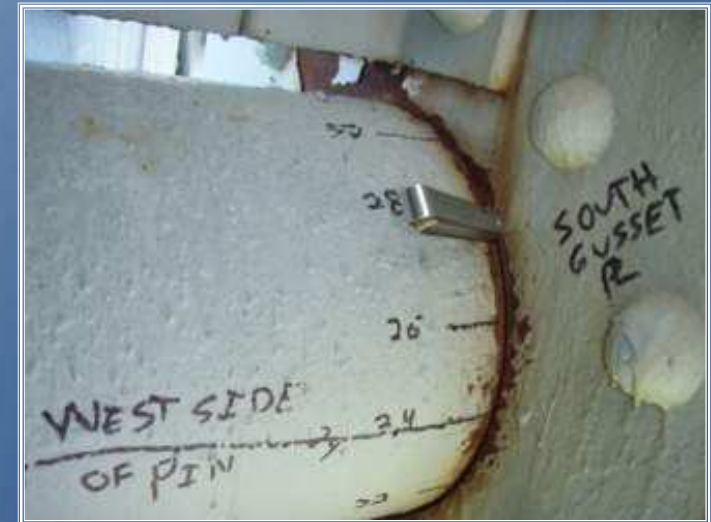
Gold Star Bridge, CT (Interstate - 95)

Seized Rocker Pin

– No Movement

- Increased stresses - Truss members
- Lateral loading on substructures

Excessive Wear

– Pin / Gusset Interface

- Non-uniform gaps and contact area.
