# Bridge Preservation

## Corrosion Mitigation Option in Concrete Repair Systems

*Northeast Bridge Preservation Partnership Meeting*

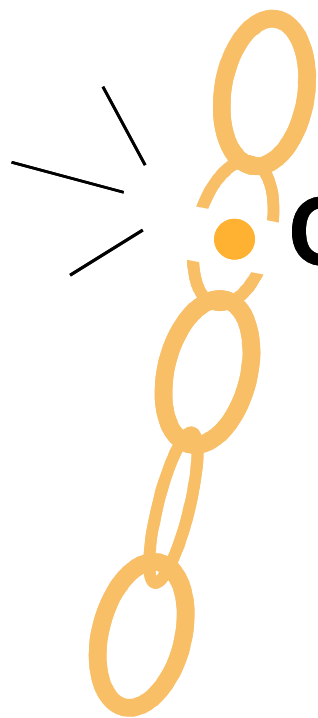
**Corrosion is like a chain.**

**The entire process can be interfered with if a link is broken.**

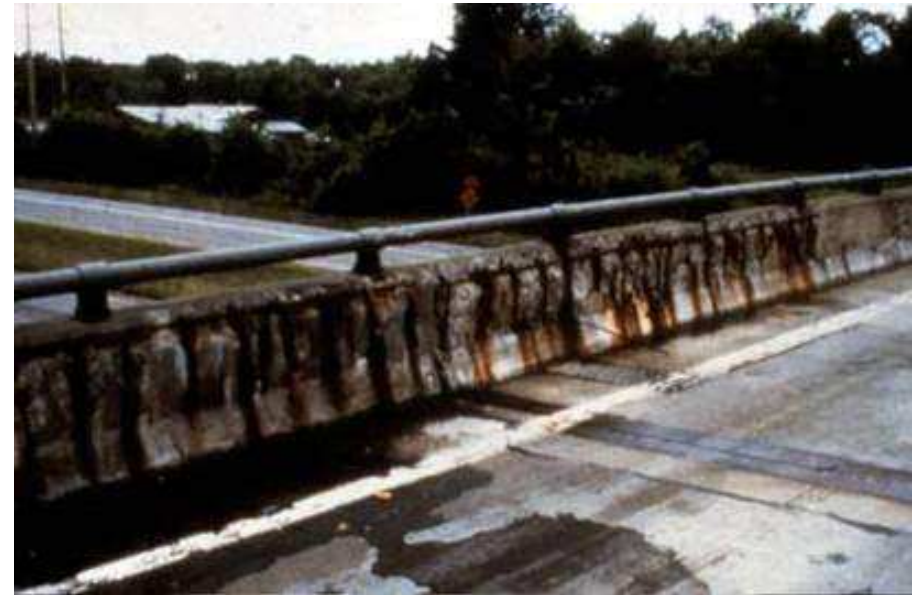
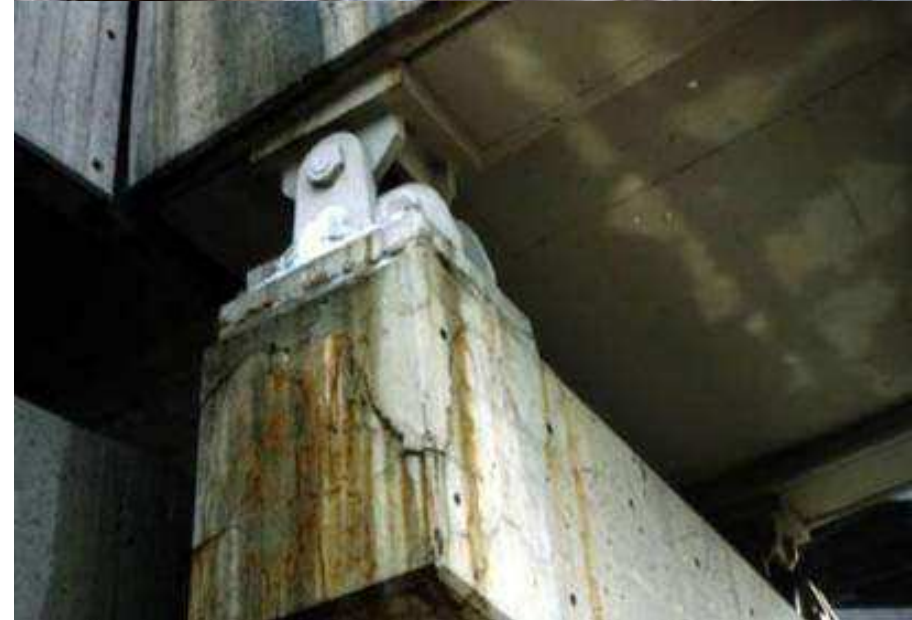
- Clear Penetrating Liquid
  - Low Viscosity
  - Low Surface Tension
  - Reactive (Concrete / steel)
- Application
  - Bridge Decks
  - Piles
  - Girders
  - Jersey Barriers
- Spray or Roller Applied

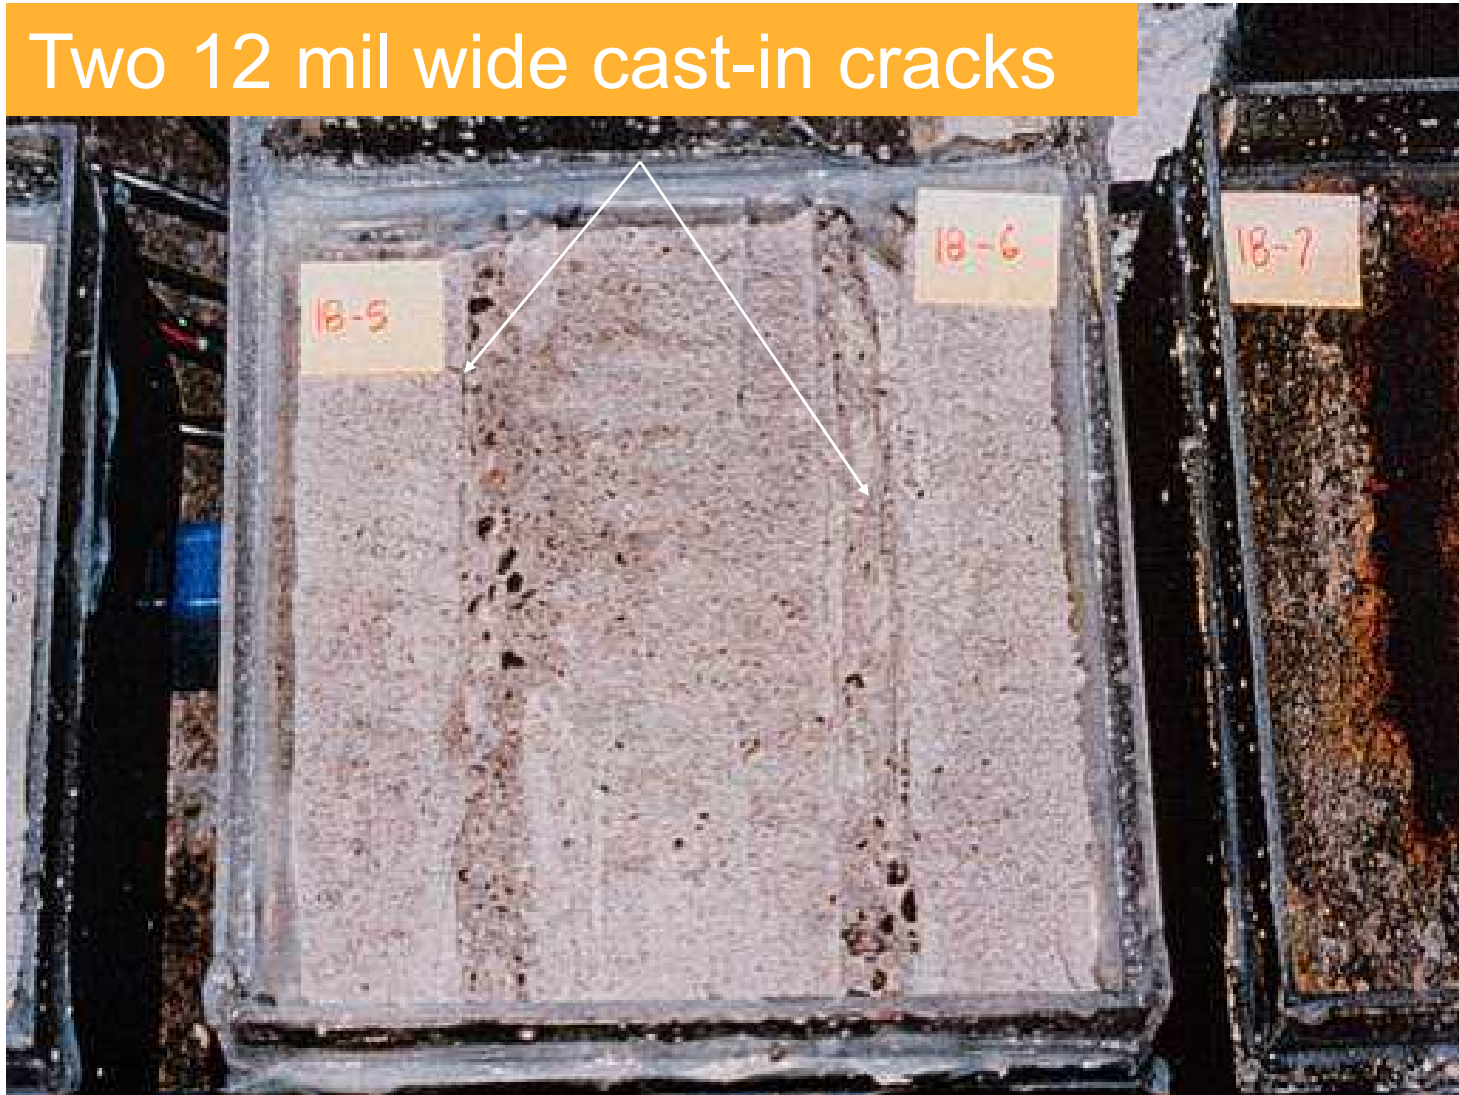
# Scenario 1: PRESERVATION “New Concrete”

Two 12 mil wide cast-in cracks

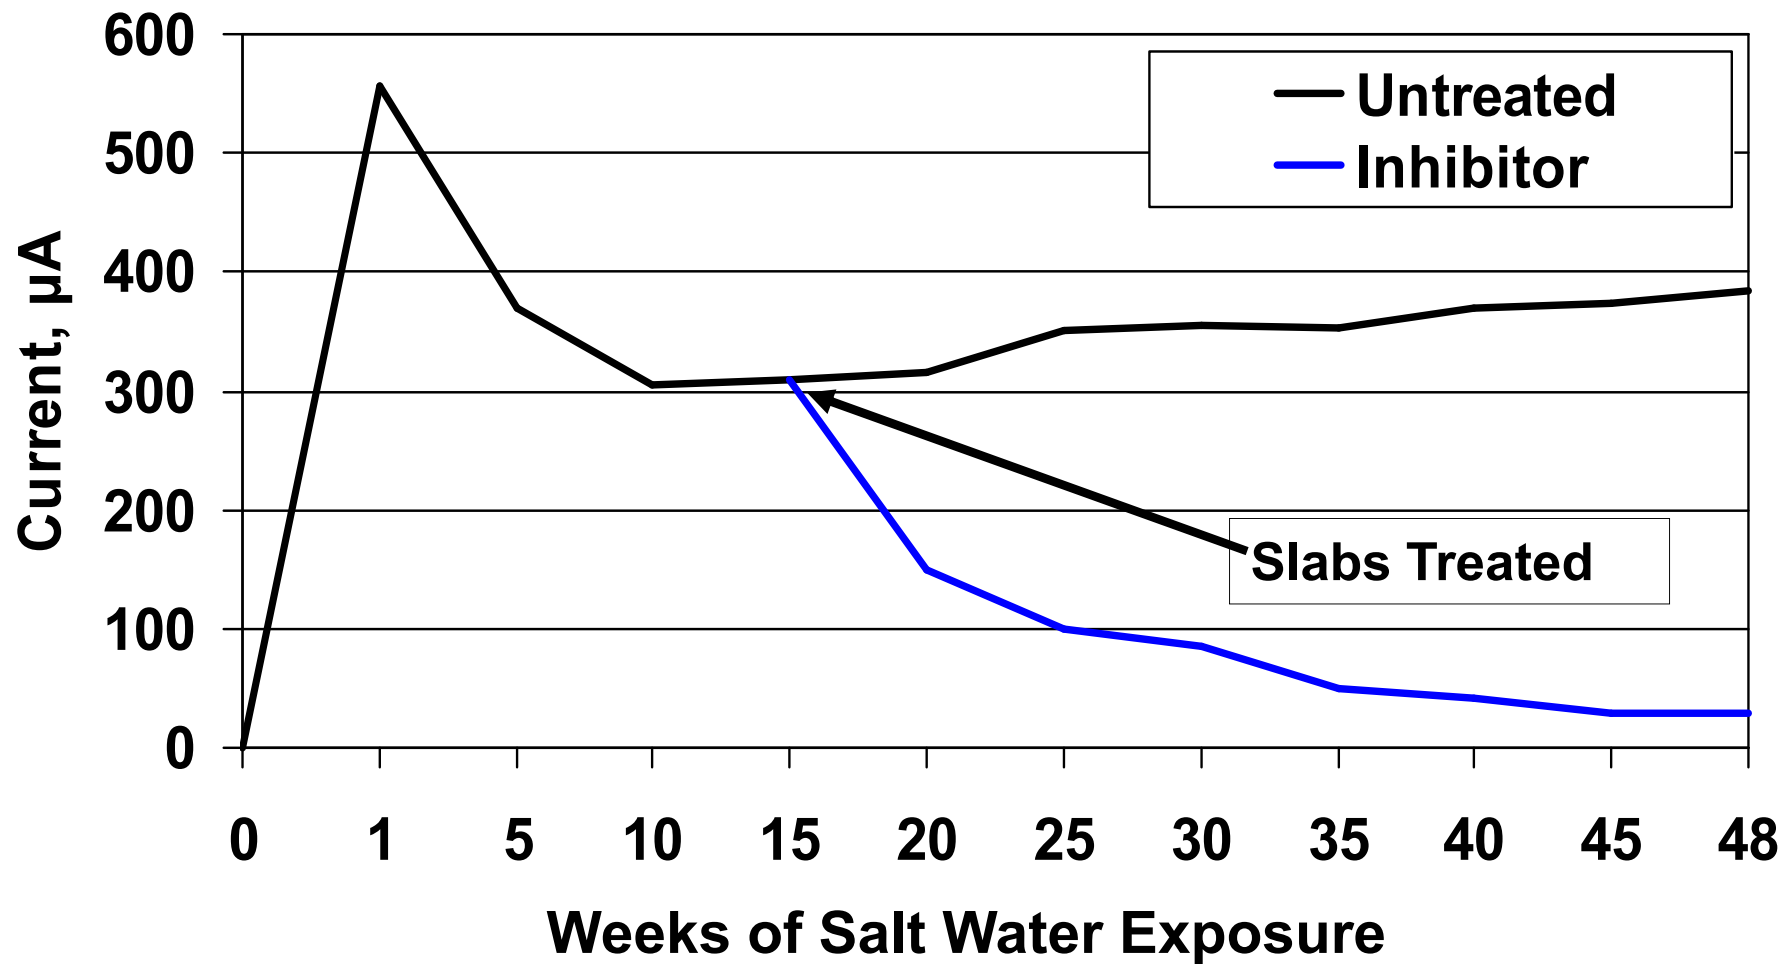
# RESULTS

## RESTORATION Existing Corrosion in Concrete

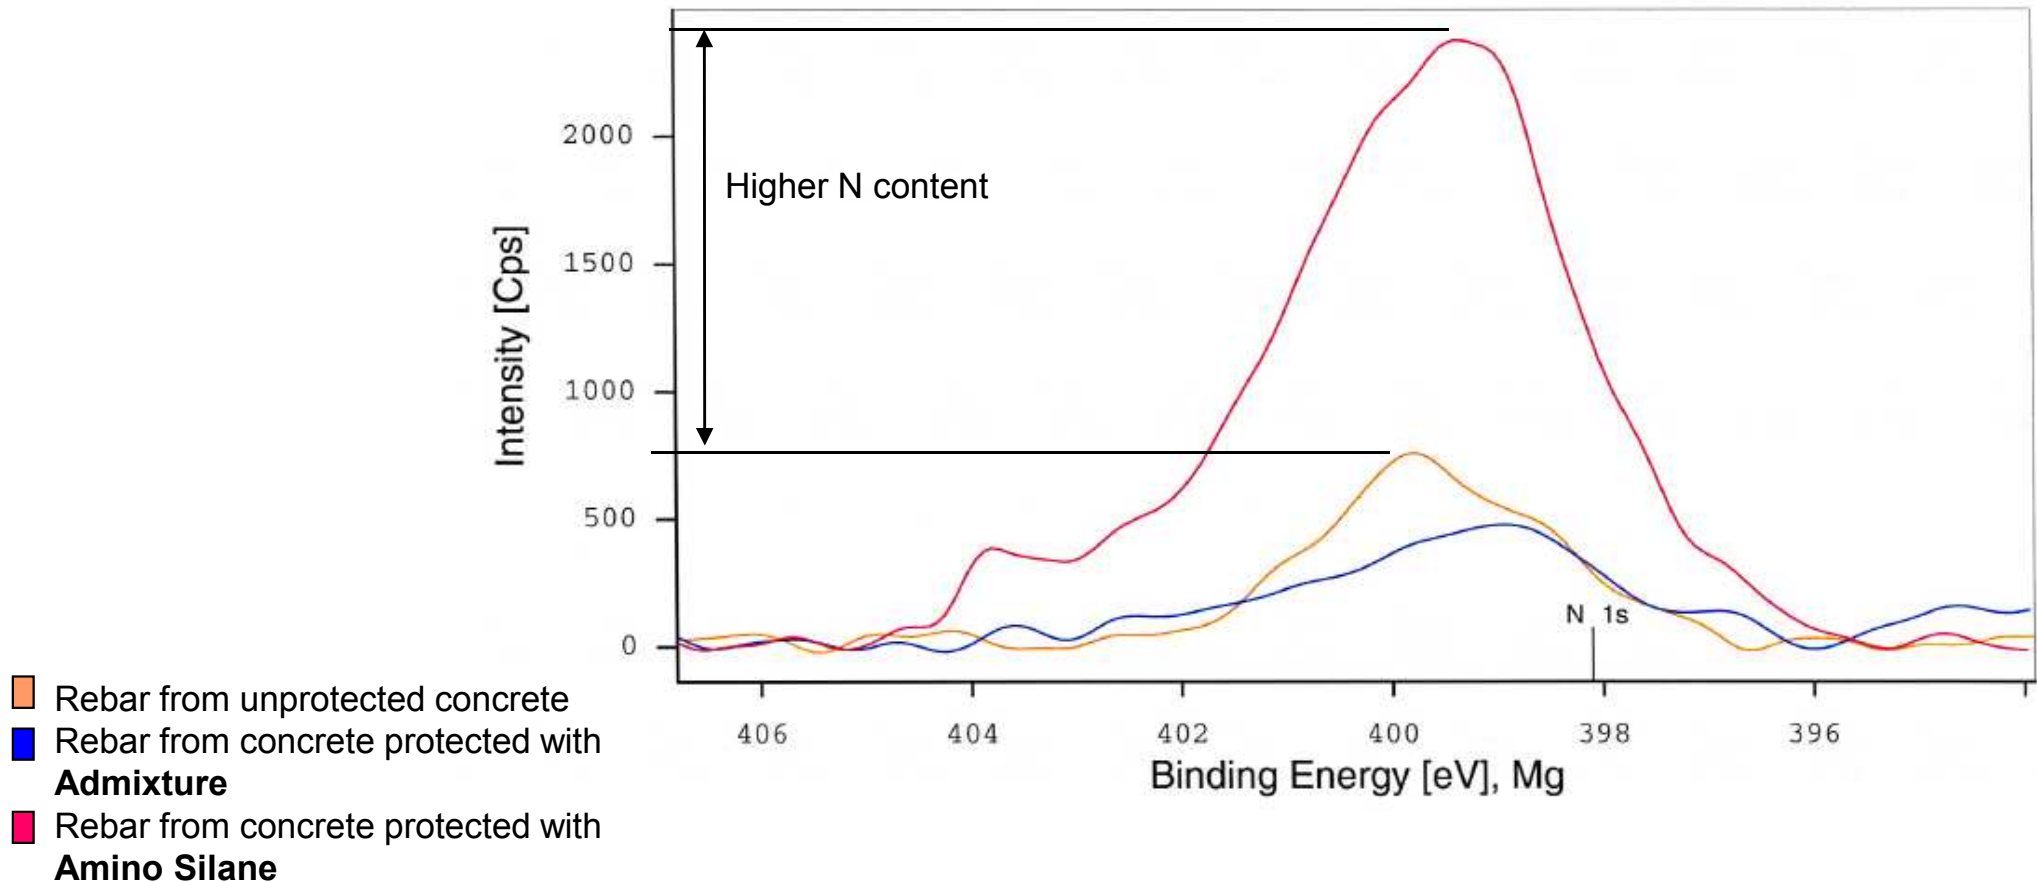
# REPASSIVATION OF STEEL

## Reaction with passivation layer

This is the nitrogen area of the curve. The admixture contains no amines, while the surface applied Corrosion Inhibitor has aminosilanes. This accounts for the higher intensity of the surface applied inhibitor.

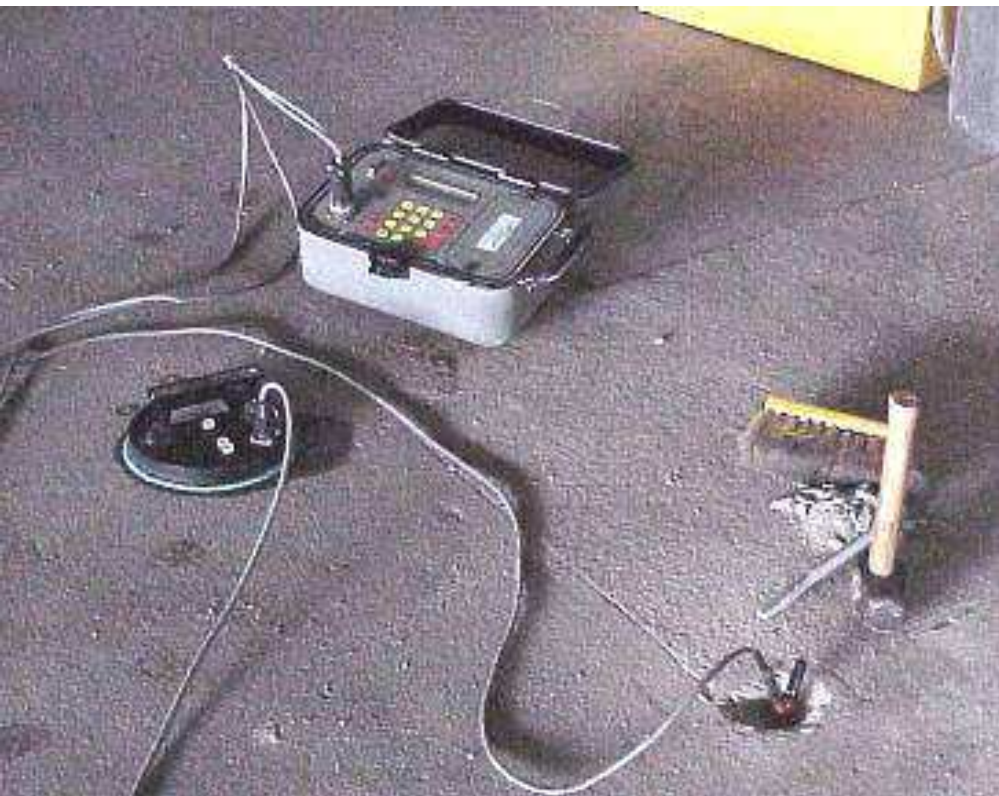
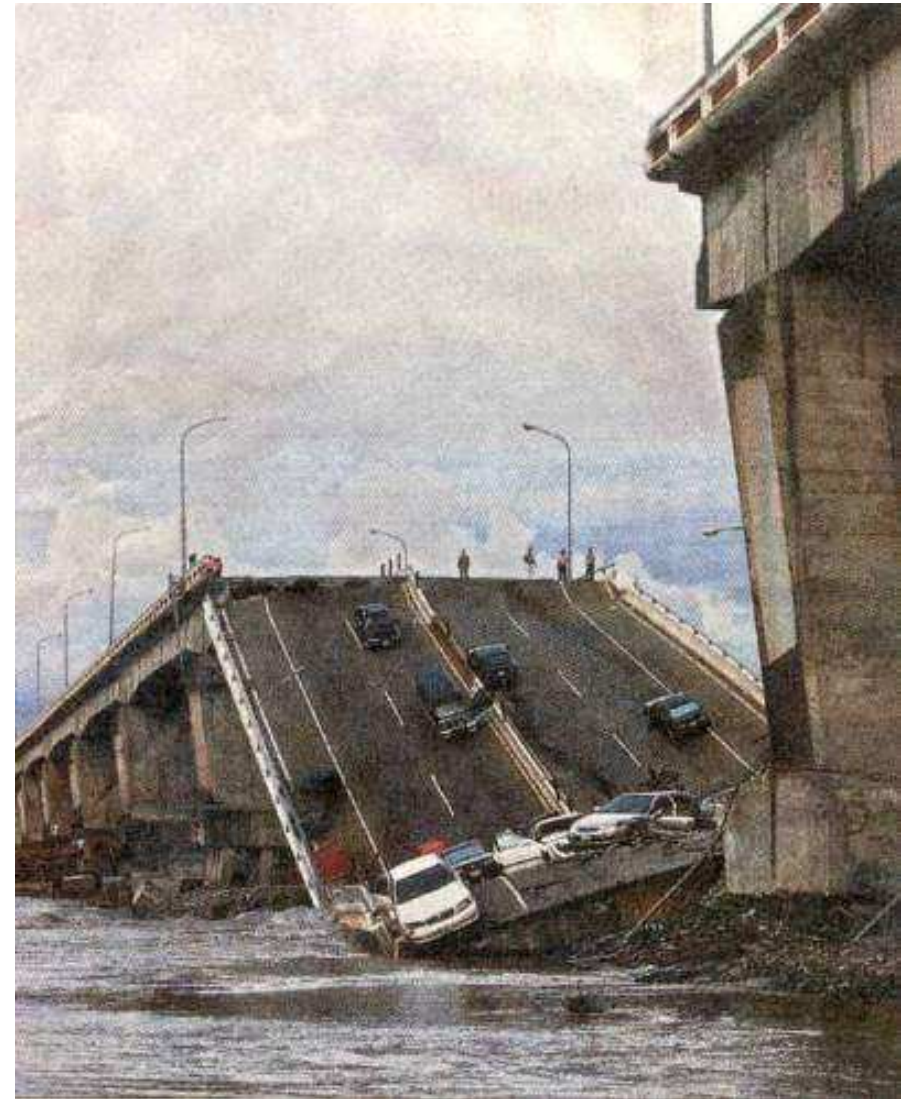
- July 2009 untreated testing performed by the University of Waterloo, Toronto
  - Corrosion rates were low although evidence of corrosion was apparent
  - A section was then treated with silane based SACI
- September 2009 measurements were taken on both treated and untreated areas
- Where SACI was applied, the resistivity of the concrete deck **increased by 180% on average.**

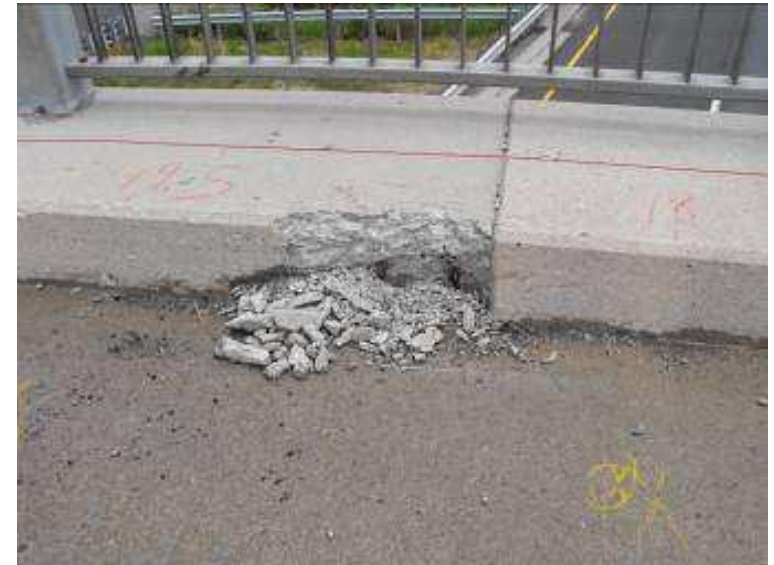
Change in Resistivity from Untreated to Treated Surface

- The resistivity at each location within the treated surface exceeded the low-to-high values of the untreated surface measurements in nearly all cases.

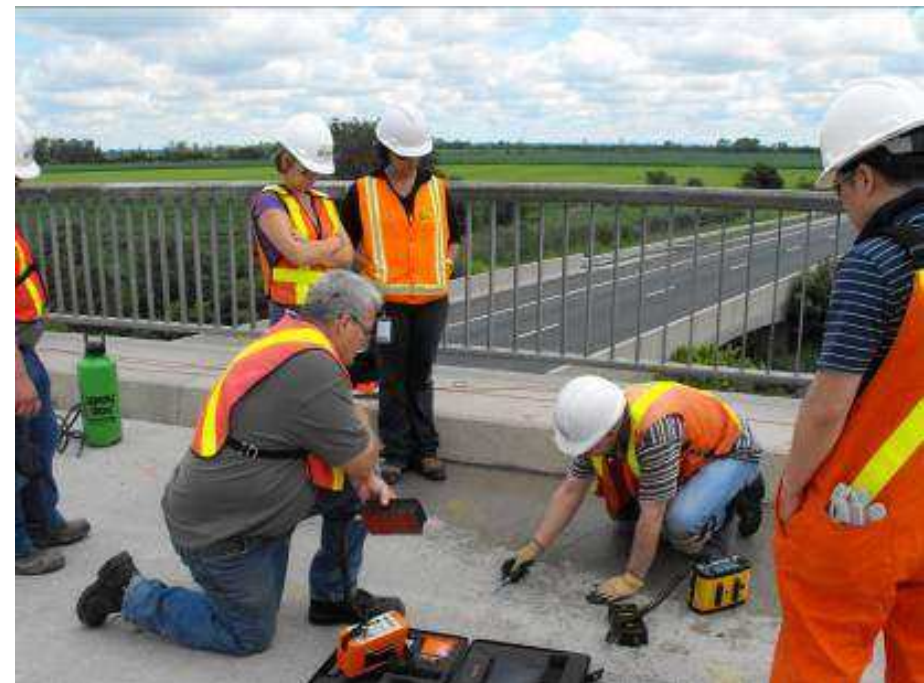
- The vast majority of the locations show an increase in the resistivity of the concrete deck.
- The inverse relationship between resistivity and corrosion rate provides excellent insight into the effectiveness of silane based SACI.

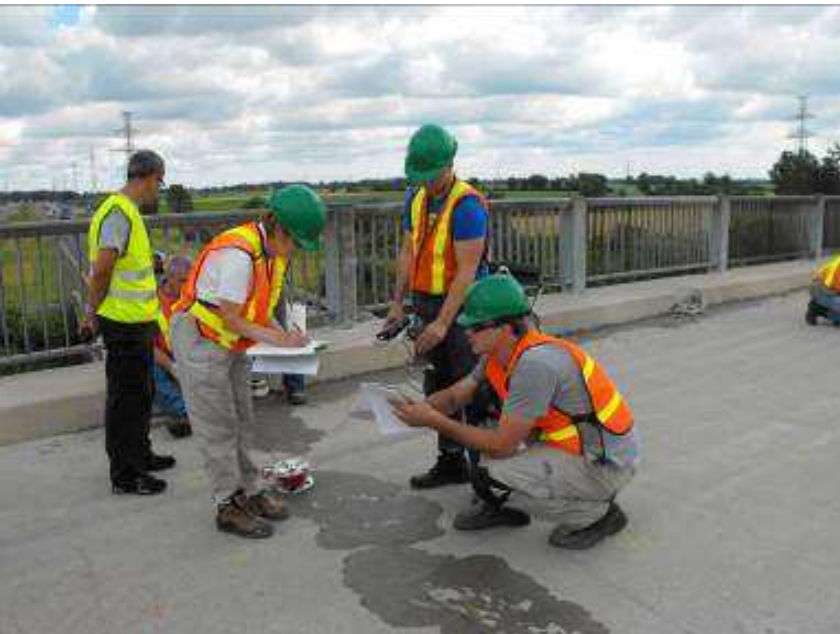
Average Change in Corrosion Rate With and Without Treatment

- Untreated areas **increased** by 0.58 μA/cm<sup>2</sup>.
- The treated areas demonstrated **virtually no change** at all
- The corrosion inhibiting properties of silane based SACI had a significant impact on the corrosion rate in a relatively short period of time.

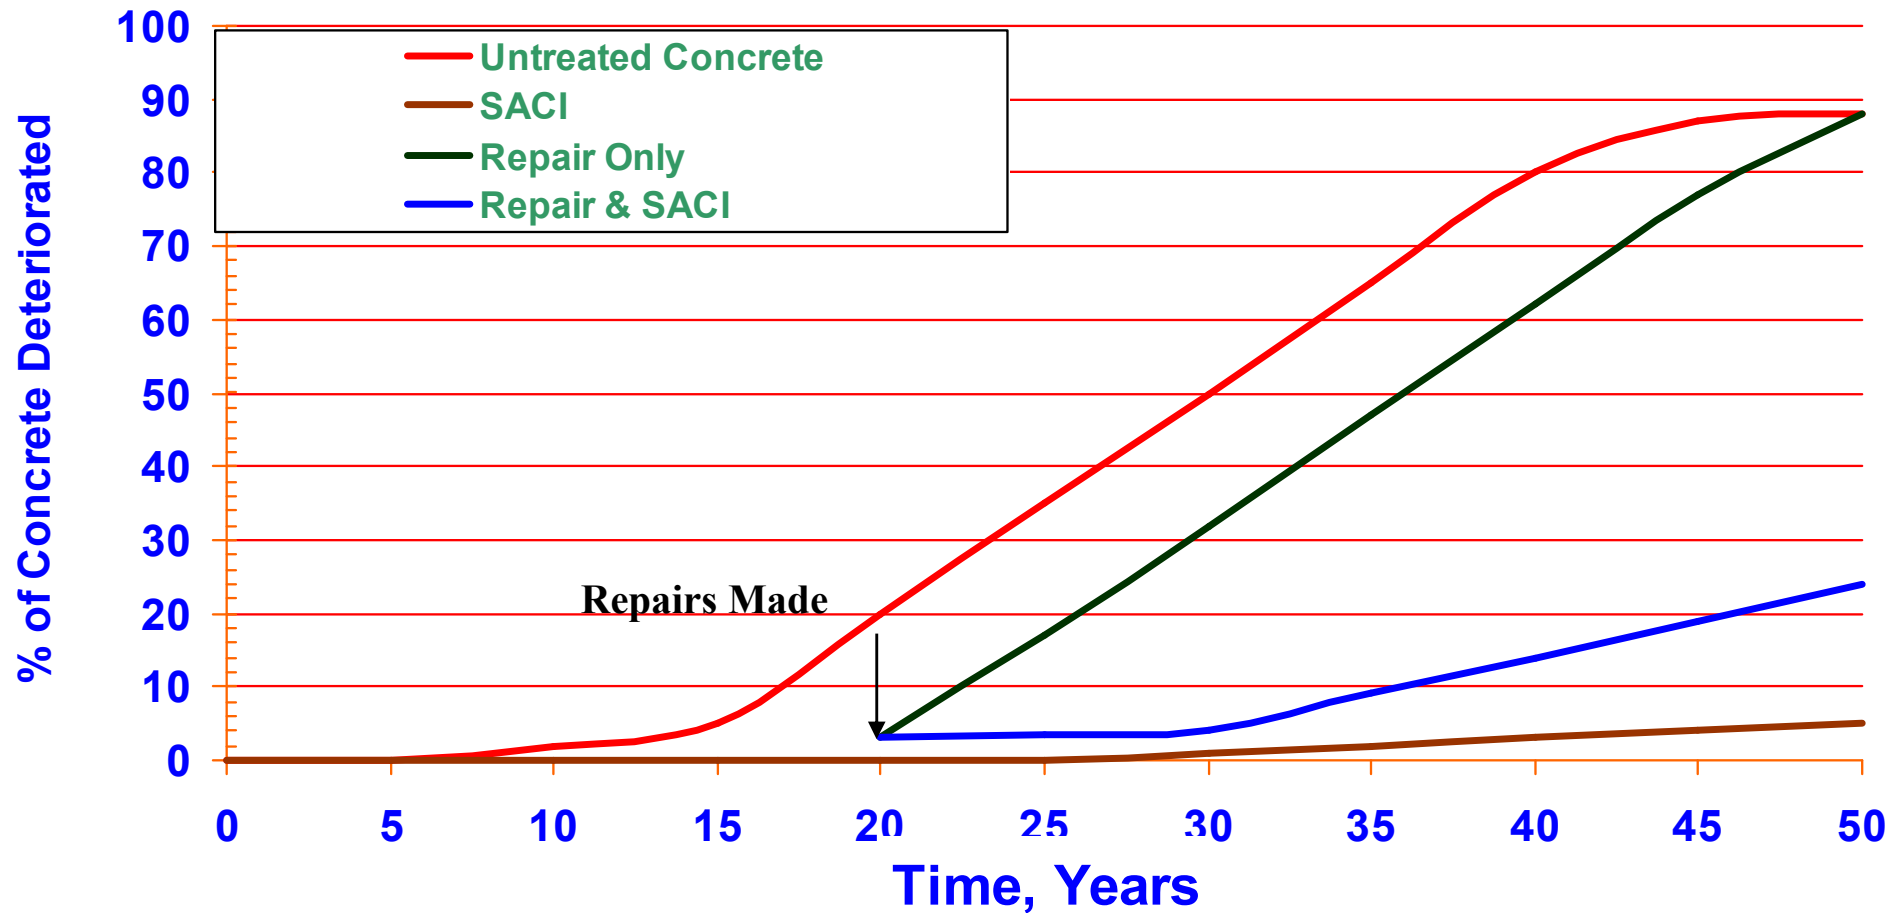
# Extension of Service Life Due to SACI Treatment

Based on concrete cover of 1" average and diffusion data from concrete

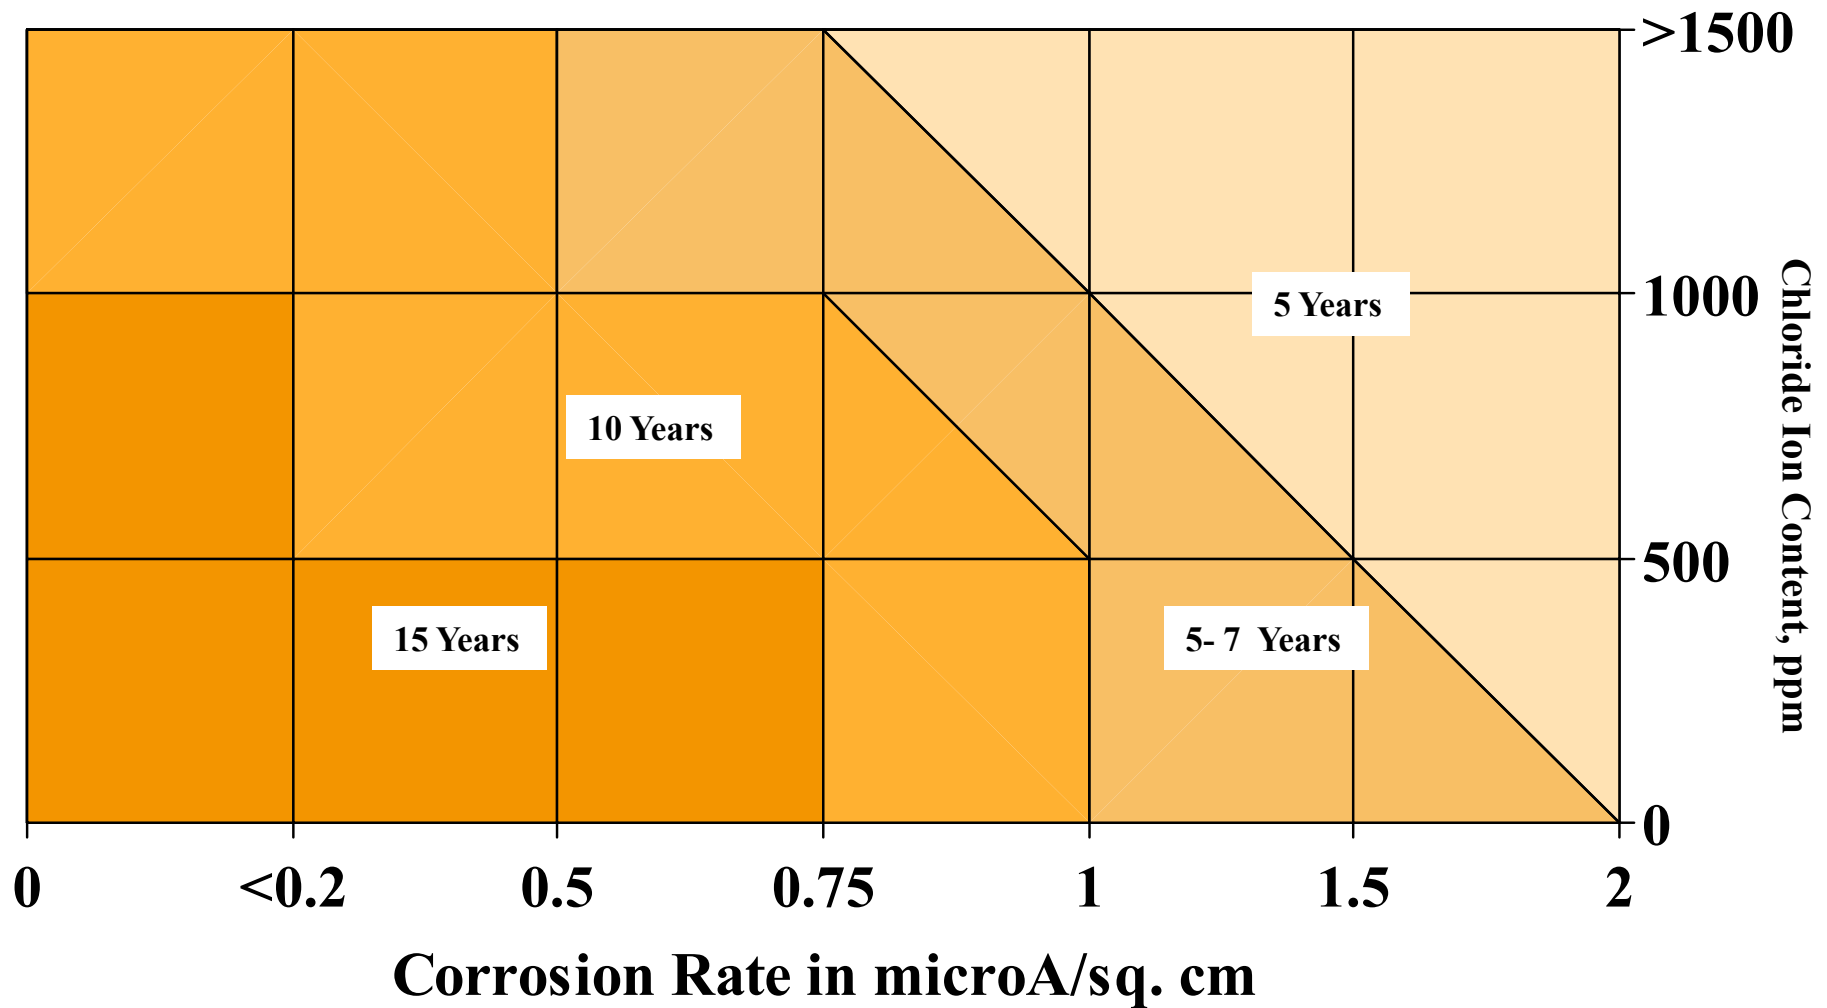
# Estimated Retreat Times for SACI
