Performance of Corrosion Mitigation Systems in Iowa Bridges

Work Performed on Behalf of Iowa Department of Transportation,
Michael Todsén

Wiss, Janney, Elstner Associates

Application to 3 Iowa Bridges

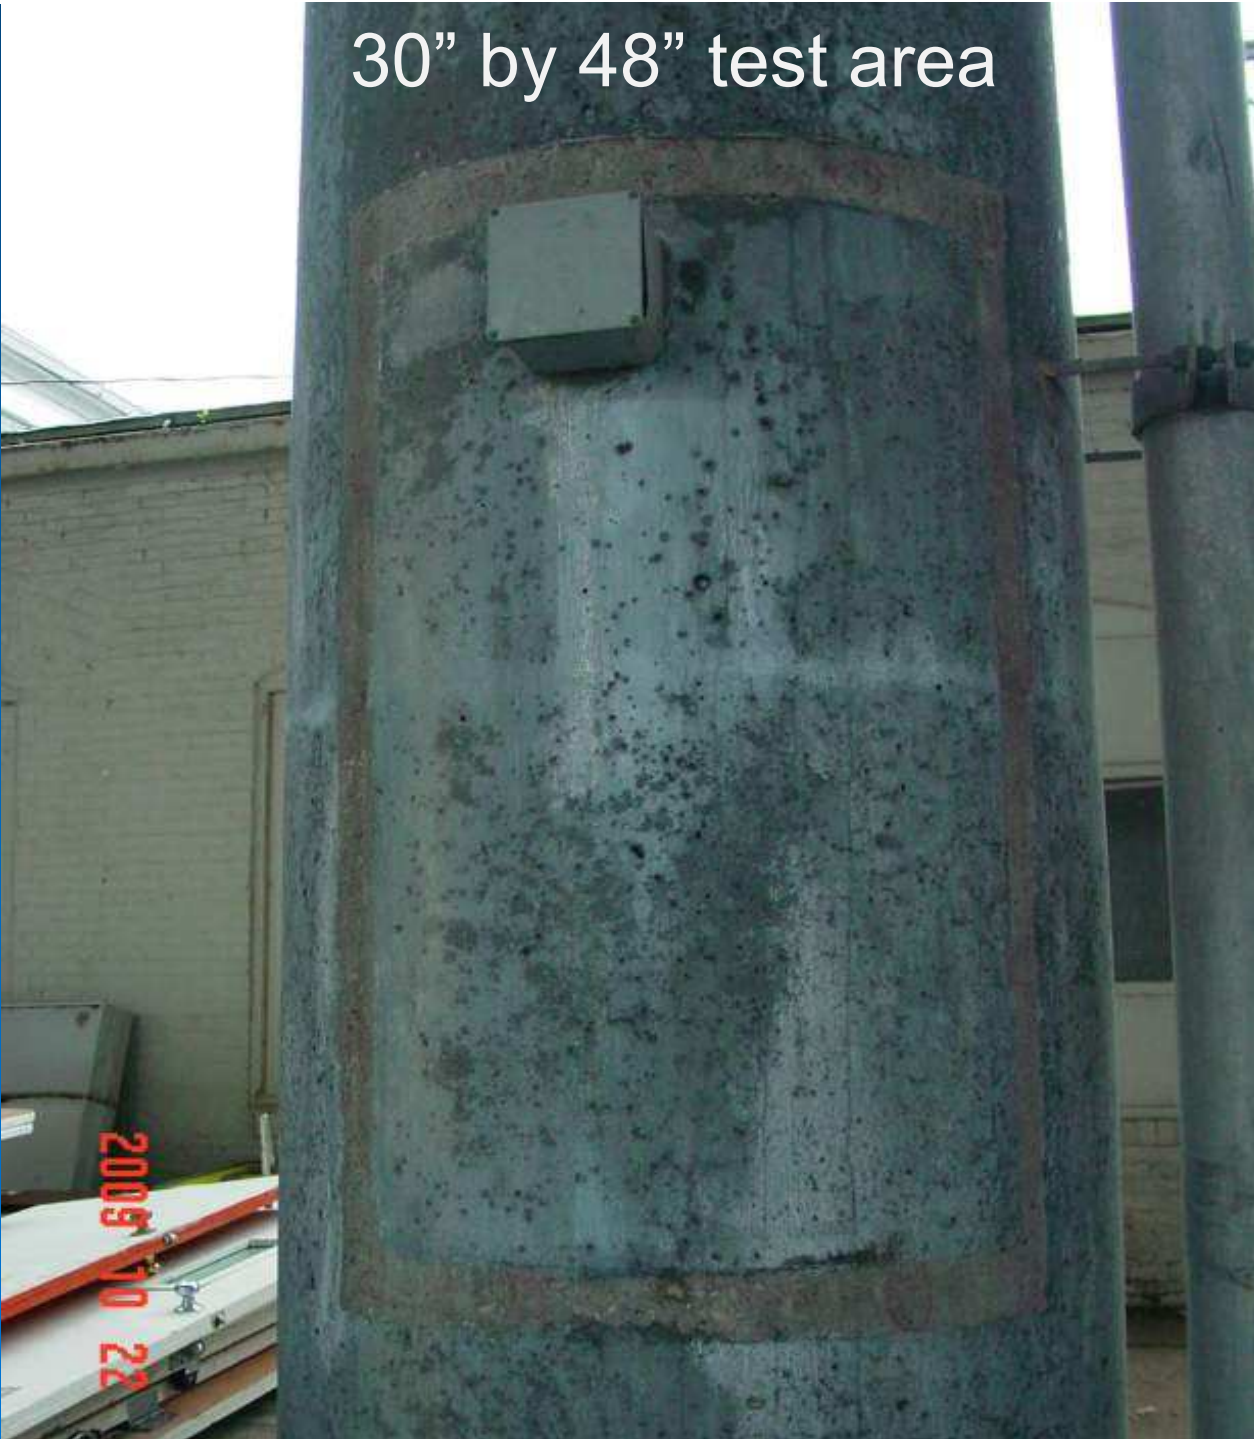
Blue wire from Ref. Halfcell

Black wire from Rebar Ground

Resistor (0.1 ohm) [Red to Black]

Switch (single toggle)

Red wire from Zn Anode (coating)

Meter setup to measure embedded reference halfcell (+ to gnd [blk], - to cell [blue])

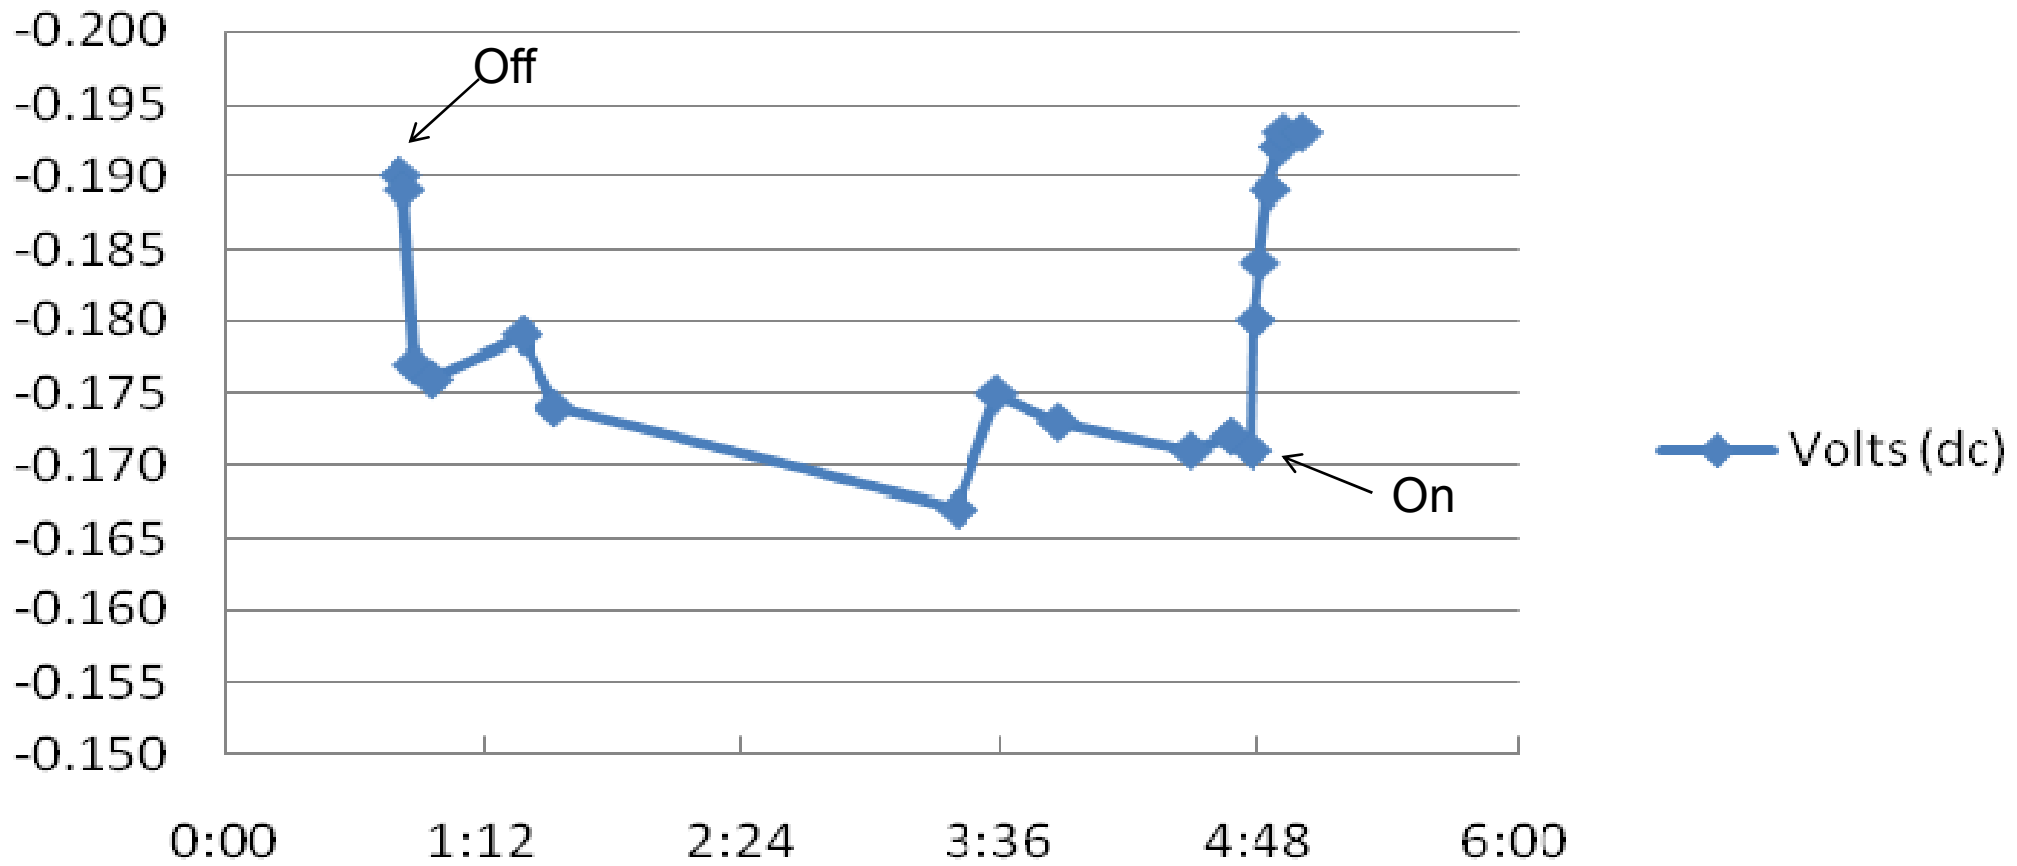
Depolarization Test (hours)

US 63 Ottumwa - Arc Sprayed Zinc

- Current was minimal
- Total shift of test area only about 20 mV (Instant off and depolarization)
- Blisters filled with zinc corrosion products have formed in coating (no chloride)
- Zinc coating thickness at blisters was 0.026" (0.018" to 0.047"), [Spec was 0.020"]
- No initial data
- Minimal concrete deterioration

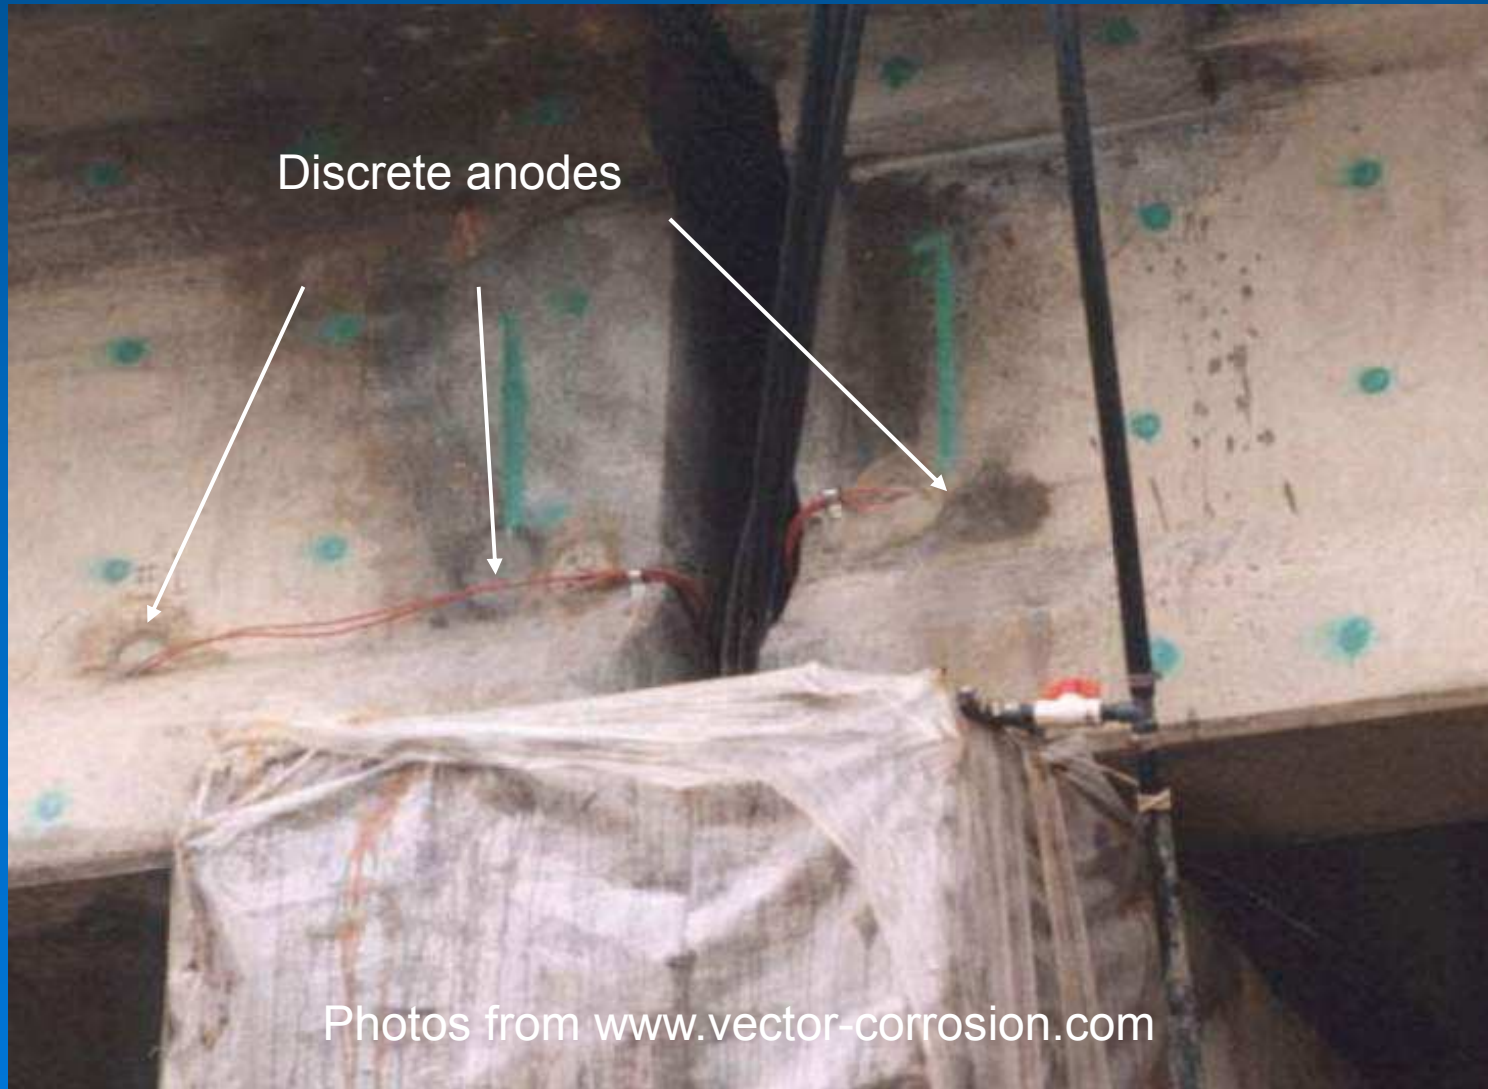
ECE and Discrete Anodes

- Corrosion-induced deterioration widespread under expansion joints
- Repaired in 1998
 - Conventional repair
 - ECE on caps & cols.
 - ECE and discrete anodes on exterior beams
 - Sealer

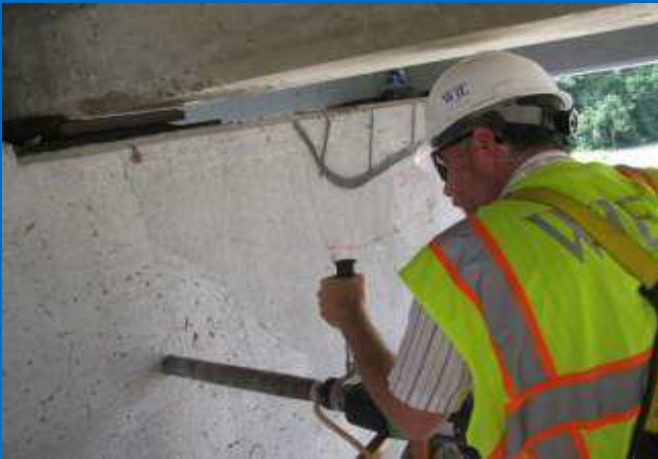
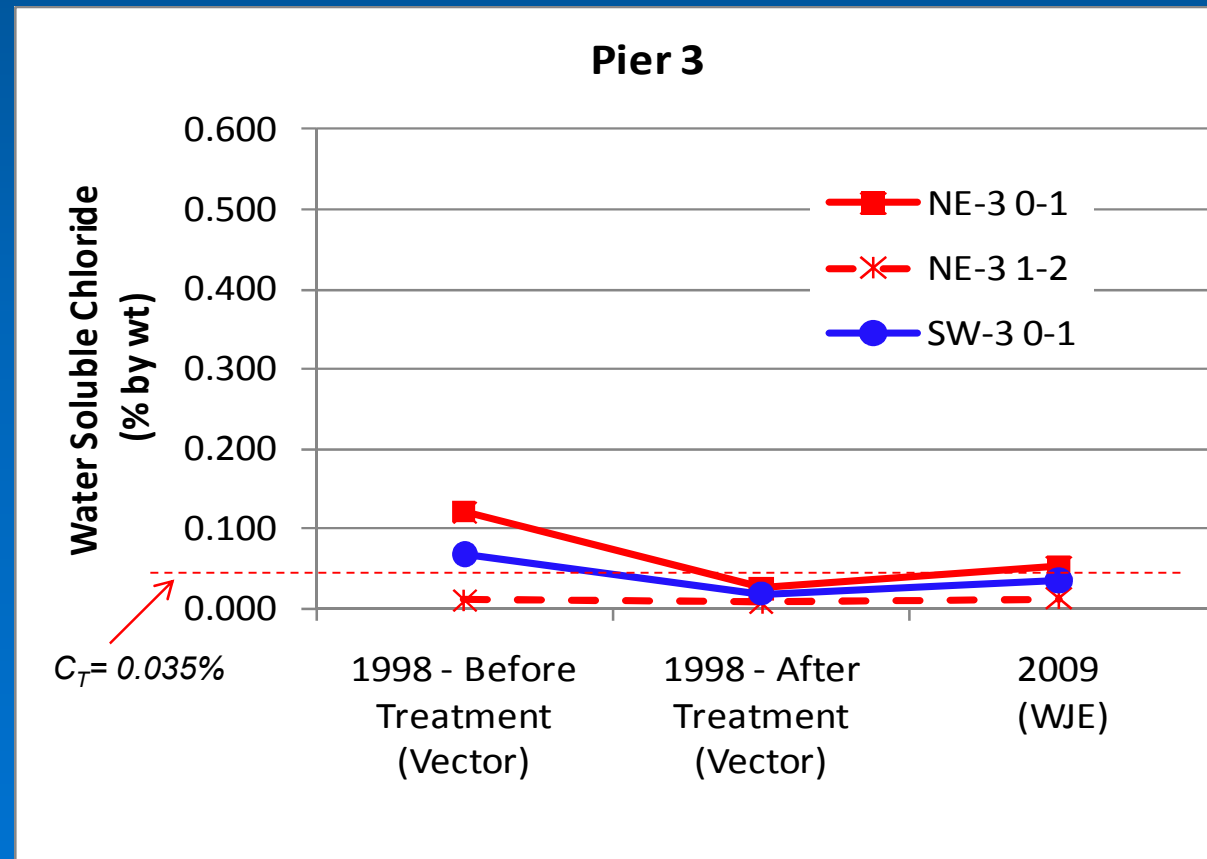
IA 192 Council Bluffs – Chloride in Pier Caps

- Core samples taken for comparison with values reported by contractor

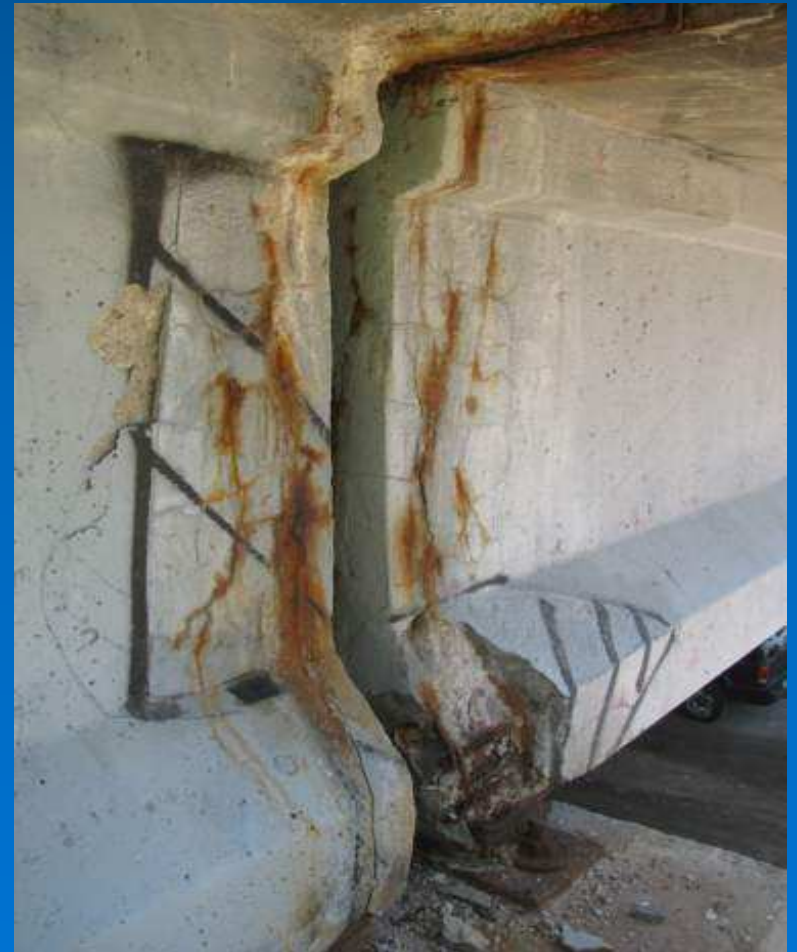
East Beams at Pier 3 – Discrete Anodes

- Test station not functional
 - Embedded ref. cell
- Current from anode to reinforcing bars was negligible
 - Zinc may be consumed
 - Minimal potential
- Limited installation

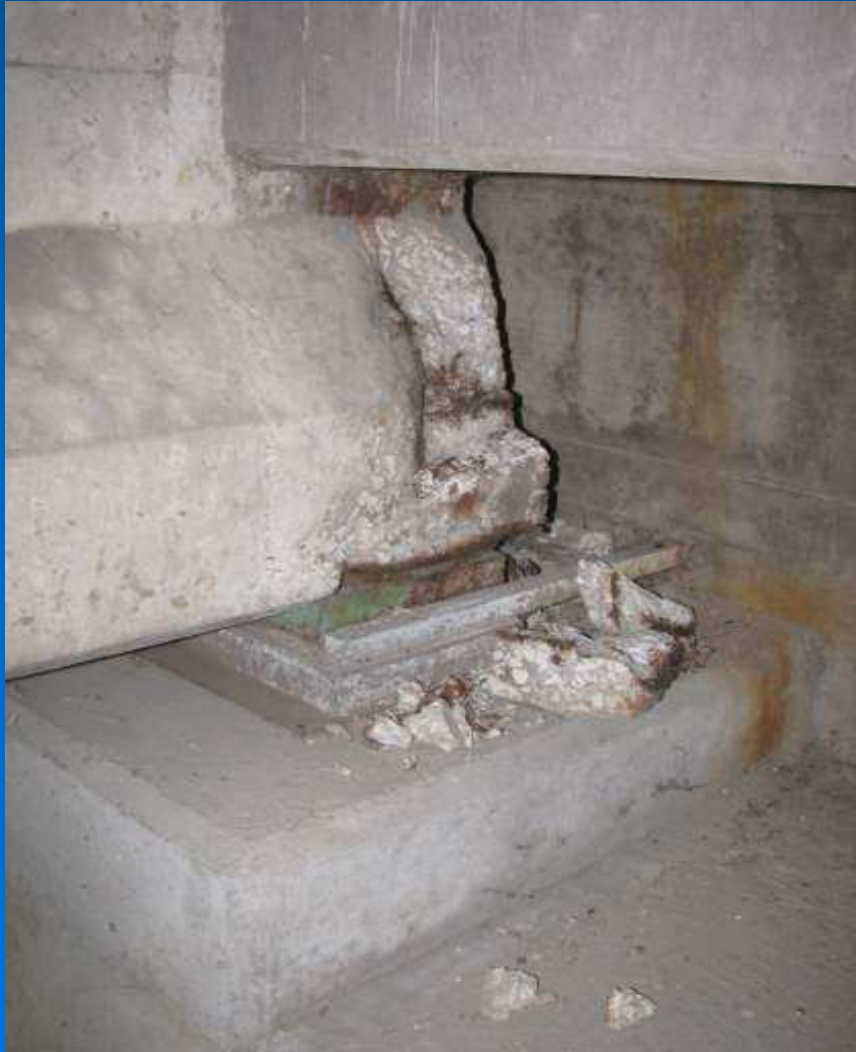
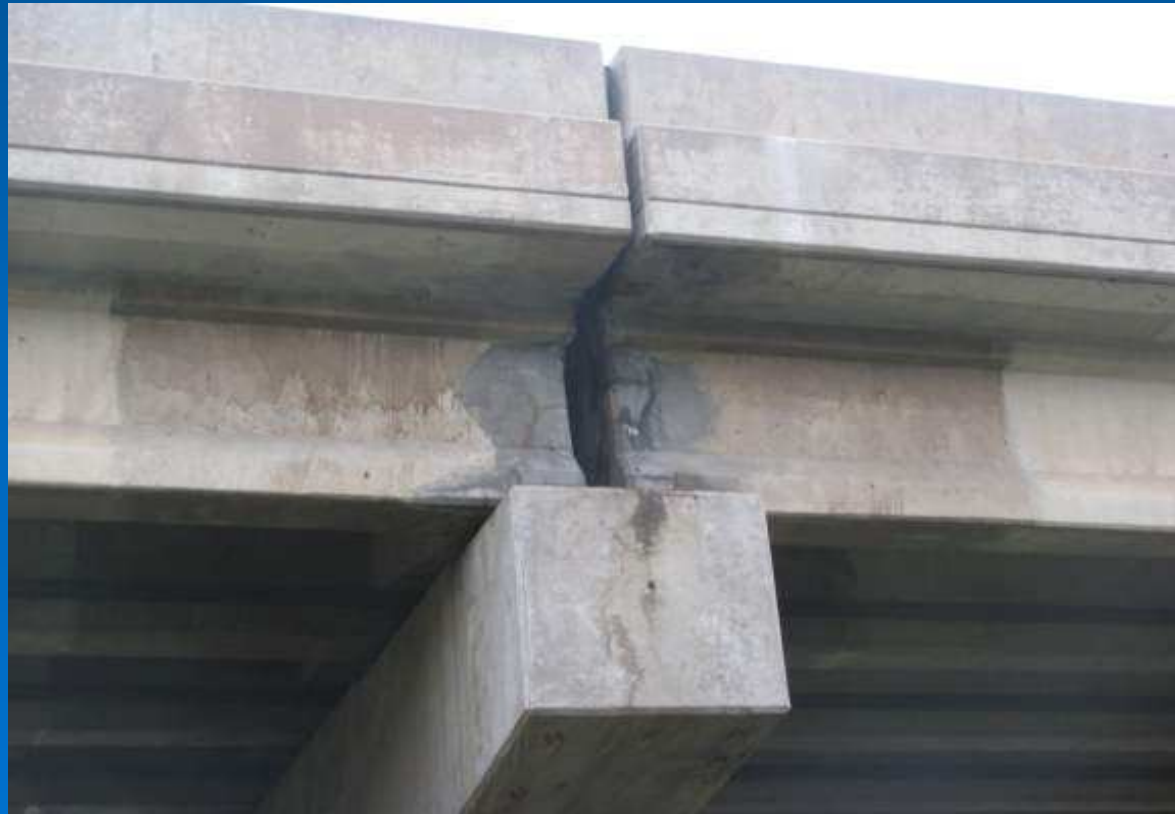
Northbound Lanes: Not Protected

I-380 Cedar Rapids – Condition of beam ends at abutments

Location	Area of Delam. or Spall (in ²)	Number of Beams with Damage
Southbound Lanes (with CP system)	815	8
Northbound Lanes (without CP system)	2129	20

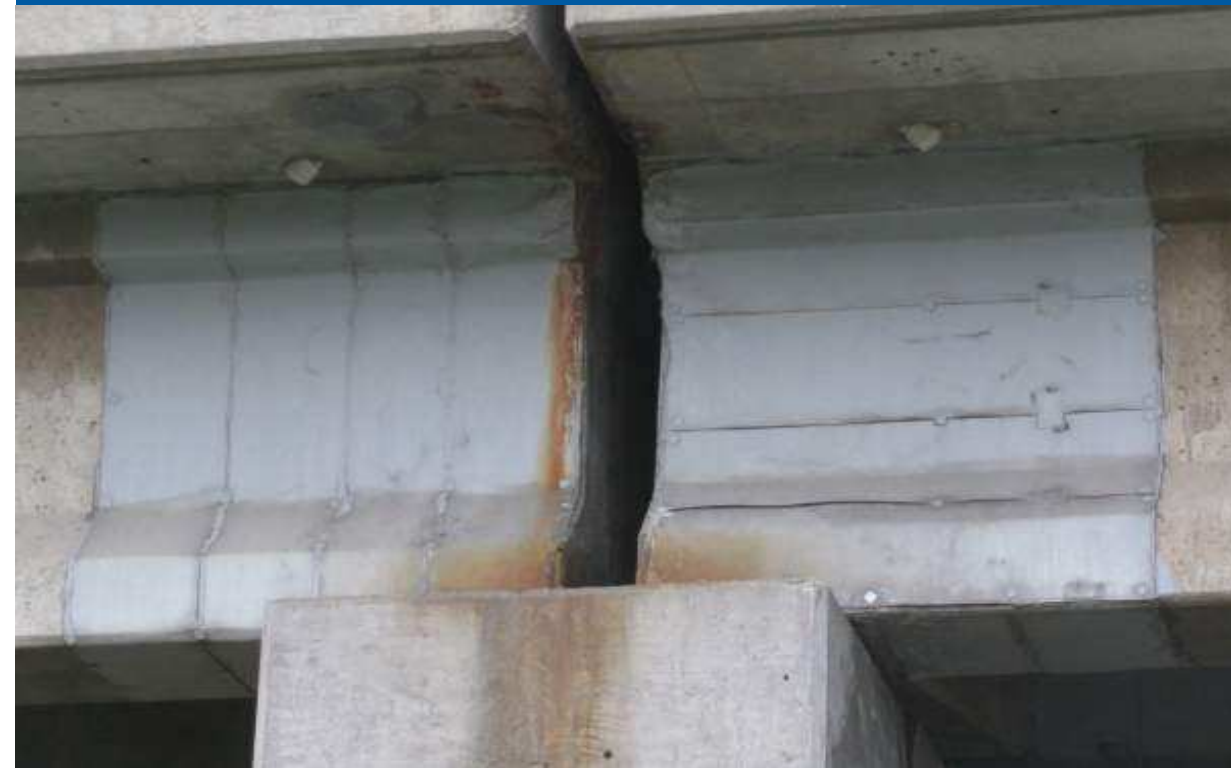
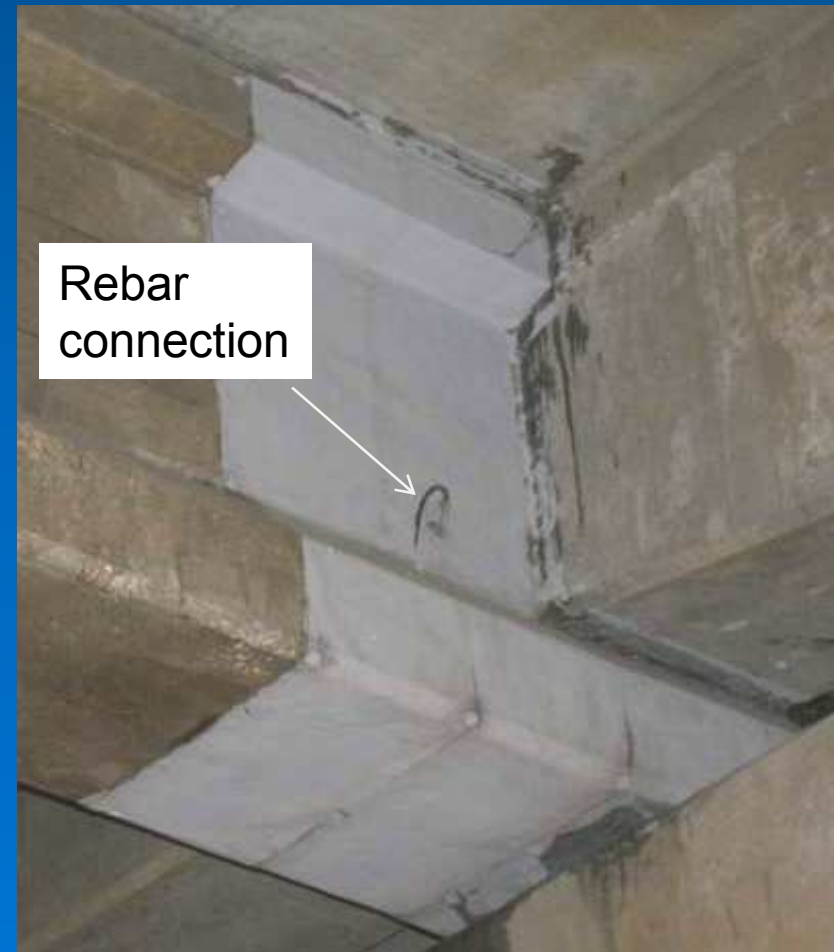
Southbound Lanes: Zinc-Hydrogel Sheet

- No baseline data
- Zinc sheet debonded in many areas and consumed at areas of greatest exposure
- Zinc sheet protecting beam ends
 - Depolarization adequate
 - Delam. or spalled area in southbound lanes only 40% of unprotected northbound lanes

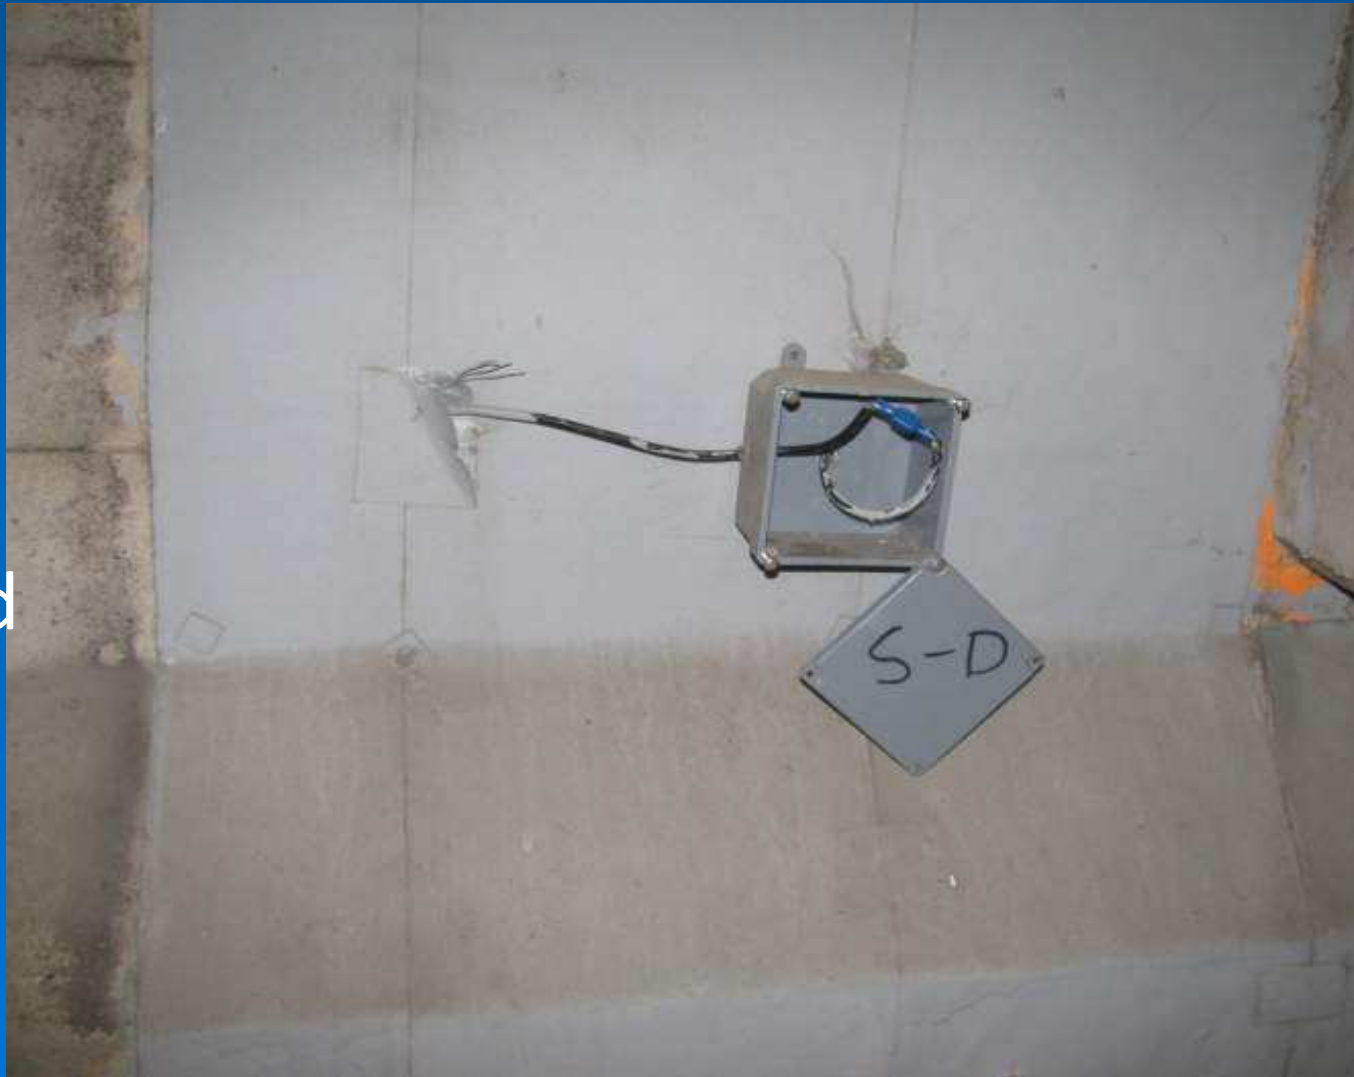
I-380 Cedar Rapids - Anode Performance

- Despite specification requiring test stations and report, stations were minimal and vandalized and report not available
