REPAIR OF DAMAGED PRESTRESSED CONCRETE GIRDER

AASHTO Midwest Bridge Preservation
Conference, Detroit, MI

Roe Enchayan, PE
Nebraska Department of Roads

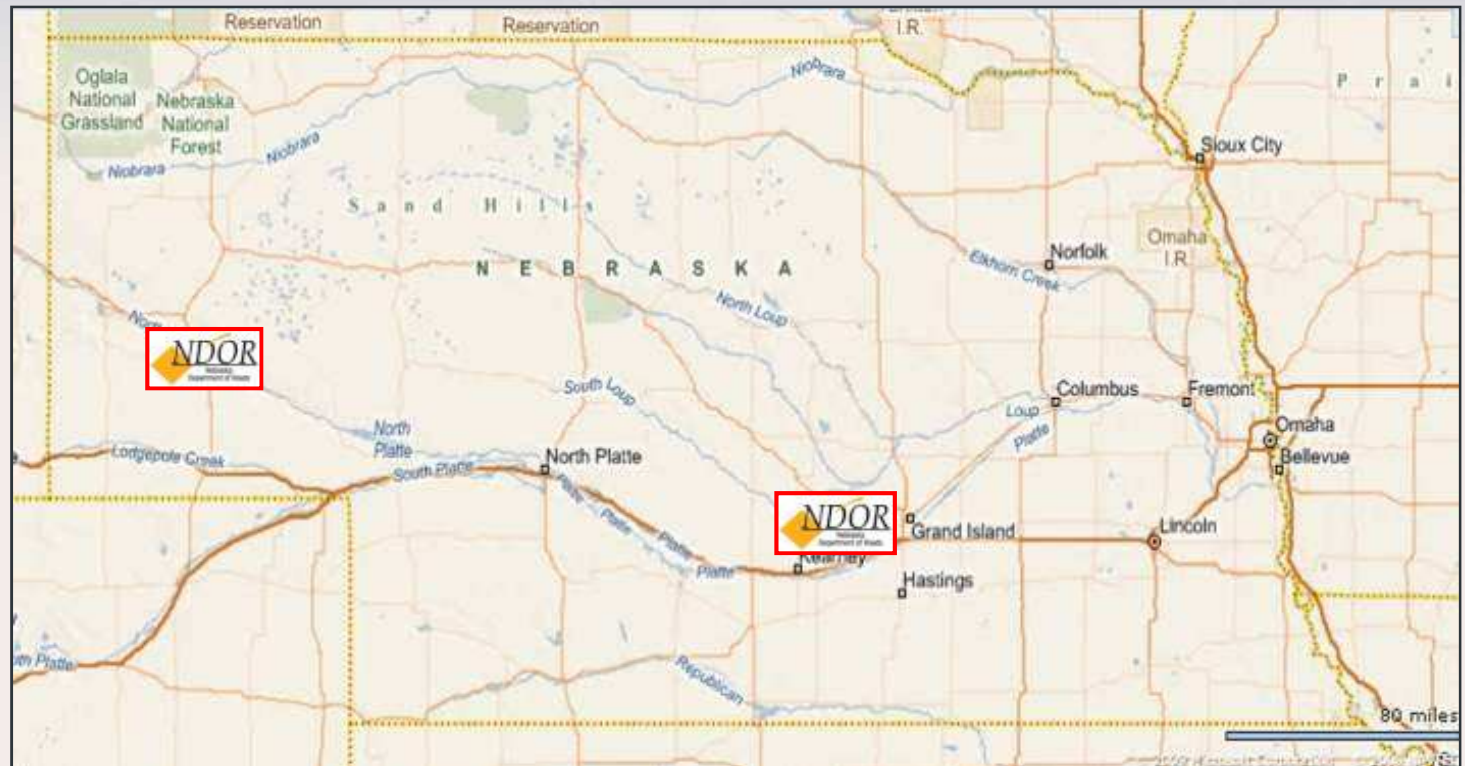
Bridge Locations

■ Wood River Interchange

Highway N-11 and I-80, approx. 4 miles S of Wood River

■ Gering By-Pass

Highway N-71, approx. 2 miles SE of Gering

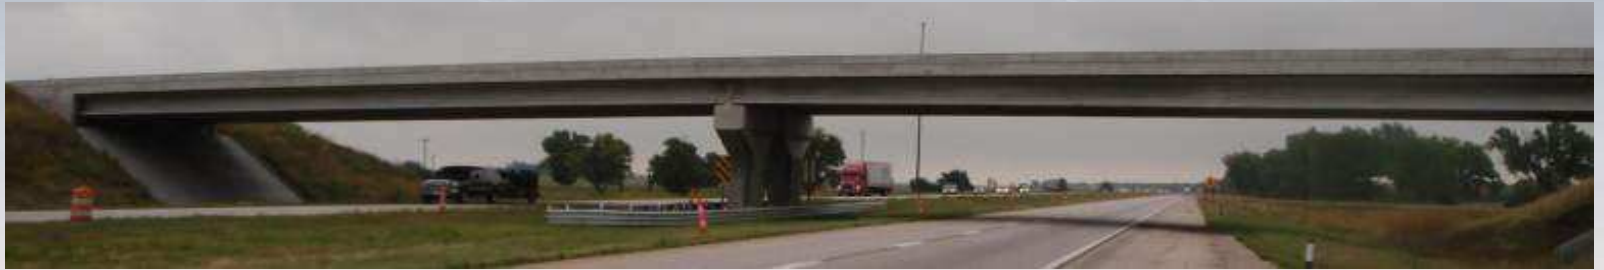
Wood River Bridge

- Two lane bridge over I-80
- Two span 145' - 145'
- Continuous for Dead Load and Live Load

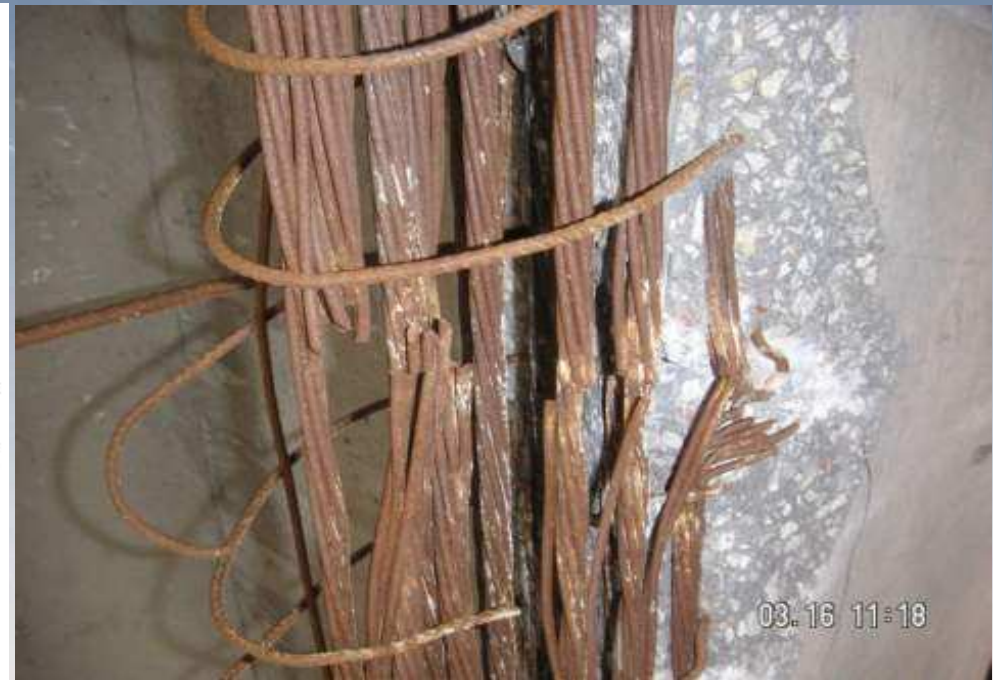
**In Depth
Field
Inspection**

- **March 16 & 17, 2009**
- **Duration of traffic control – 3 to 4 hours**
- **Inspection tasks included:**
 - **Document damage – field notes, photos**
 - **Inspect impact location and load path**
 - **Measure extent of visible damage**
 - **Sounding of girder concrete**
 - **Measure loss of camber using level rod**

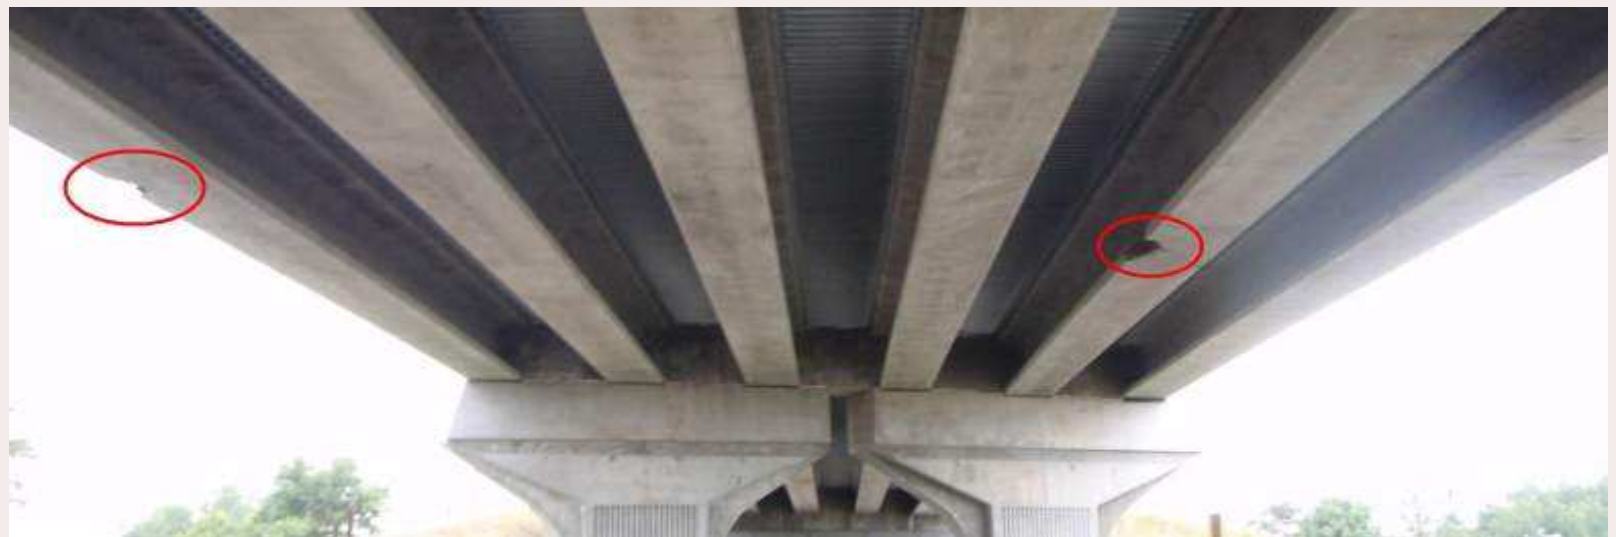
Comparative Camber < 1.48"

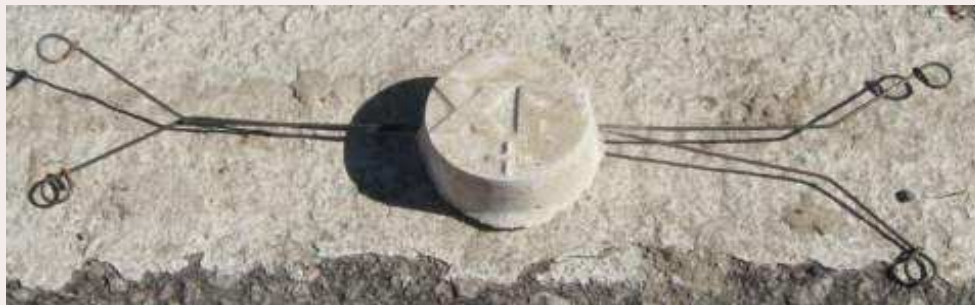
- **Corrosion protection is critical:**
 - Concrete reactivity decreases with age. New concrete has greater reactivity & corrosion potential.
- **To protect against corrosion:**
 - Blast clean exposed reinforcement.
 - Use anodic protection for reinforcing

- **Regain original condition and performance by:**
 - **Splicing the broken strands,**
 - **Recovering moment capacity,**
 - **Preventing corrosion of strands and reinforcing steel, and**
 - **Using compatible grout to replace the broken concrete.**

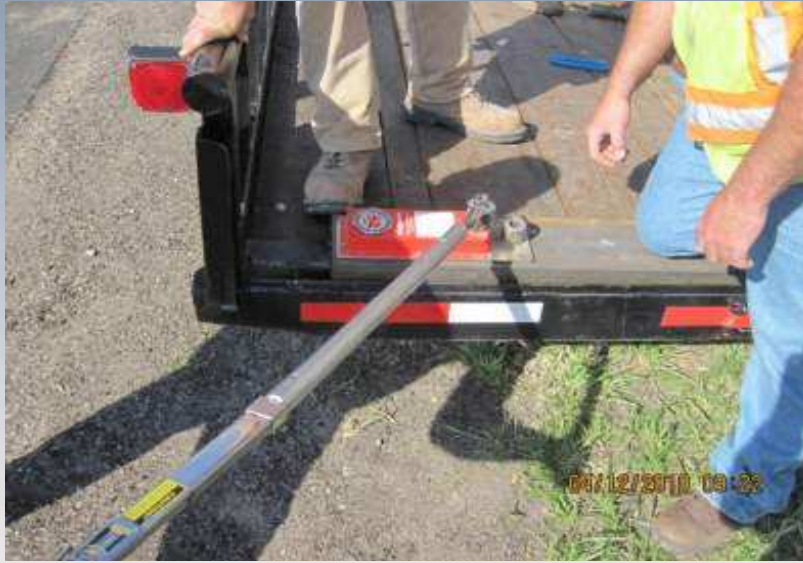
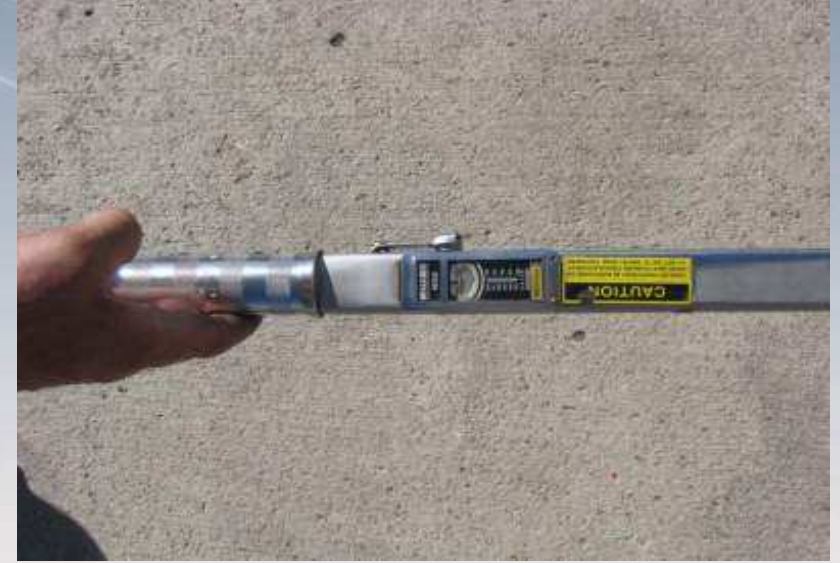
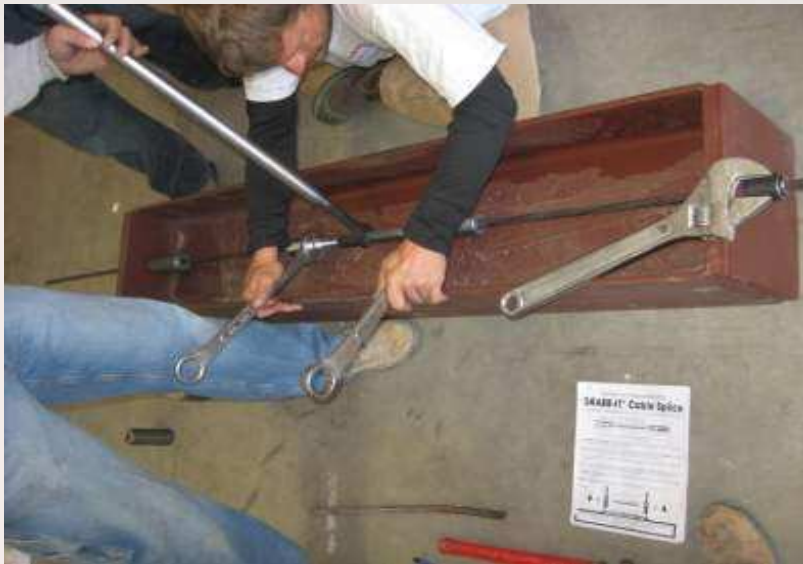
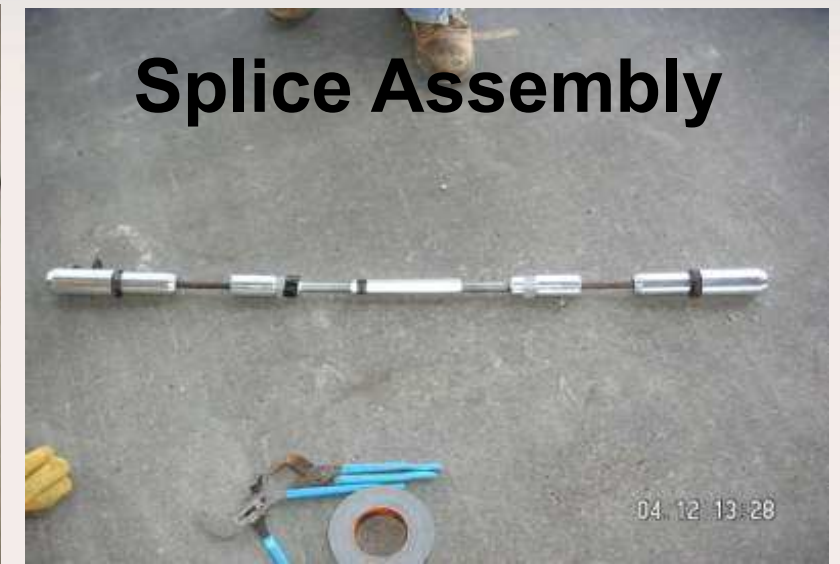
**Strand
Splicing
Hardware**

Calibrate the torque meter.

Splice Assembly

Practice the procedure.

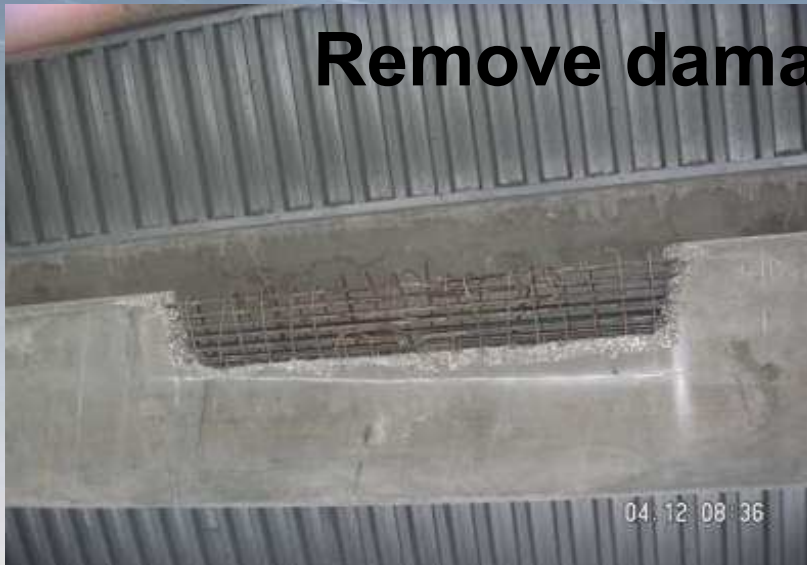
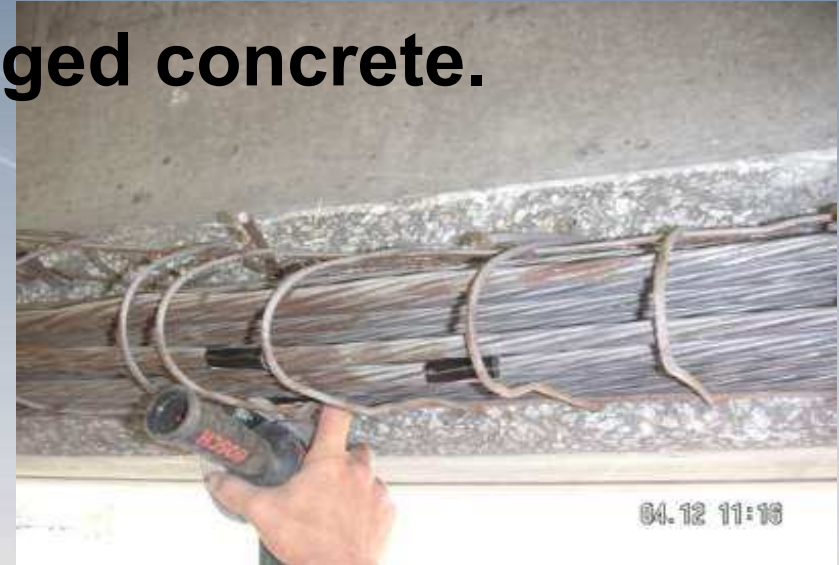
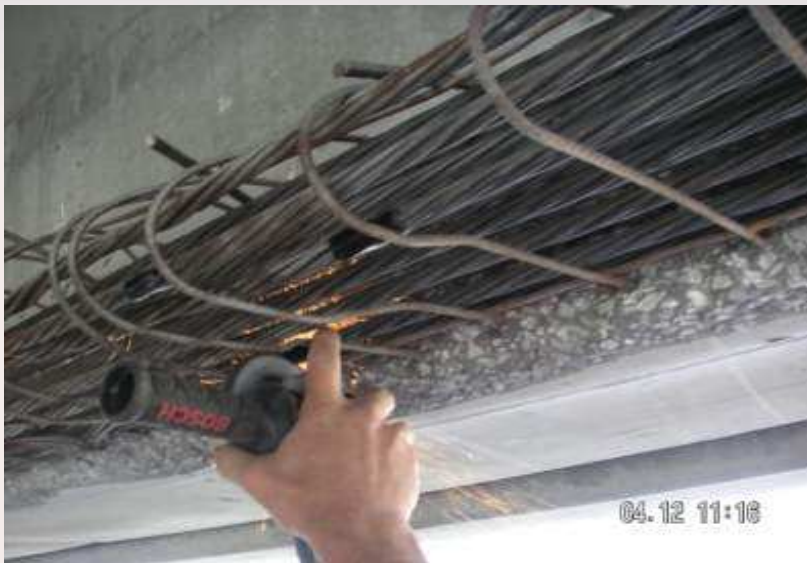
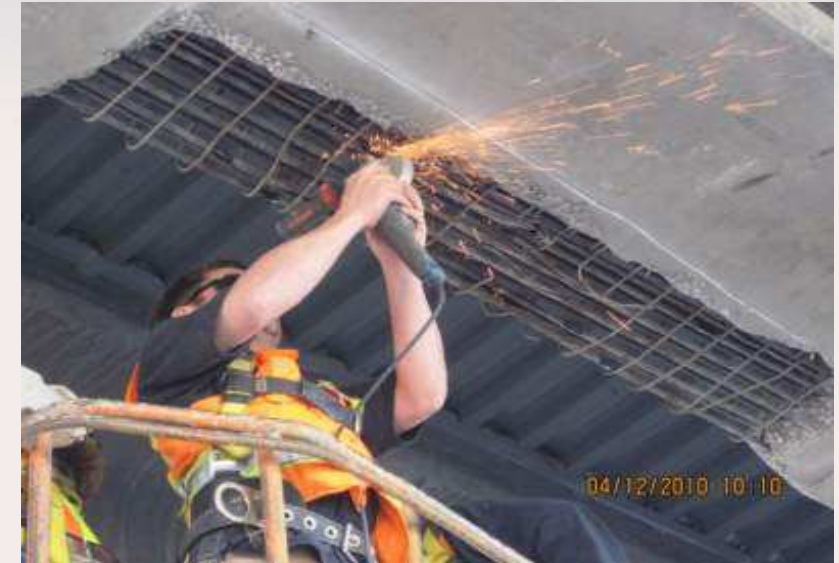
Surface Prep and Strand Cutting

Remove damaged concrete.

Cut damaged strands.

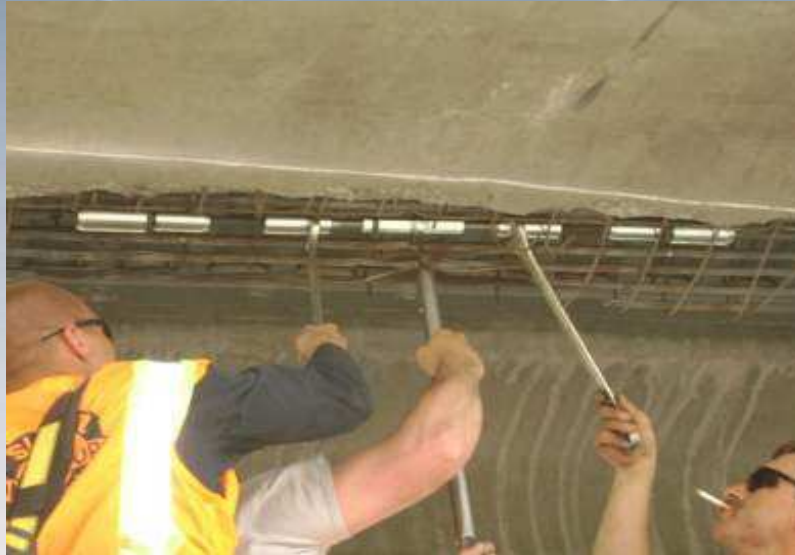
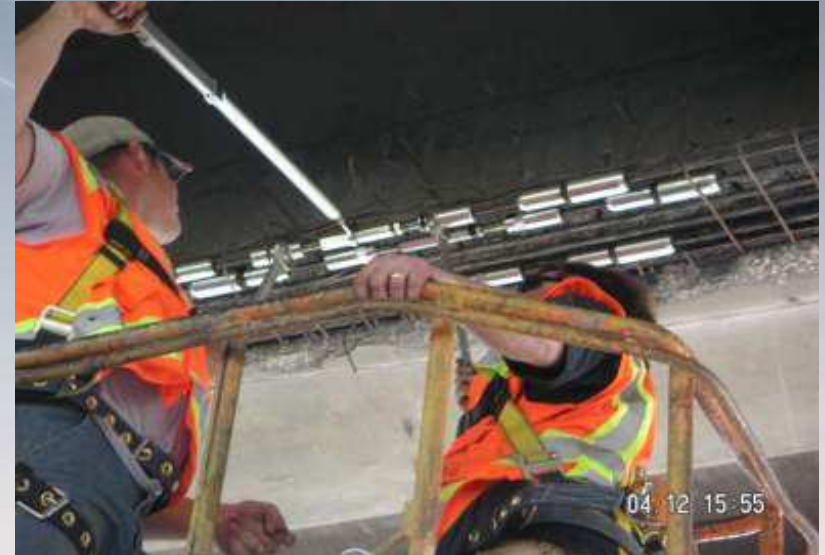
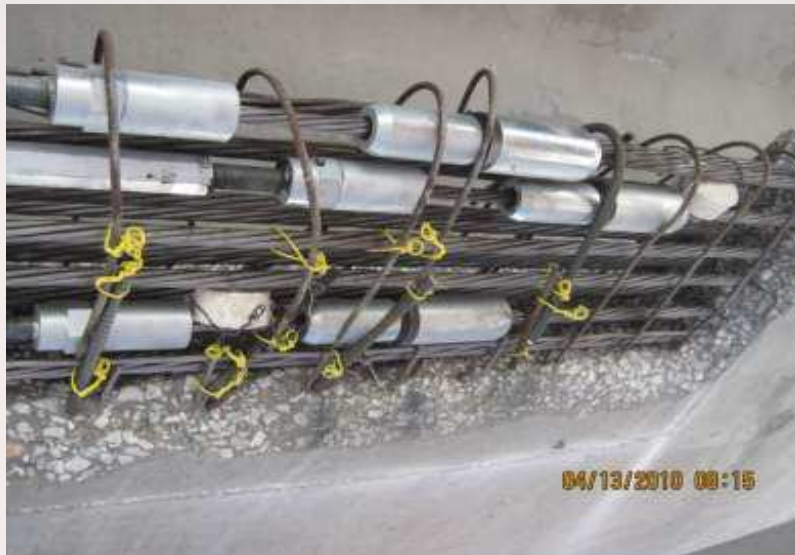
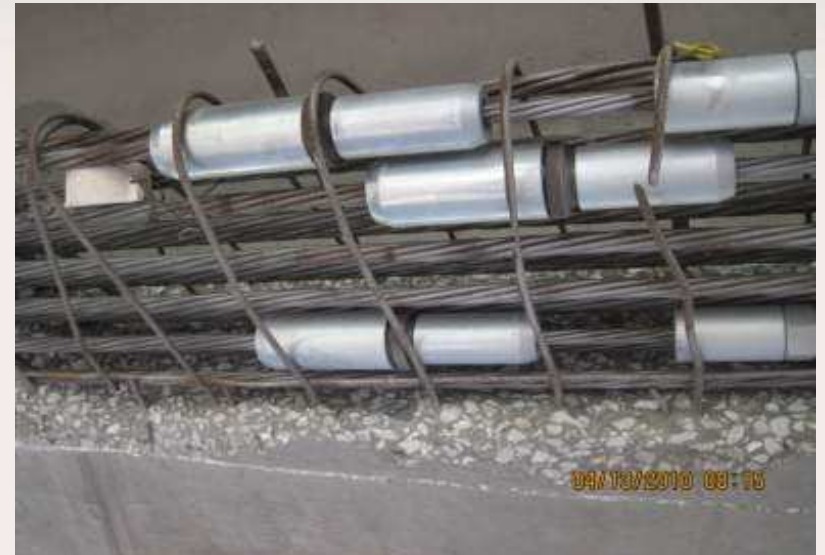
Strand Splicing

Completed forms

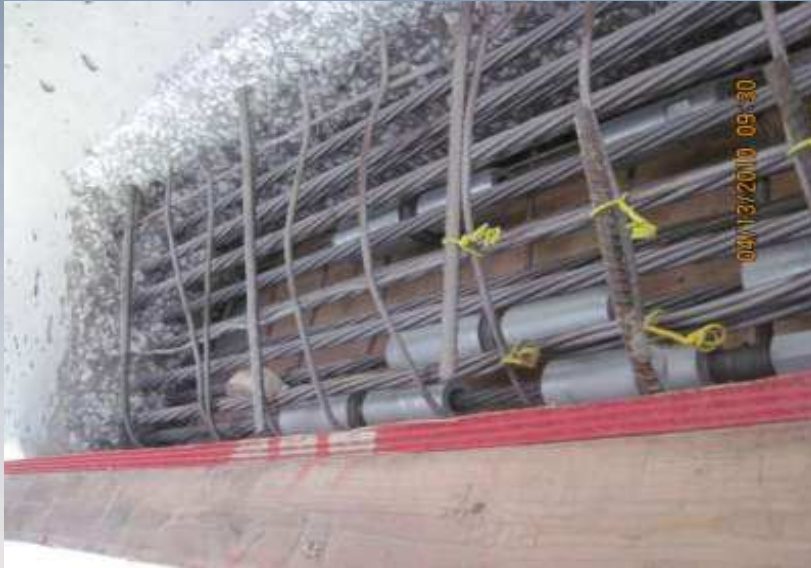
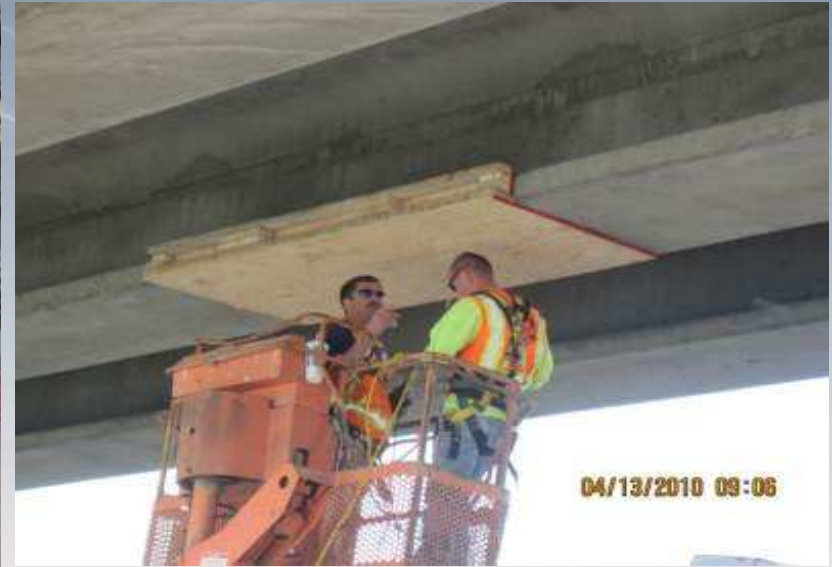
Forming and Placing Grout

Sample the grout.

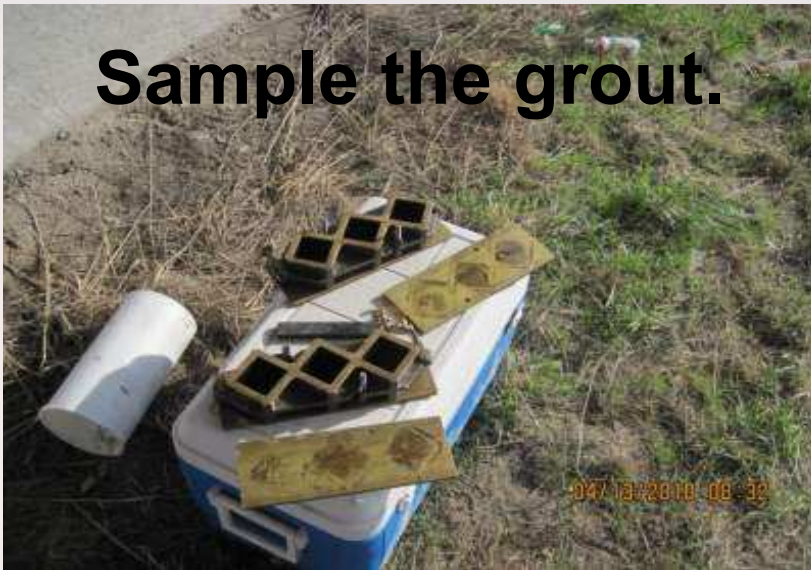
Finished grout placement
