Scour Mitigation Strategies Used in Washington State

Armor, Barbs, and Engineered Log Jams

Chris Keegan, P.E.
Region Operations Engineer.

Western Bridge Preservation Partnership
Sacramento, California
November 30, 2010

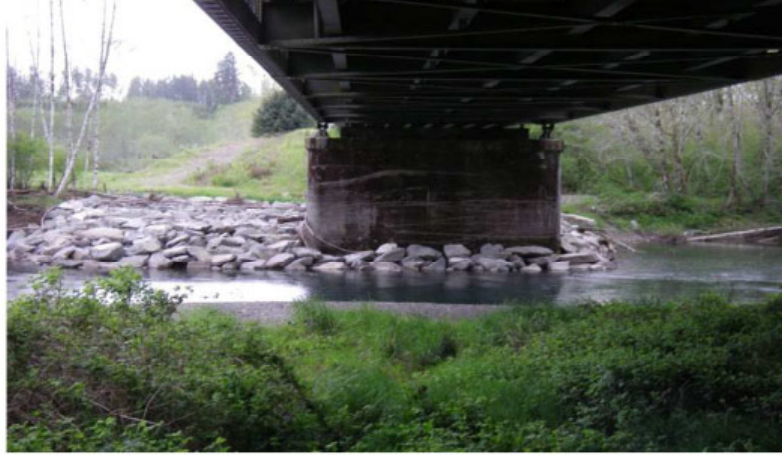
Humptulips River, US 101, Armor around Pier
4. (Spread Footing)

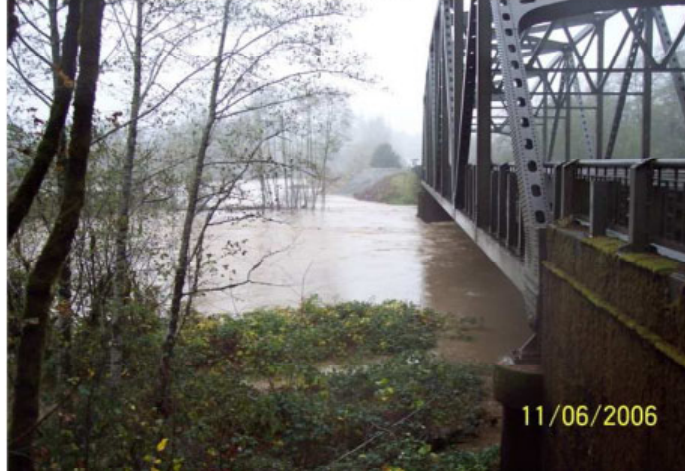
Humptulips River at Flood Stage

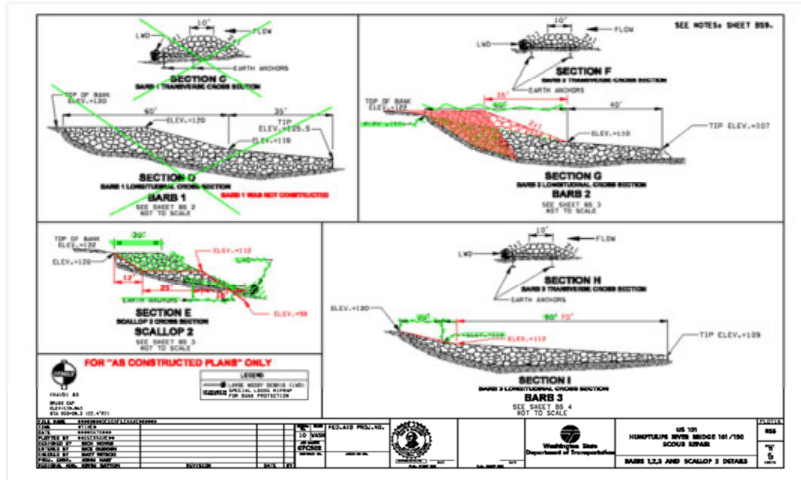
Humptulips River Barbs

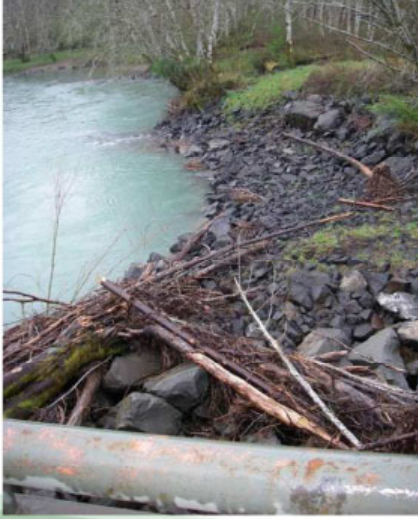
Humptulips River Upstream Barbs

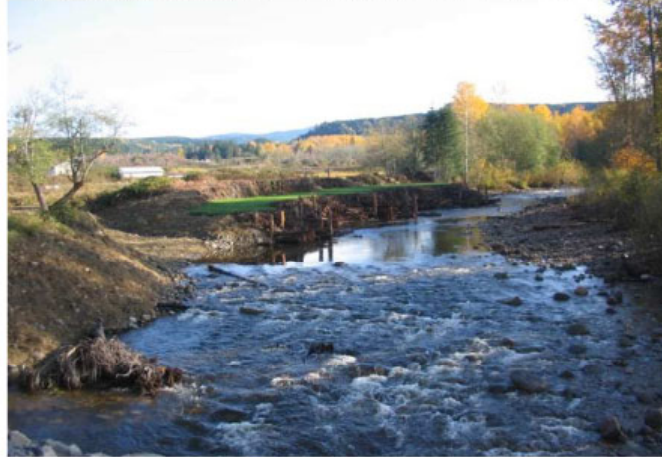
Upstream of Mashel River Br. Nisqually Tribe's ELJ's

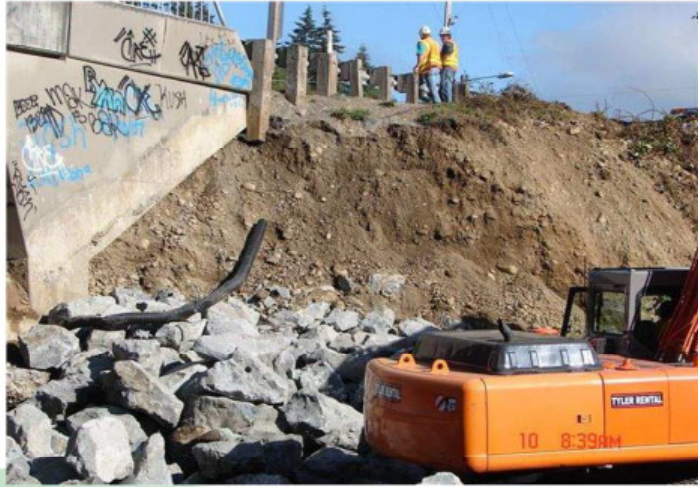
Eroded Abutment

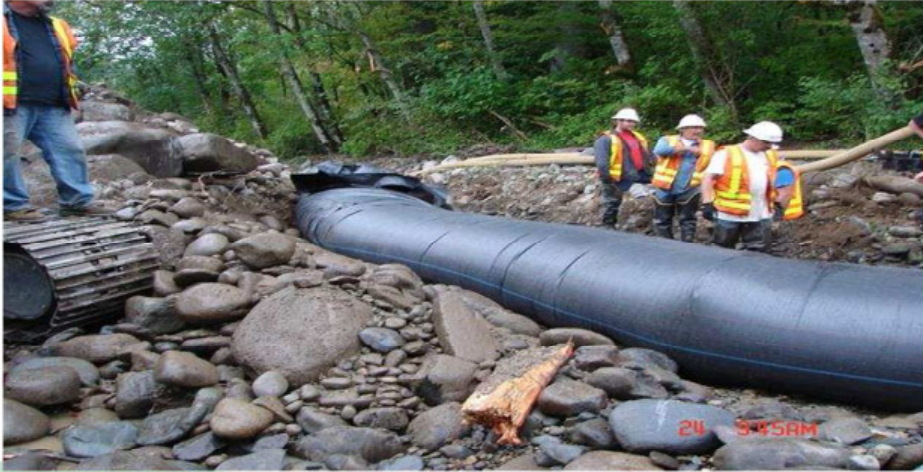
Water Filled Barrier to Isolate the Work Area

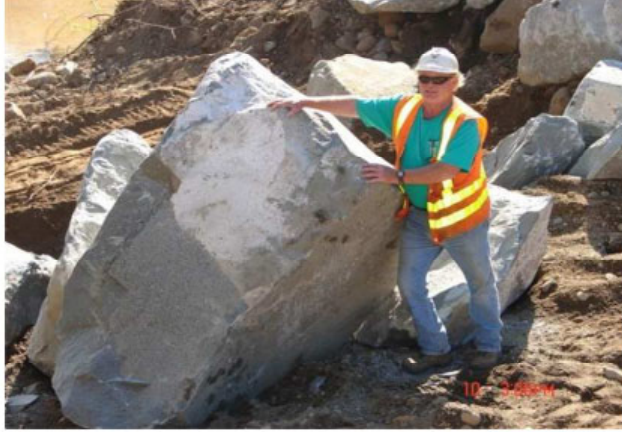
Use Large Angular Rock

- Develop a close working relationship with habitat biologists for Fish & Wildlife & tribes
- Use large rock
- Key in the rock
- Keep the access roads
- Armor, Barbs, and ELJ's require maintenance
- Keep your As-Built plans on file.

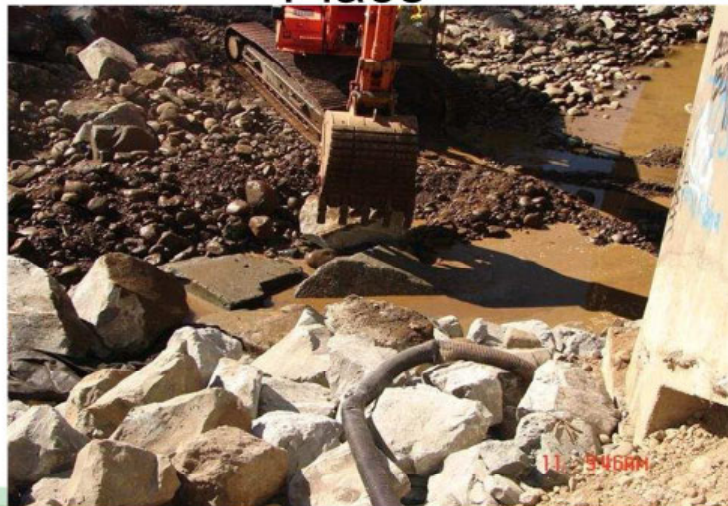
Dig down and Key the Rock in Place

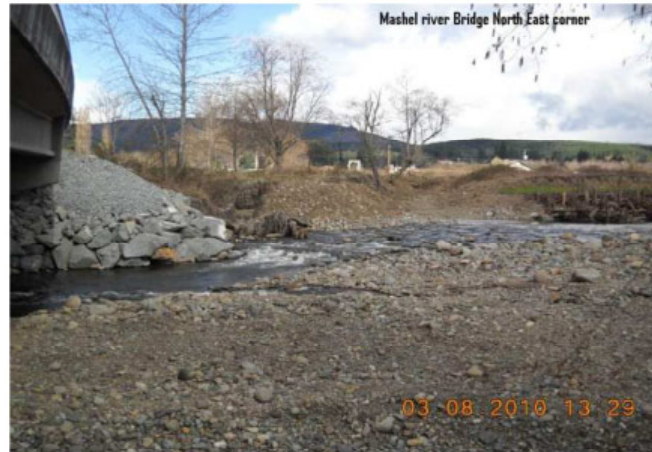
Mashel River N. E. Corner, (note ELJ) on right

Large woody Debris placed upstream at toe of slope. Nisqually Tribes Engineered Log Jam on far right of photograph.

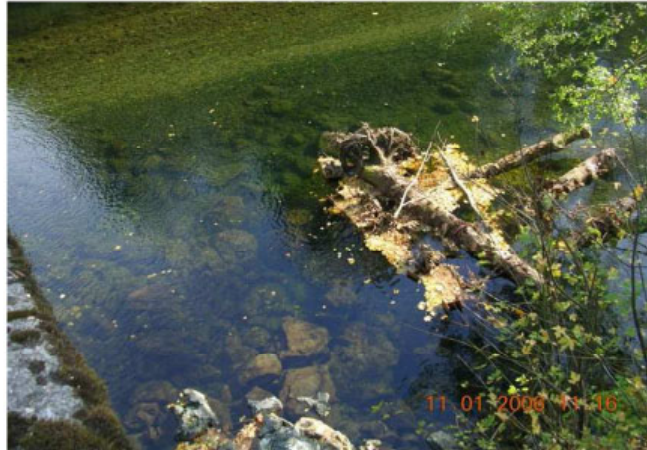
Sol Duc River Large Woody Debris

Kayaker killed when caught under logs.

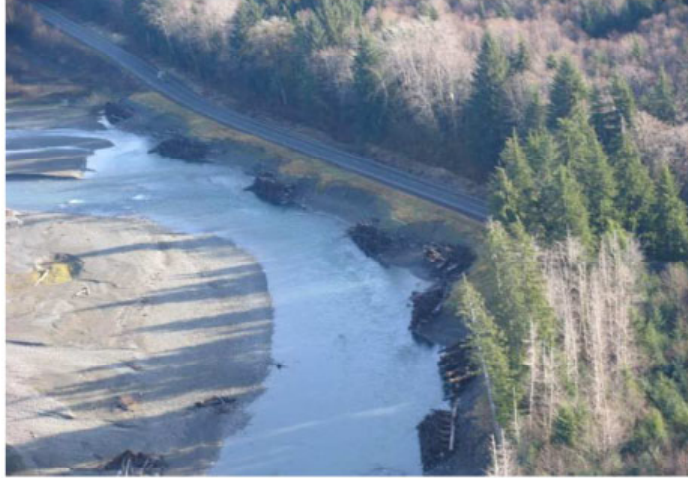
ELJ's used to Roughen the Bank

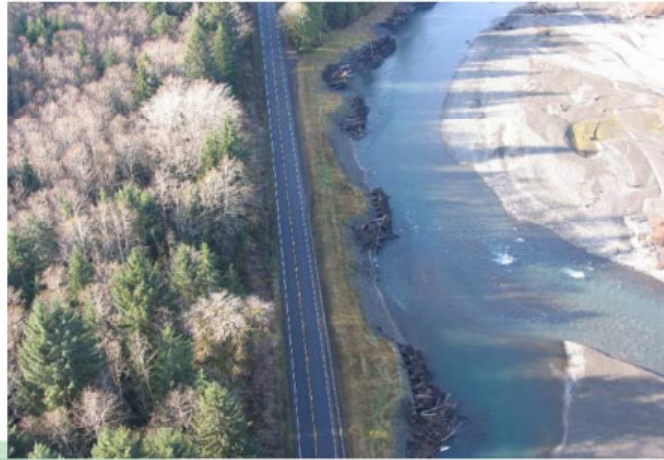
ELJ's Bank Roughening Moves River Force Away from Bank

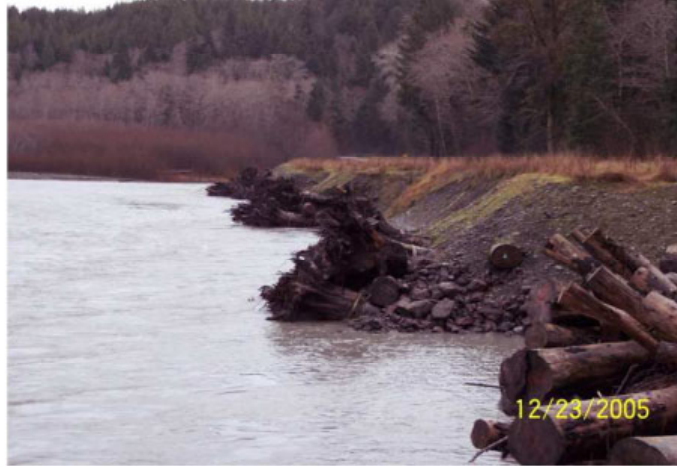
Close Up of ELJ's Along Bank

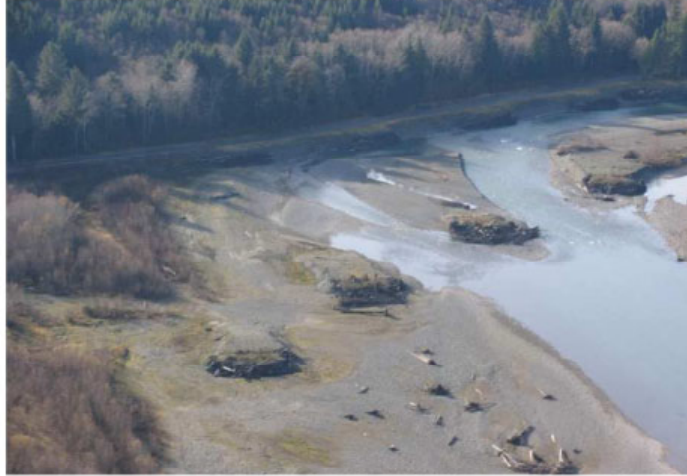
ELJ Islands Used to Split the Force of the River
