High Molecular Weight Methacrylate Crack Penetration Study

Michael J. Lee

Structure Maintenance and Investigations

Study Overview

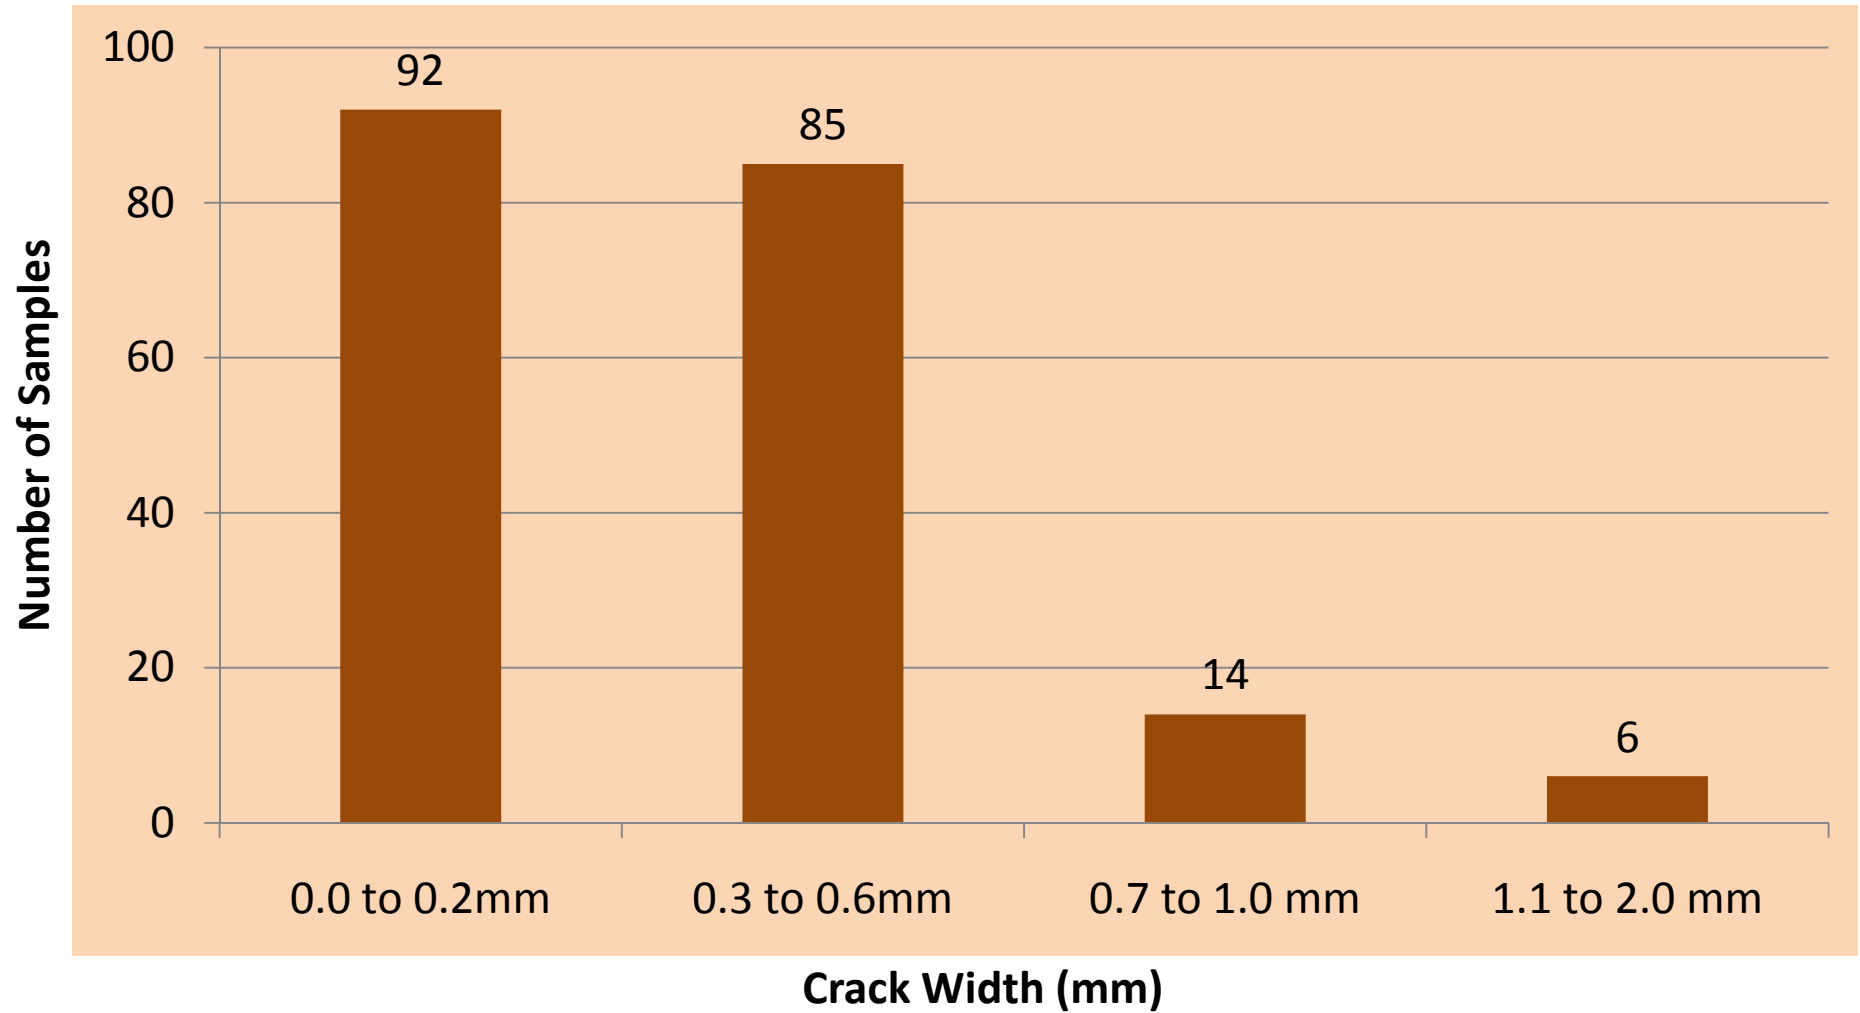
Crack Width Distribution

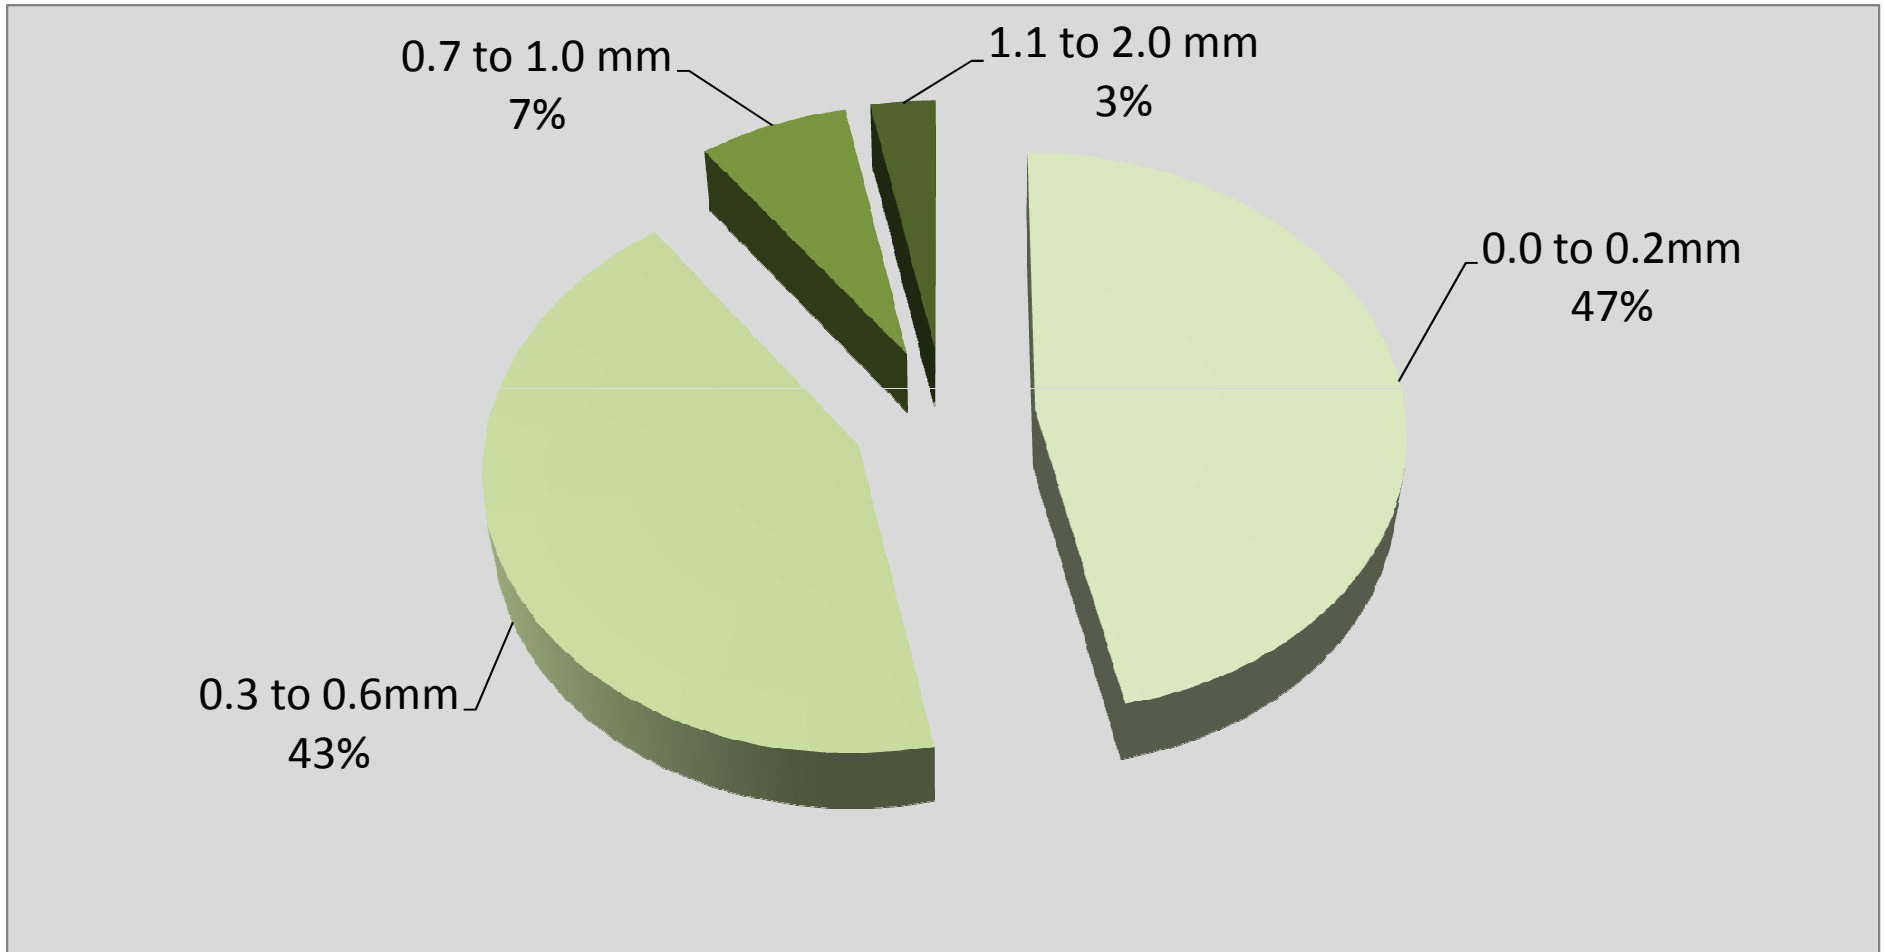
Crack Width Distribution

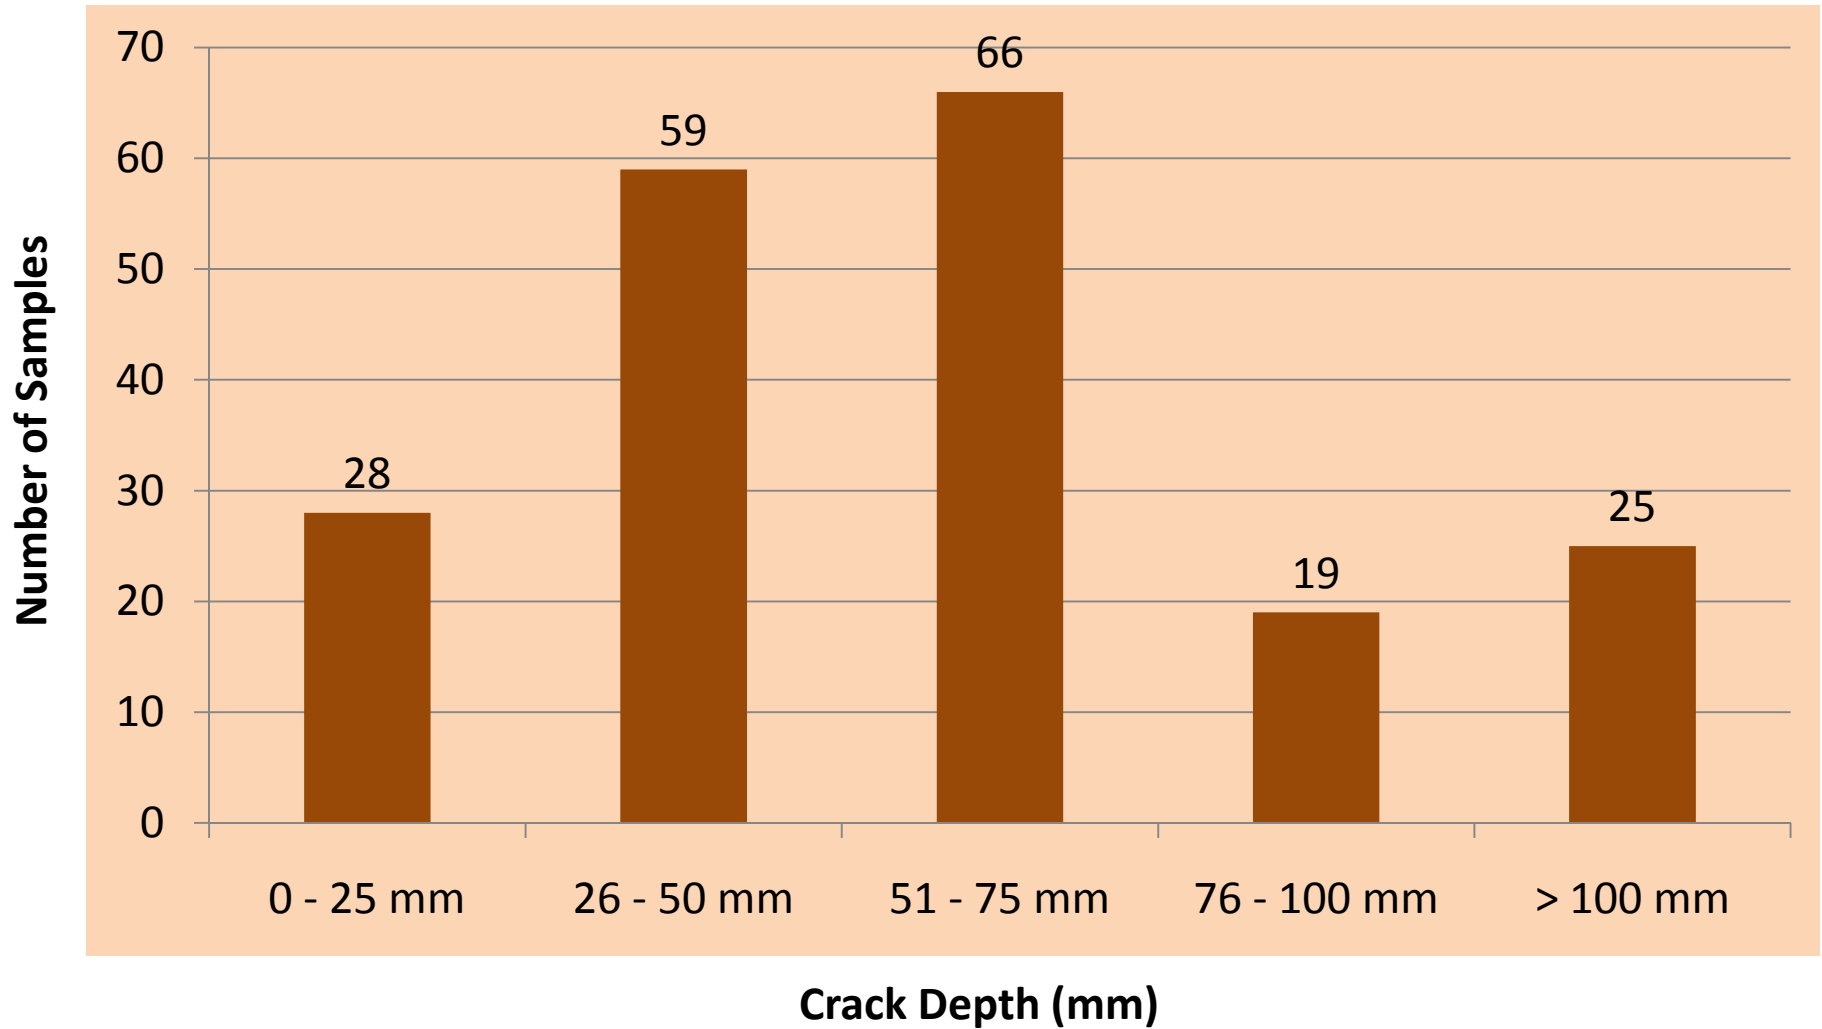
Crack Depth Distribution

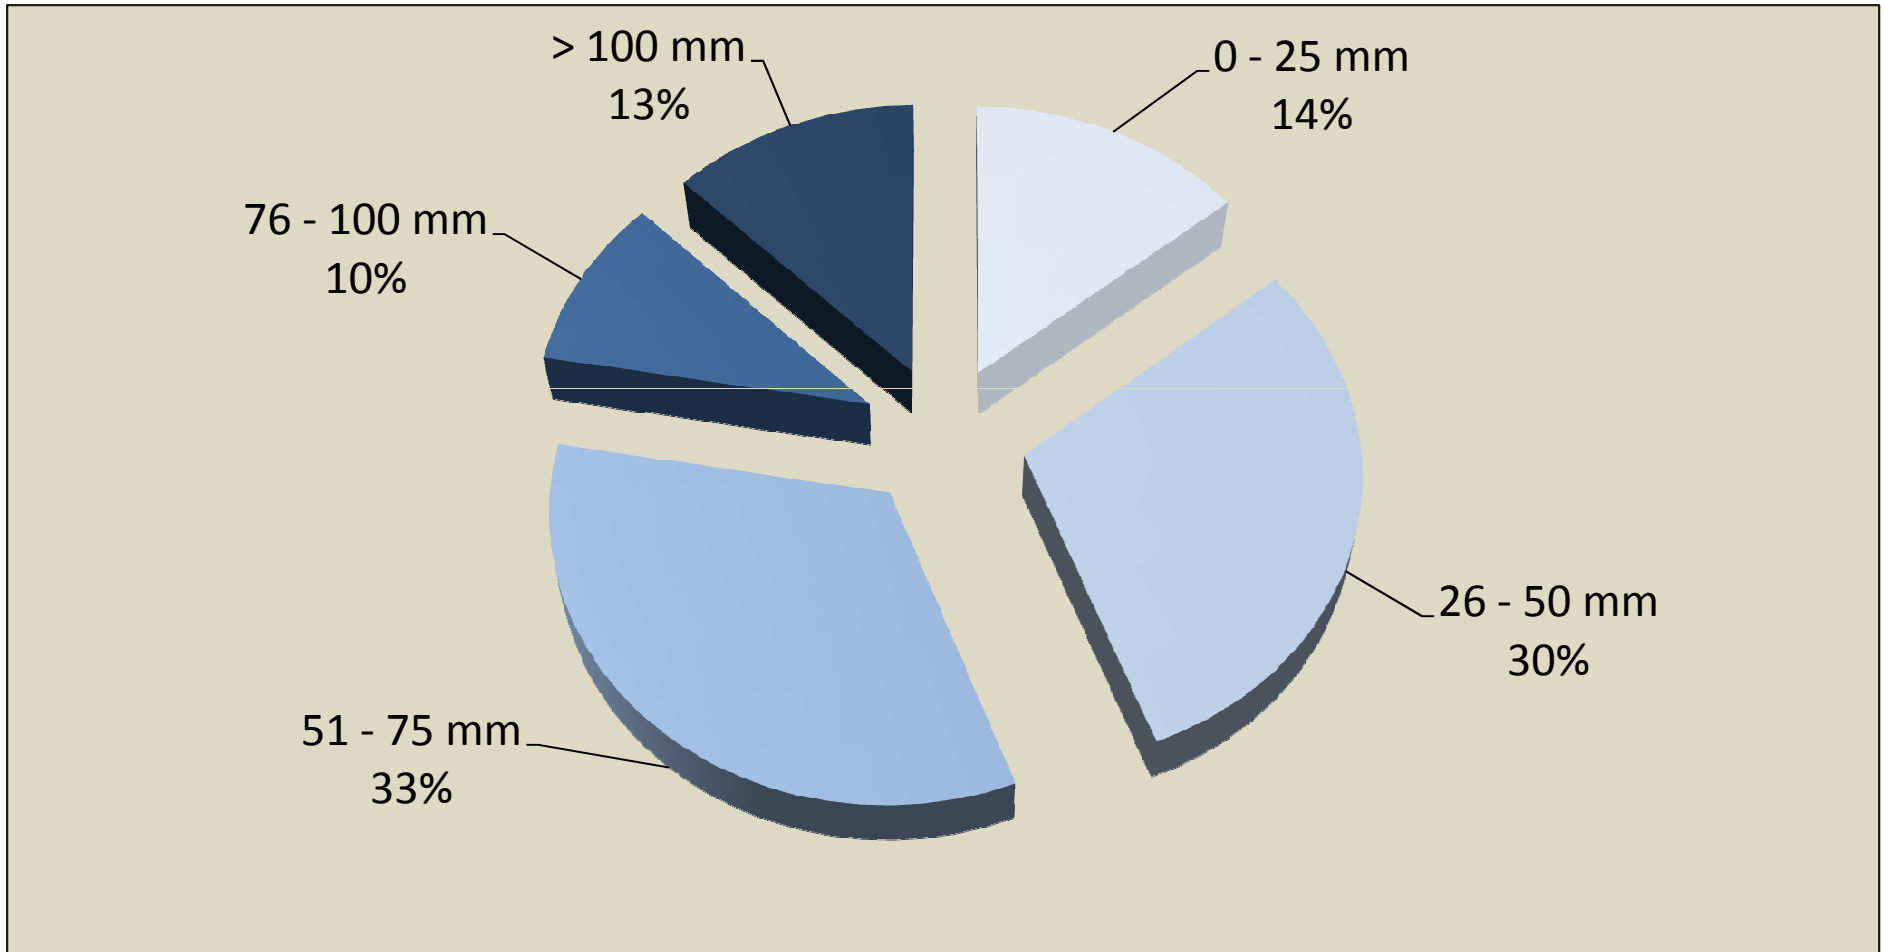
Crack Depth Distribution

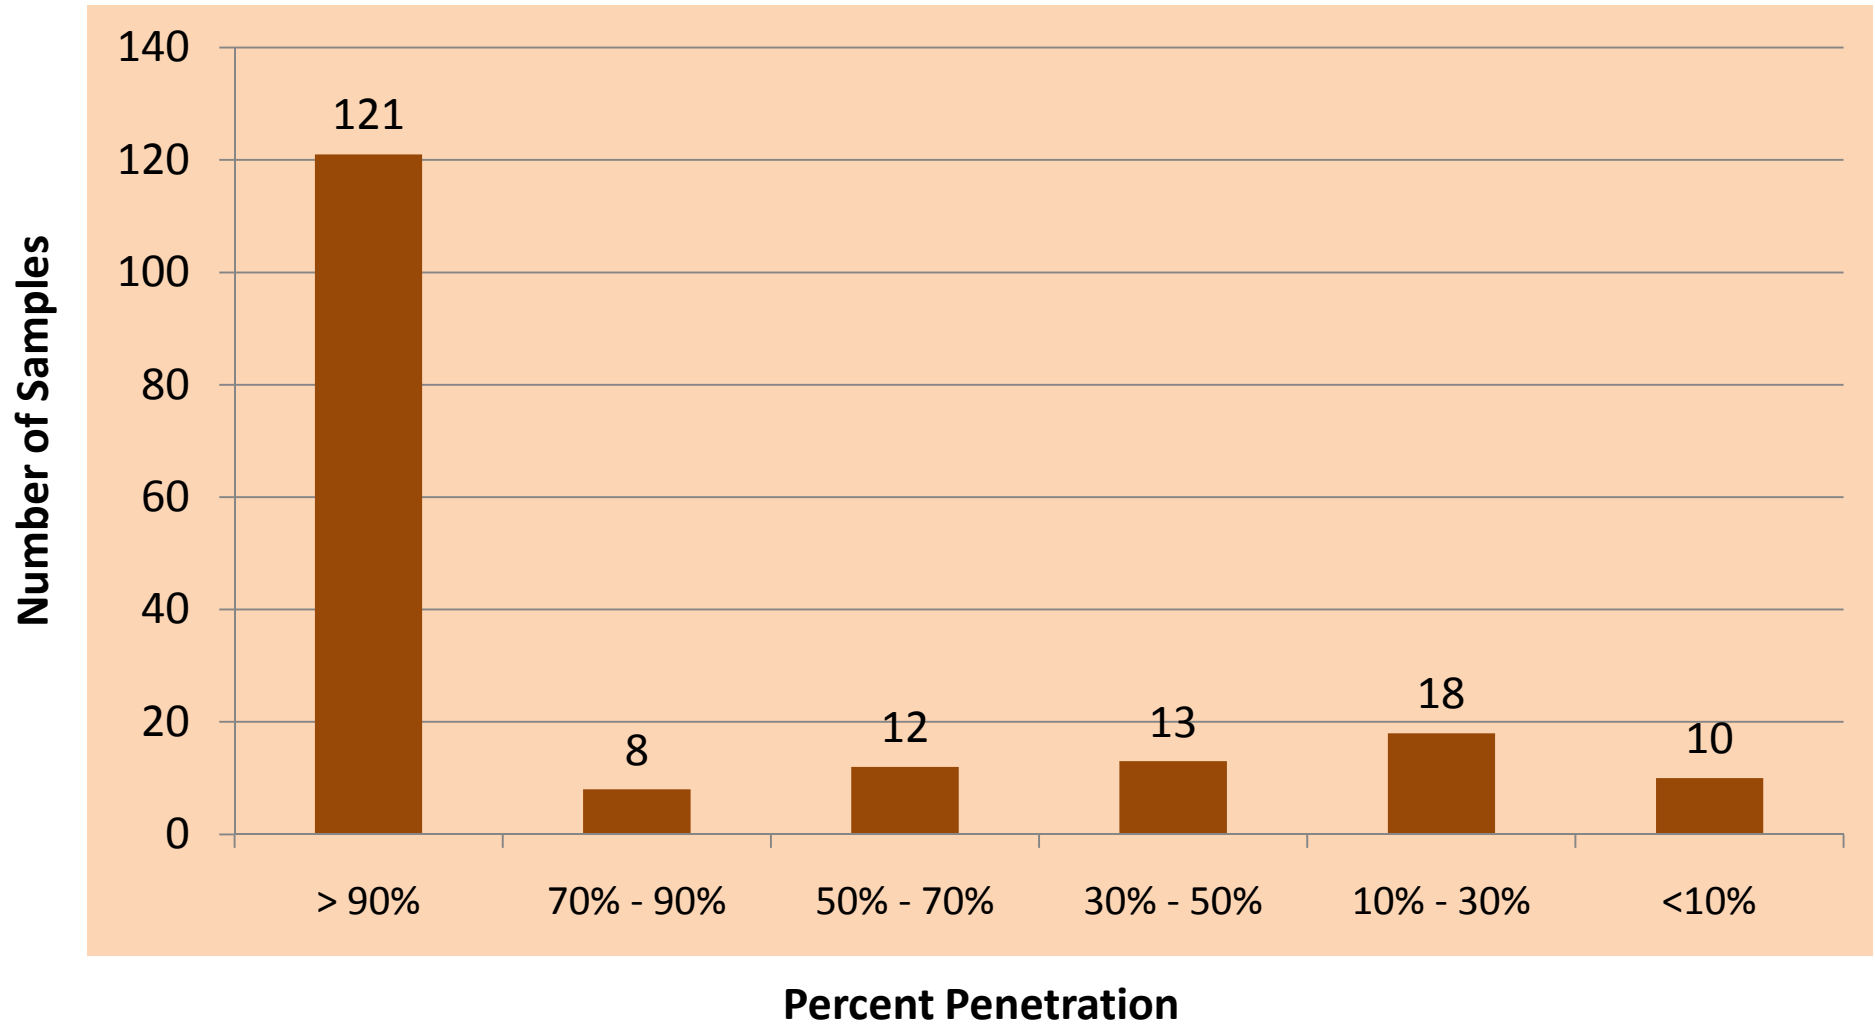
Percent Penetration Distribution (without considering depth of crack)

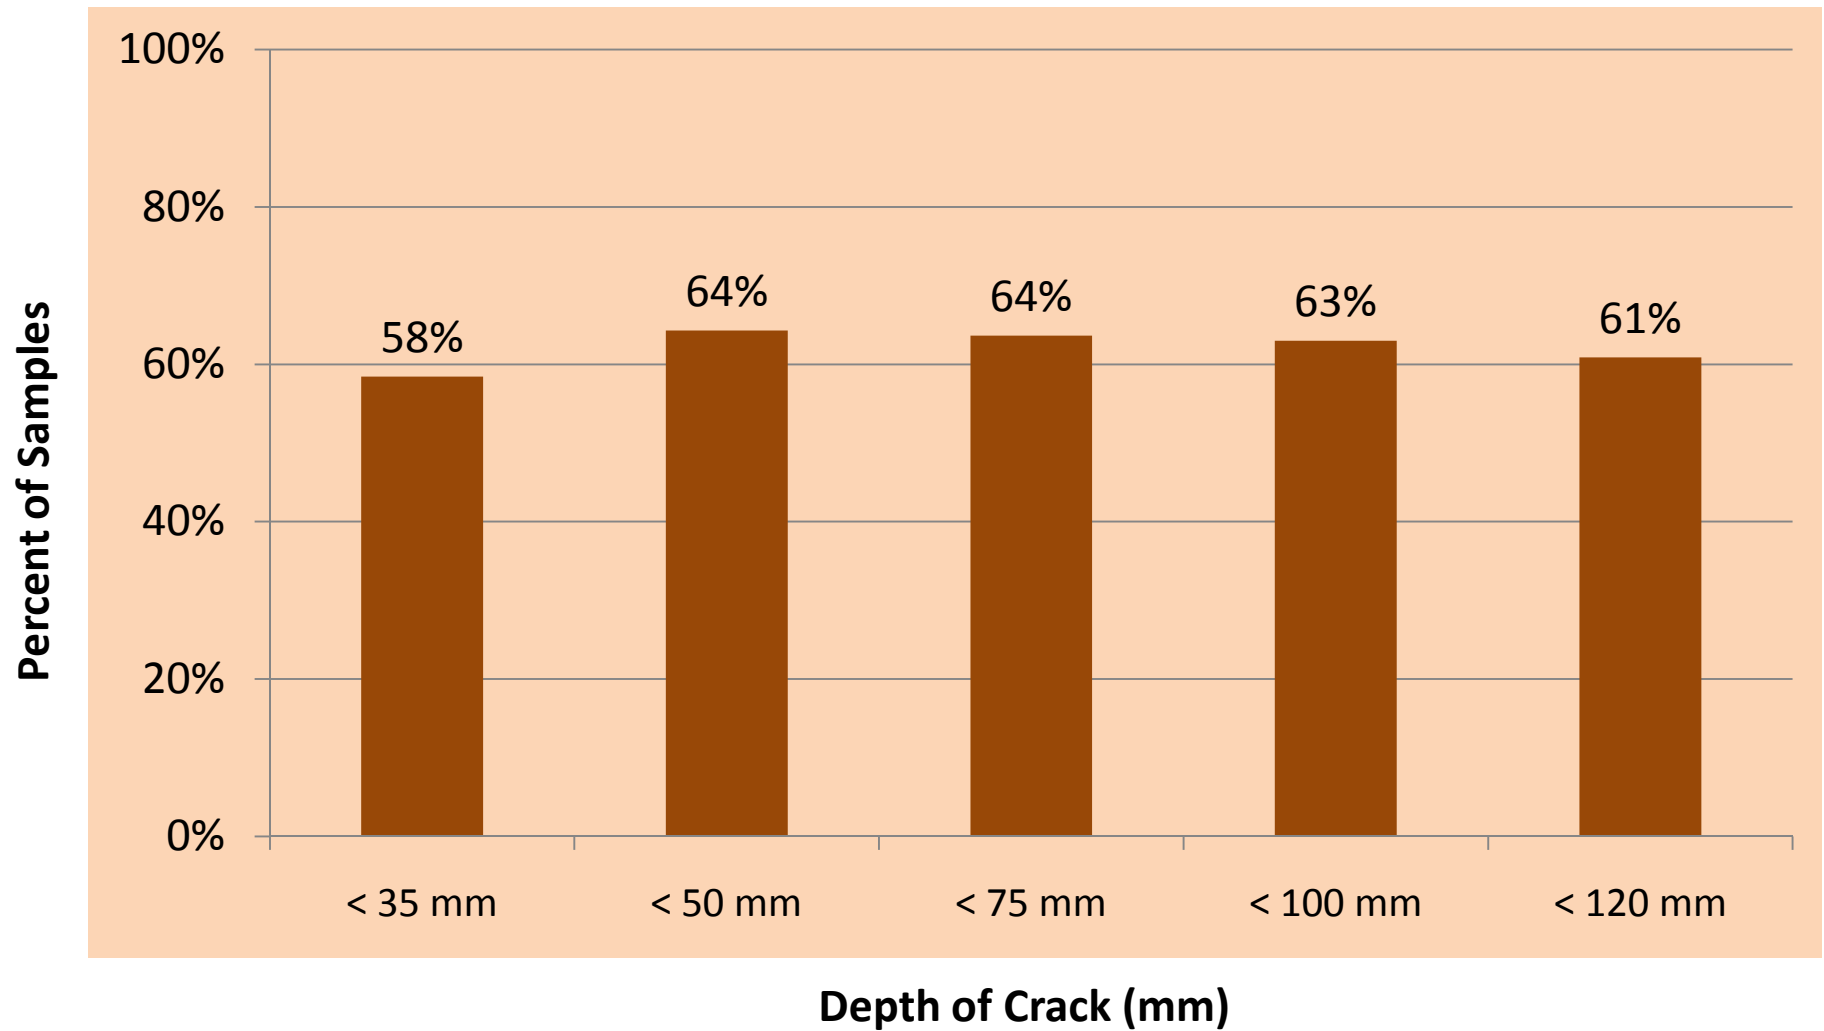
Full Depth Penetration (considering depth of crack)
