# Pavement Preservation For Longitudinal Paving Joints

## With A Maltene Based Polymerized Emulsion

John Calvert

May 2008 Meeting

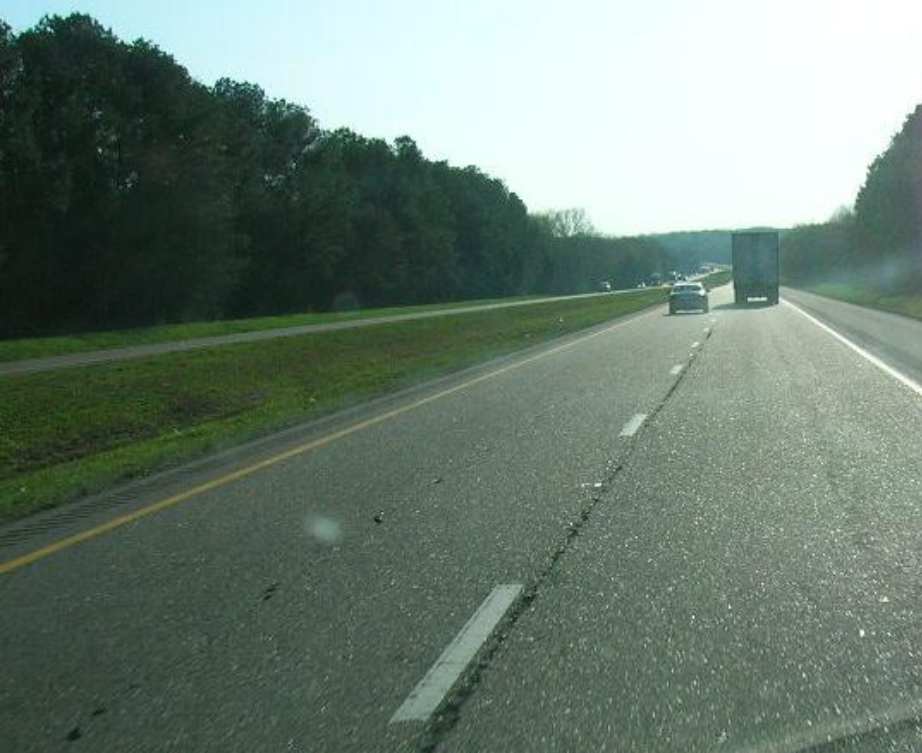
**The weakest part of a new asphalt pavement is the longitudinal construction joint between paving machine passes.**

**This is the area where most pavements first begin to fail.**

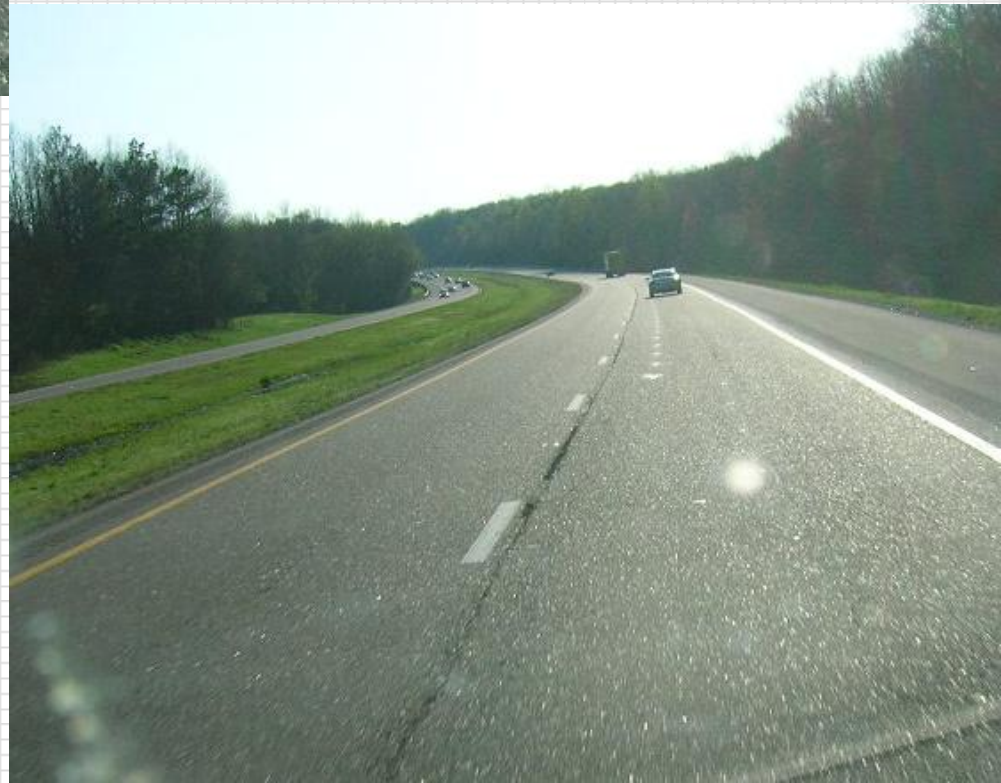
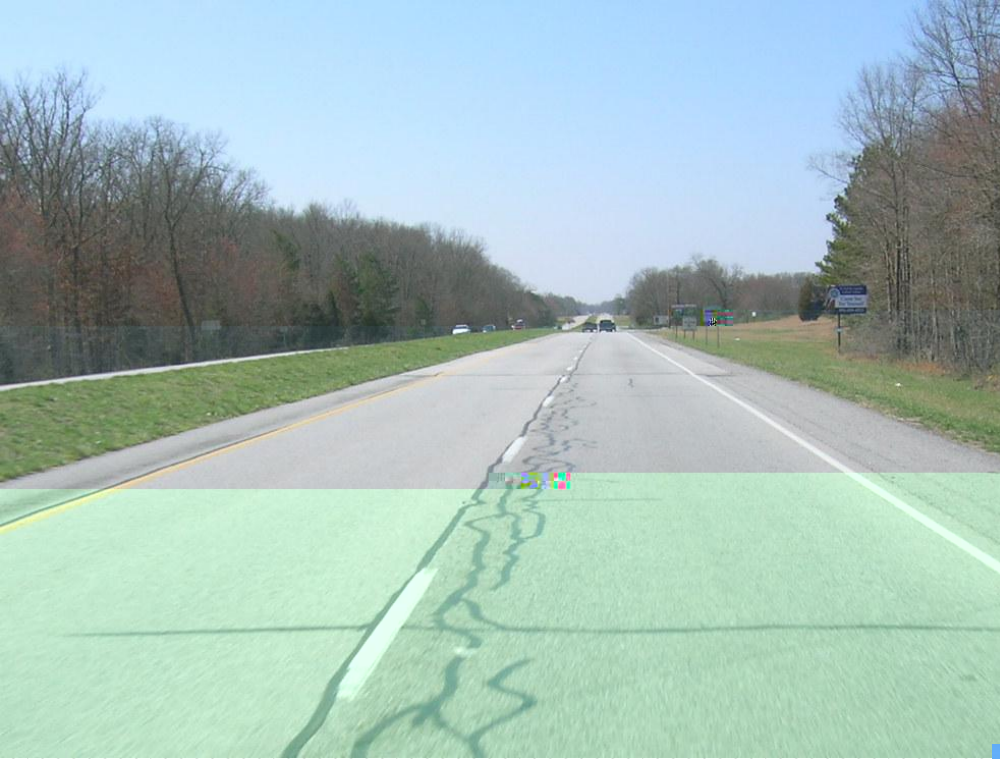
**LJ cracking typically starts showing up 3-5 years after the wearing course has been put down.**

**The joint begins separation with hairline cracking then the width grows a little wider each year.**

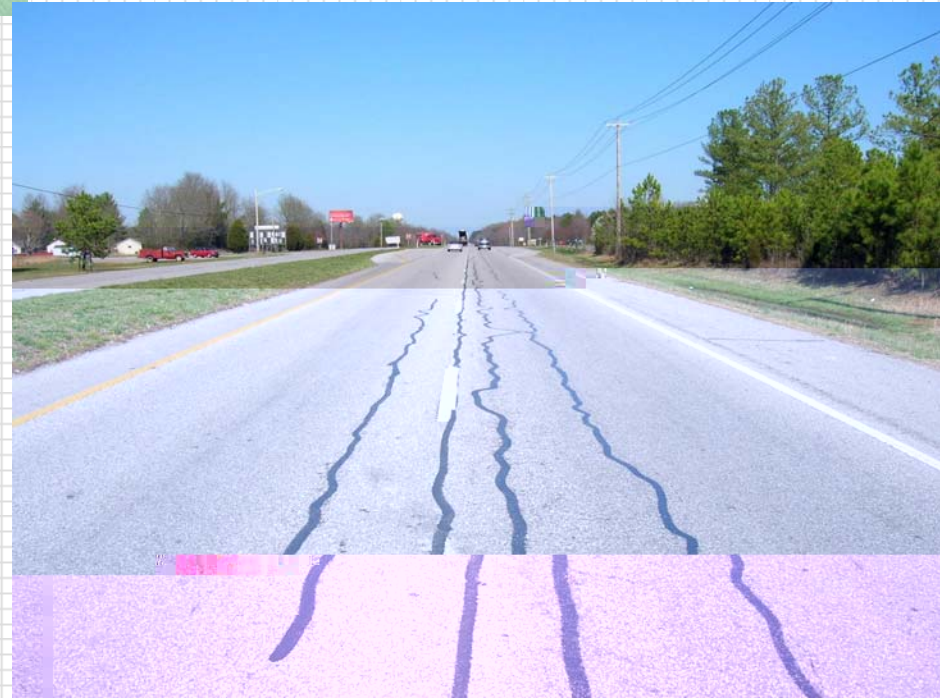
**Once the cracking occurs one of the most common practices is to seal or fill the joint to prevent water & moisture from entering it.**

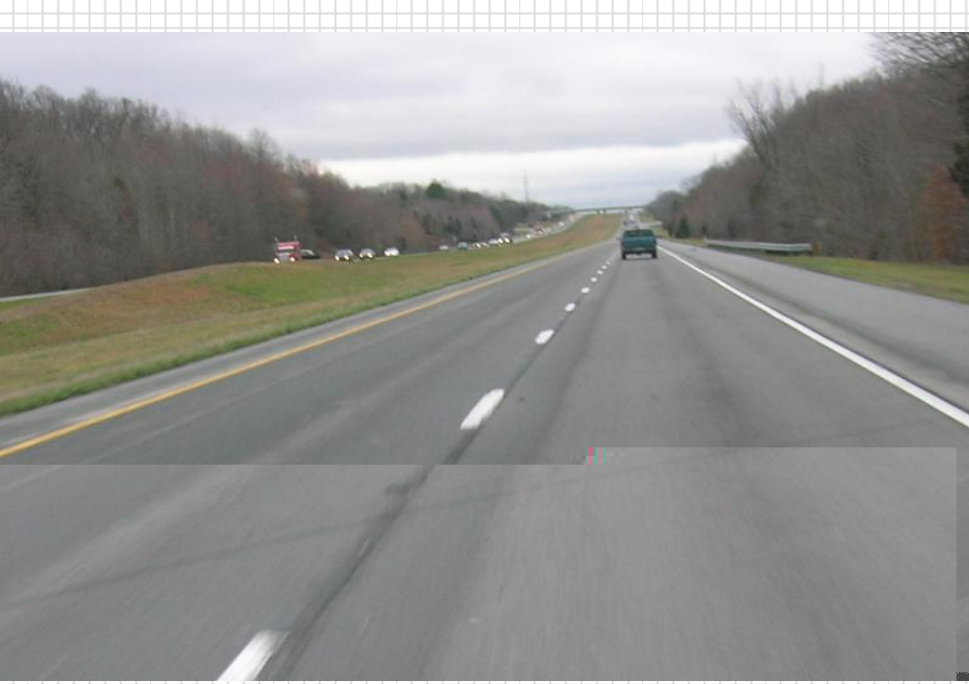
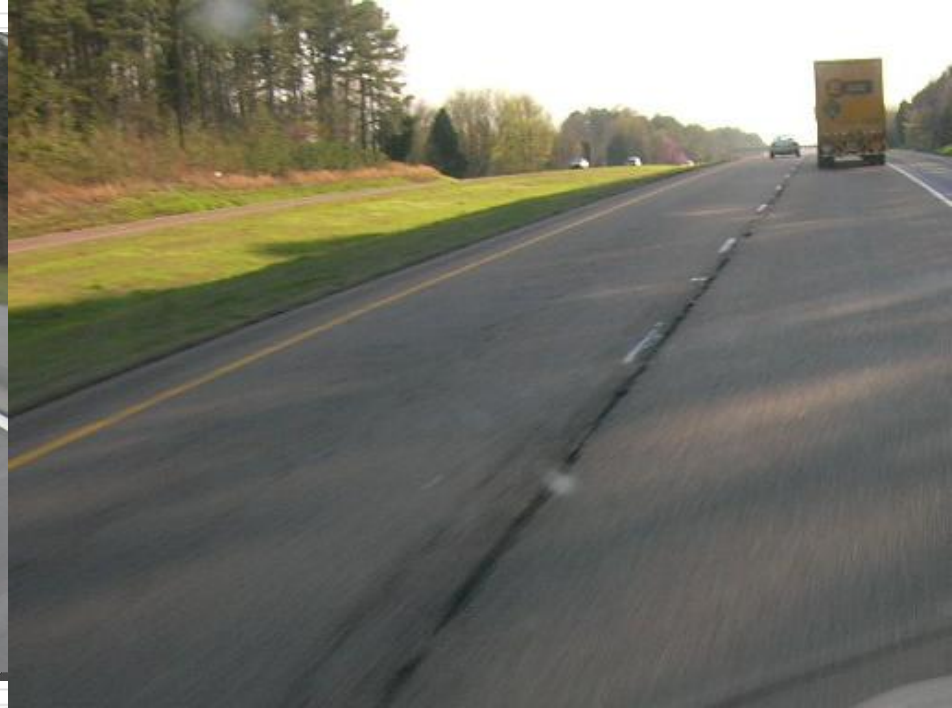
**If not prevented or sealed problems can occur.**

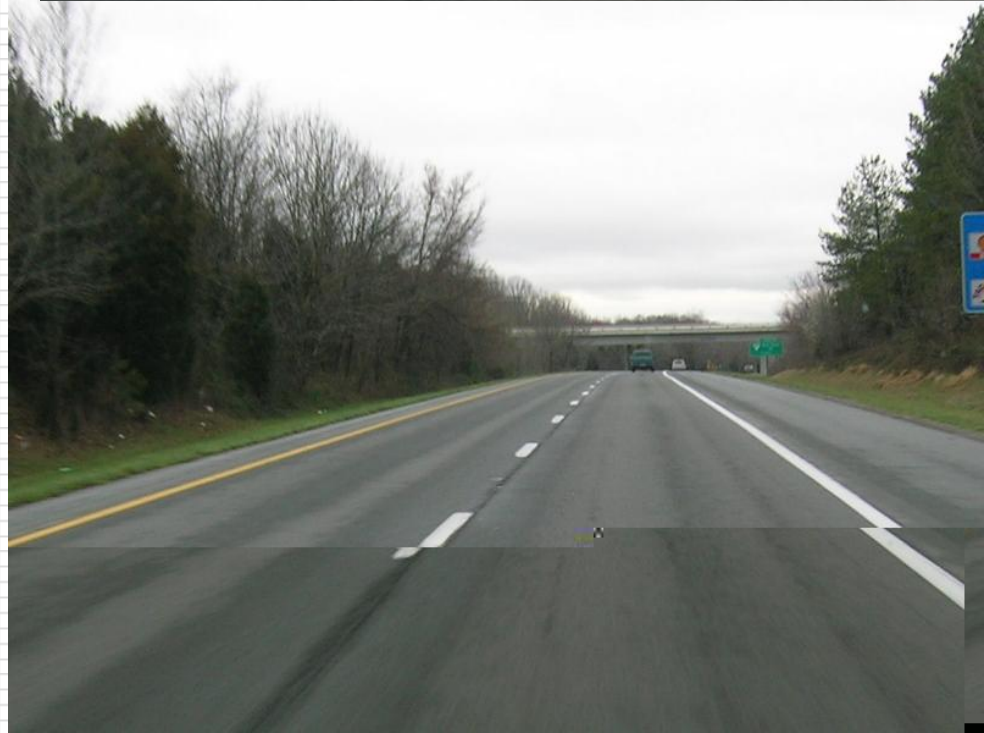
**Add a little rain and moisture, then some freezing weather and the next thing you know.....**

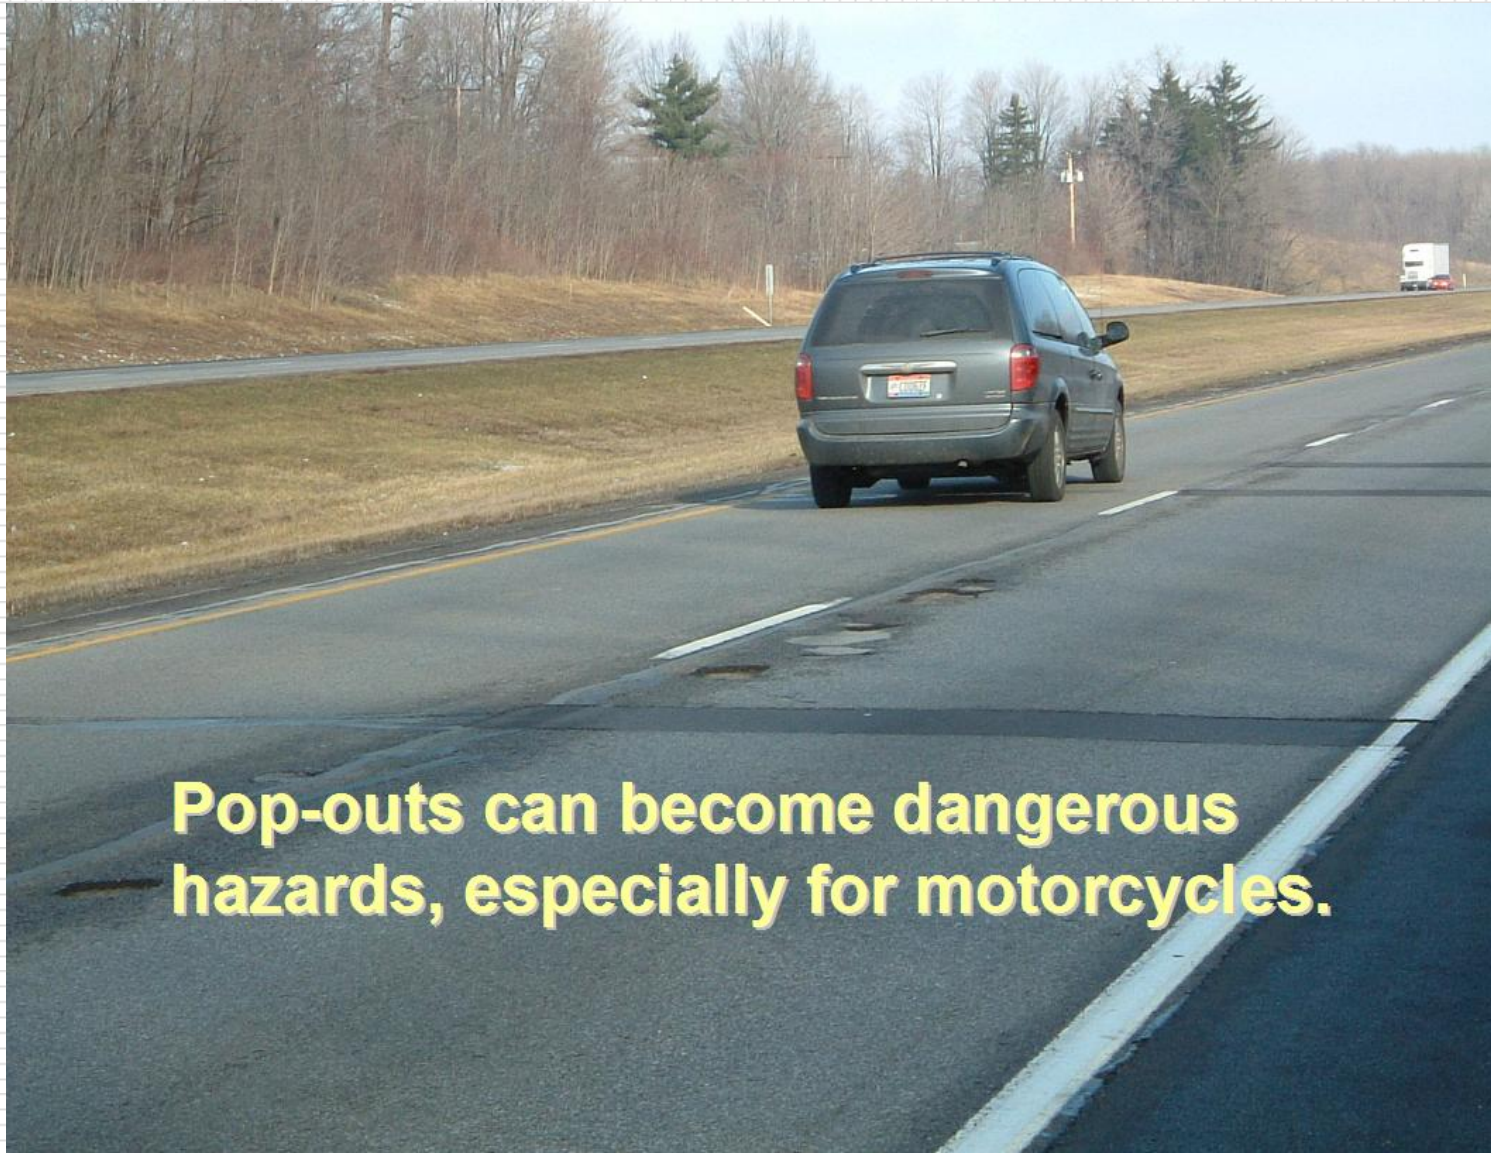
**.....Pop-outs along the longitudinal joint  
begin to show up.**

**Pop-outs can become dangerous  
hazards, especially for motorcycles.**

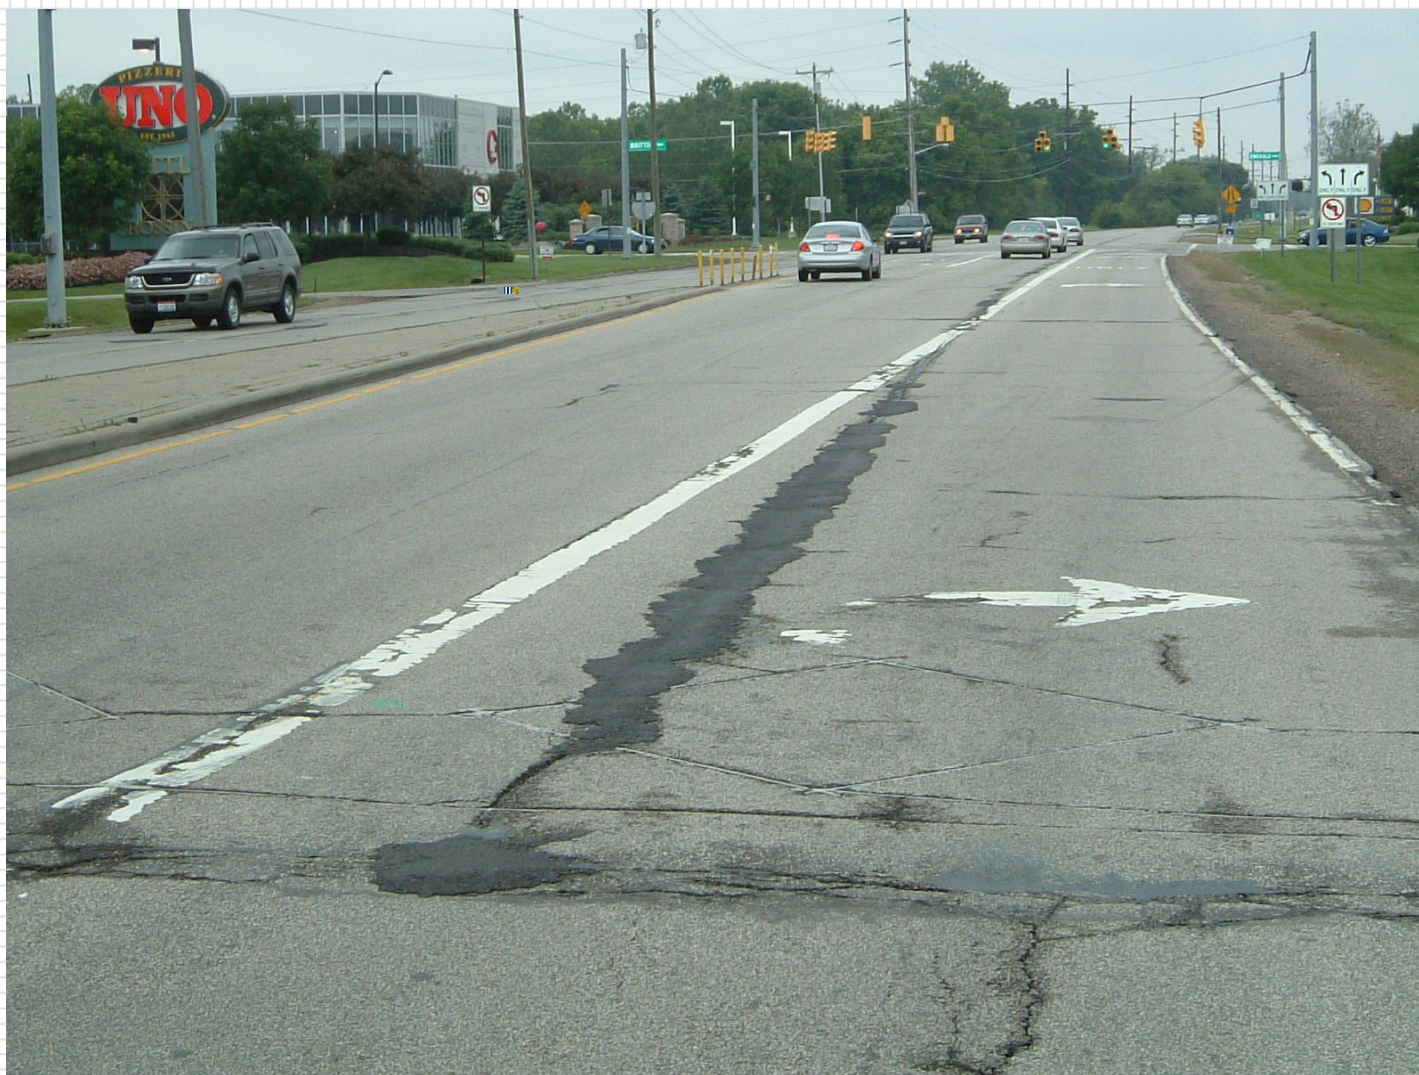
**Some agencies wait too long and the cracks become so wide they need HMA as a filler in addition to normal crack fill material.**

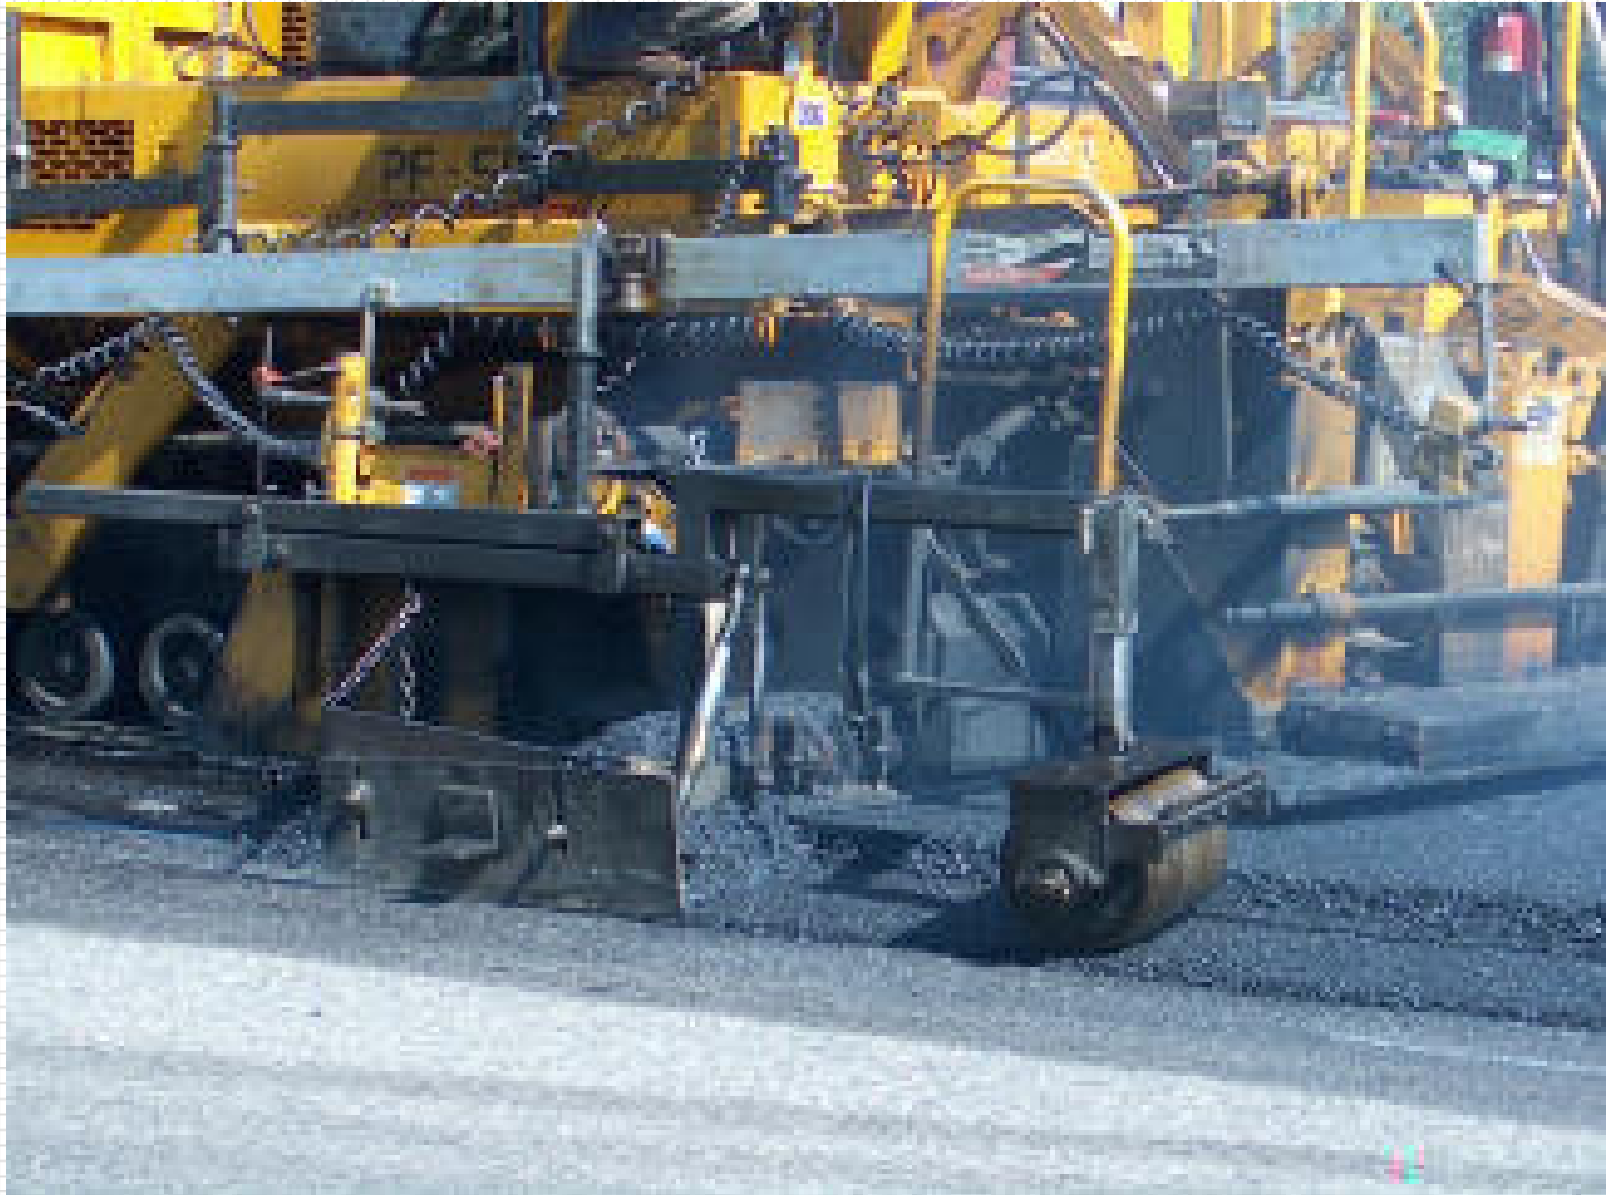
**Various physical means for preventing LJ deterioration have been experimented with including the use of a notched wedge shaped attachment placed on the edge of the paving machine screed.**

**The intent of this method is to provide a wedge shaped overlap along the joint as a means of reducing possible early deterioration by improving density.**

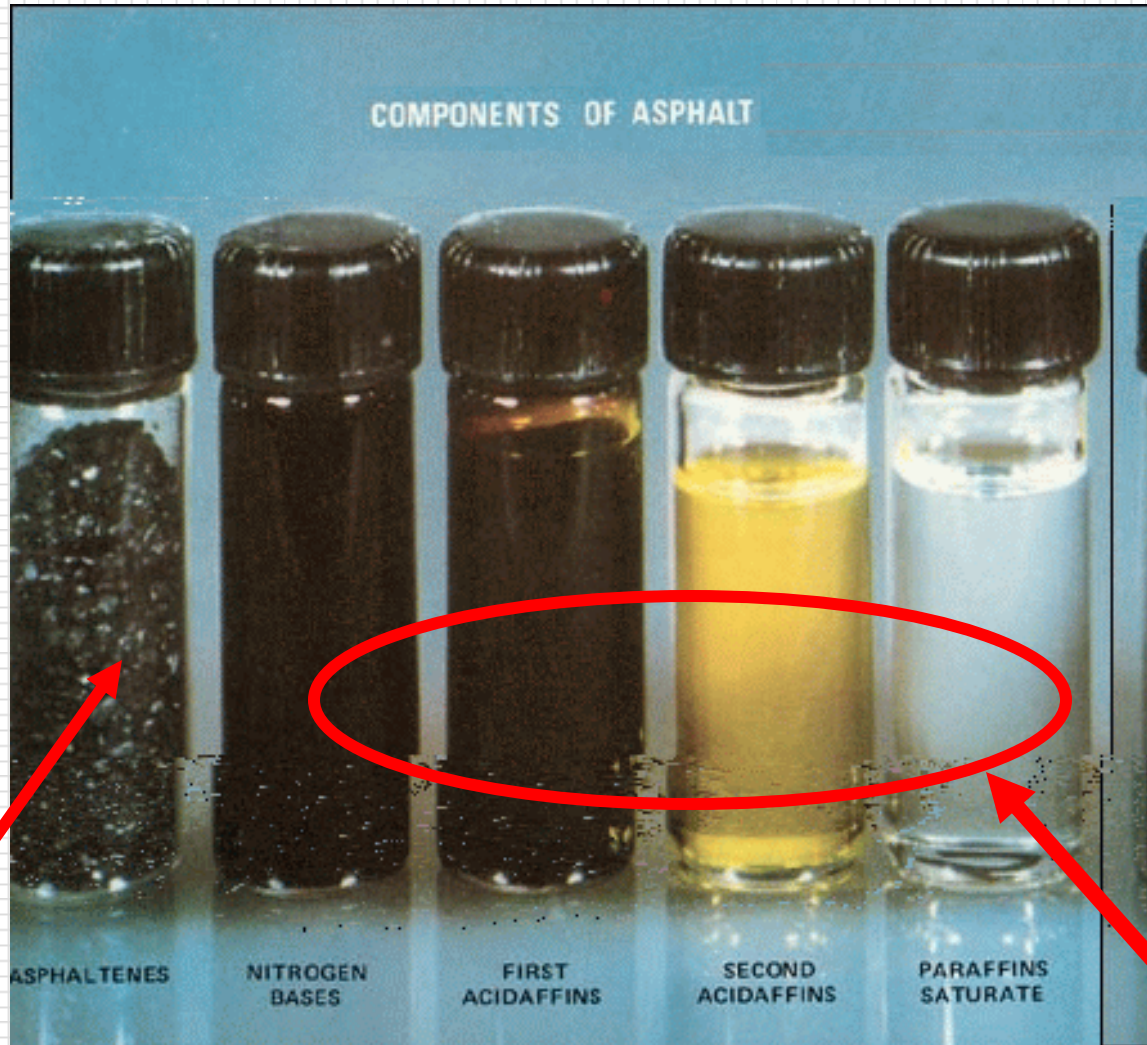
Asphaltene fraction

Maltene fractions

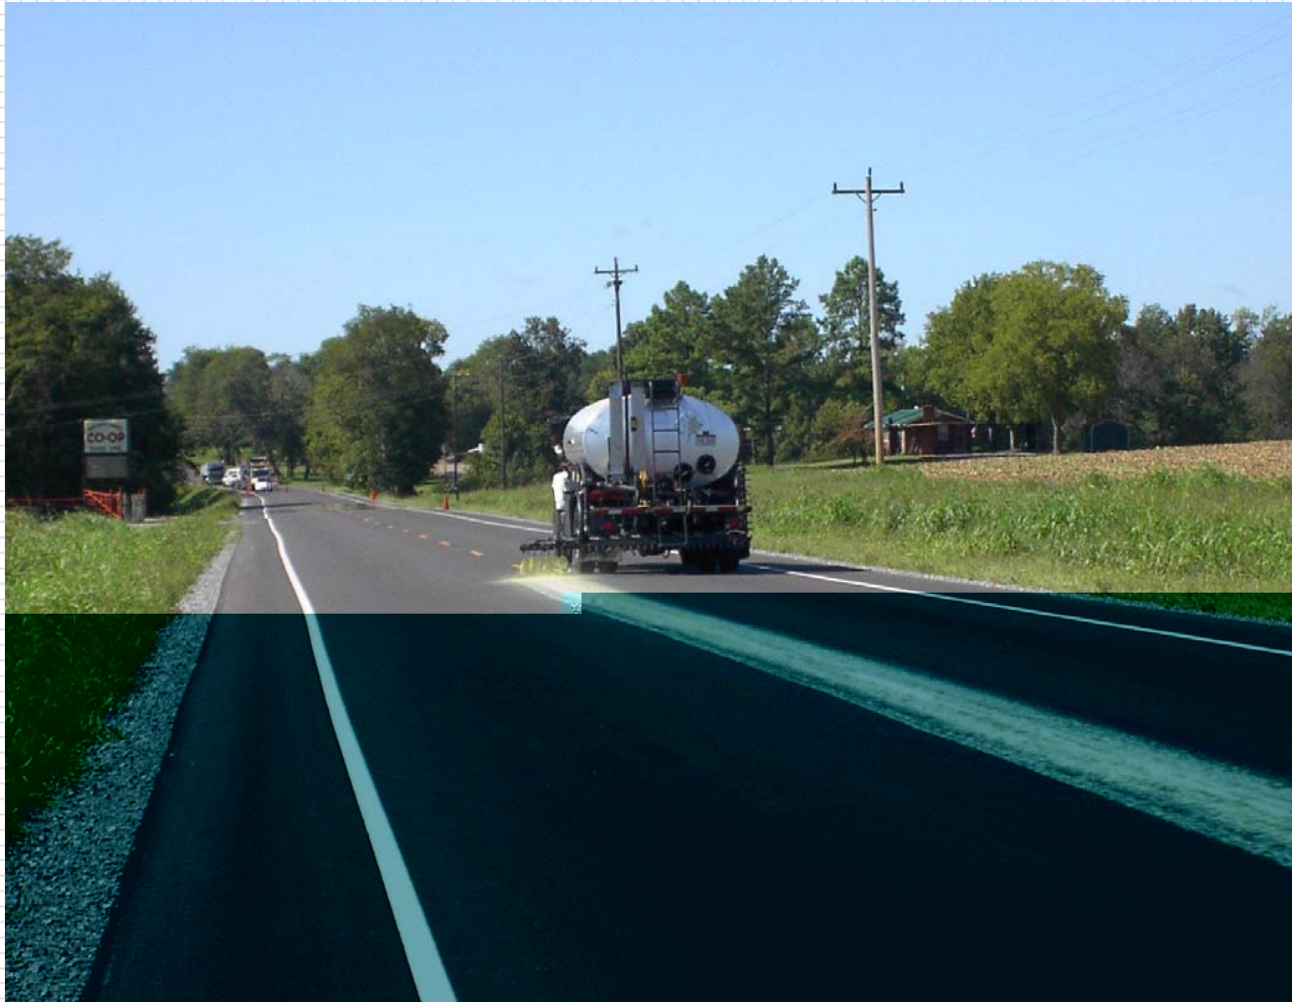
In 2003, tests were applied for the Tennessee DOT on state routes near Nashville.

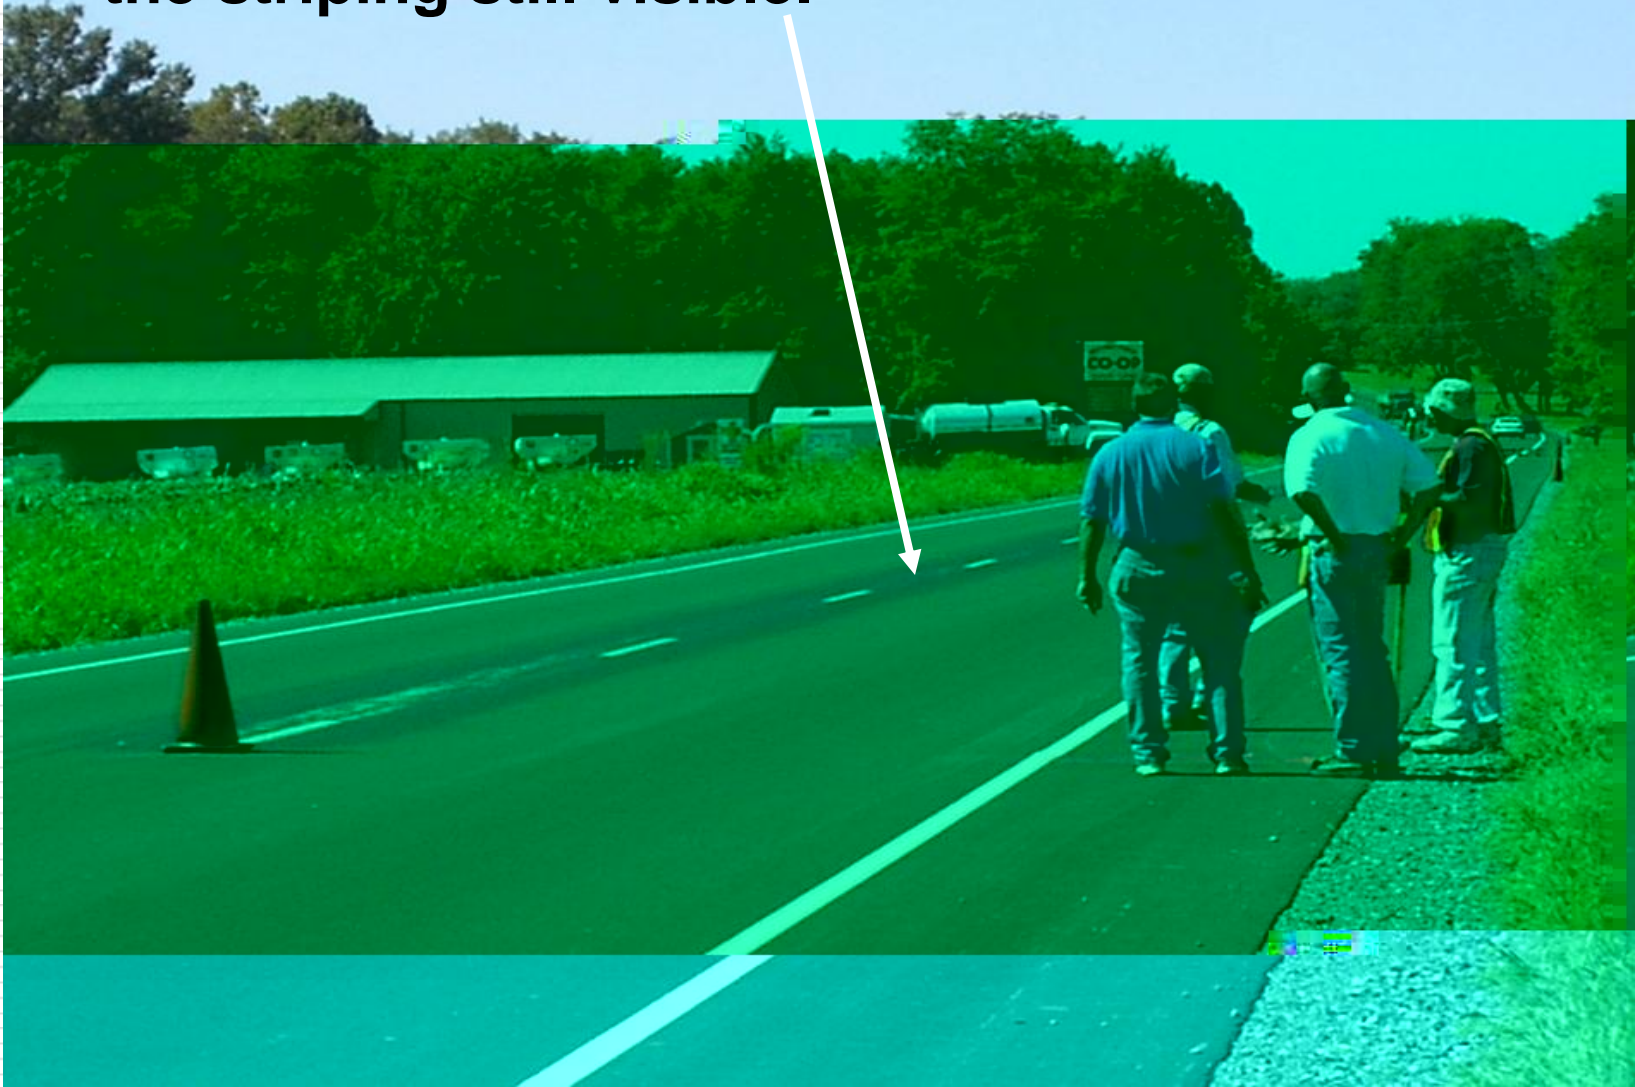
It quickly penetrated into the pavement and left the striping still visible.

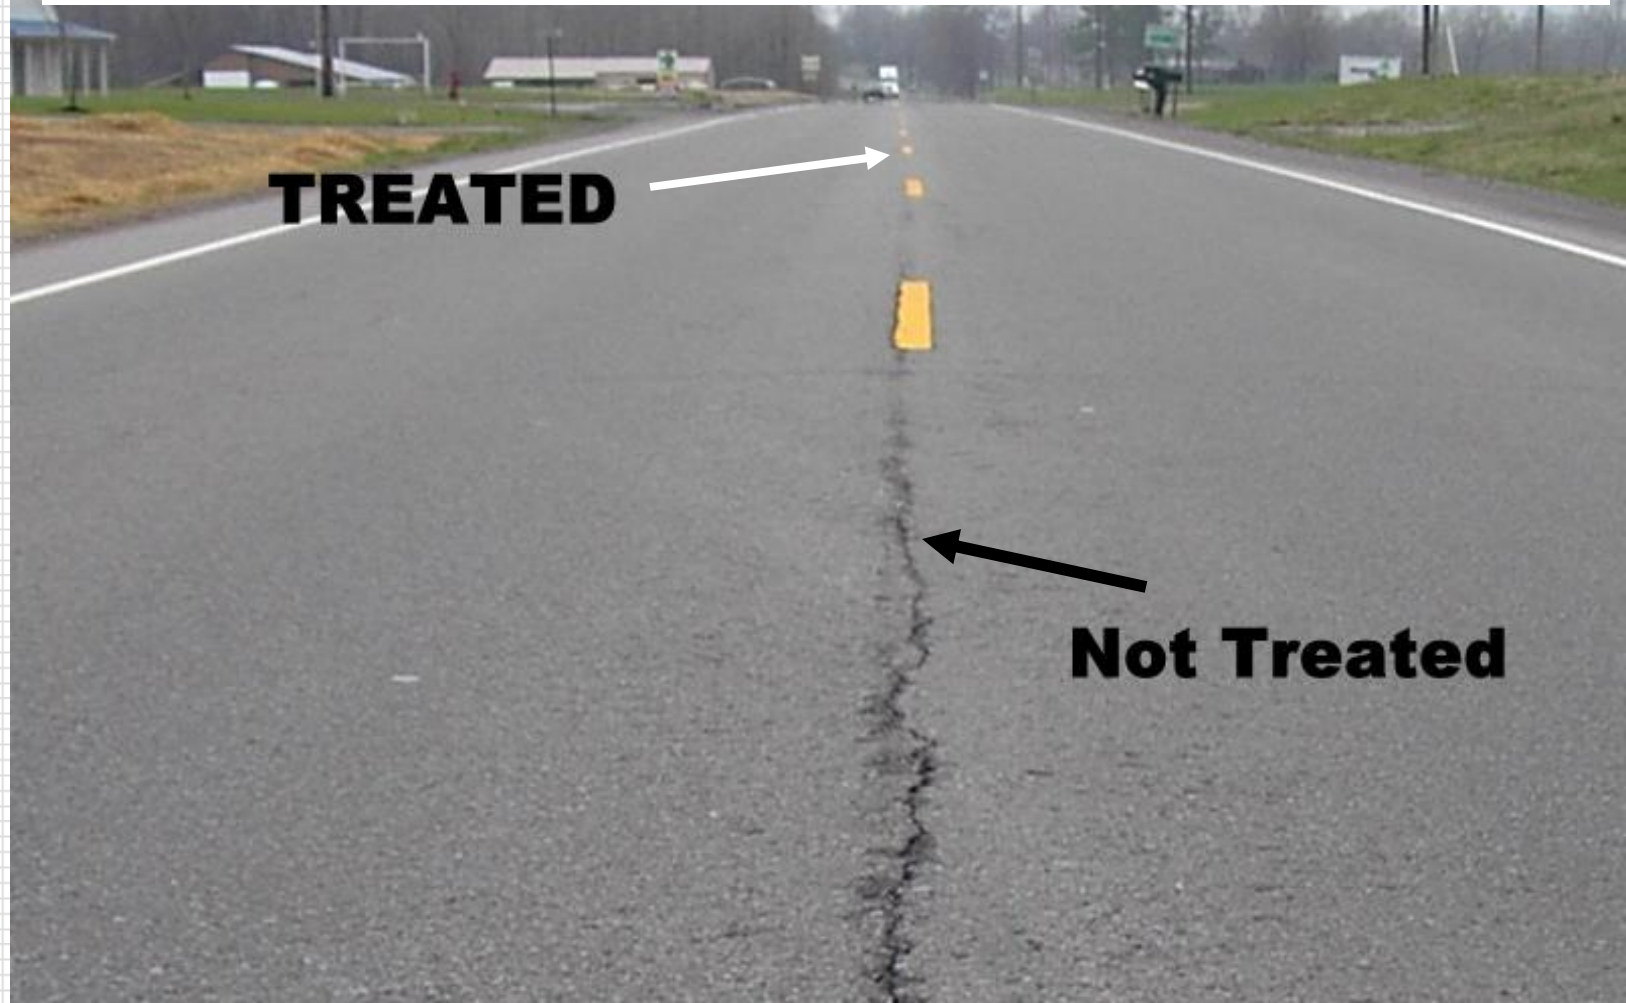
After 3 years hairline cracking was observed along the untreated sections of the longitudinal joint while the treated sections remained crack free.

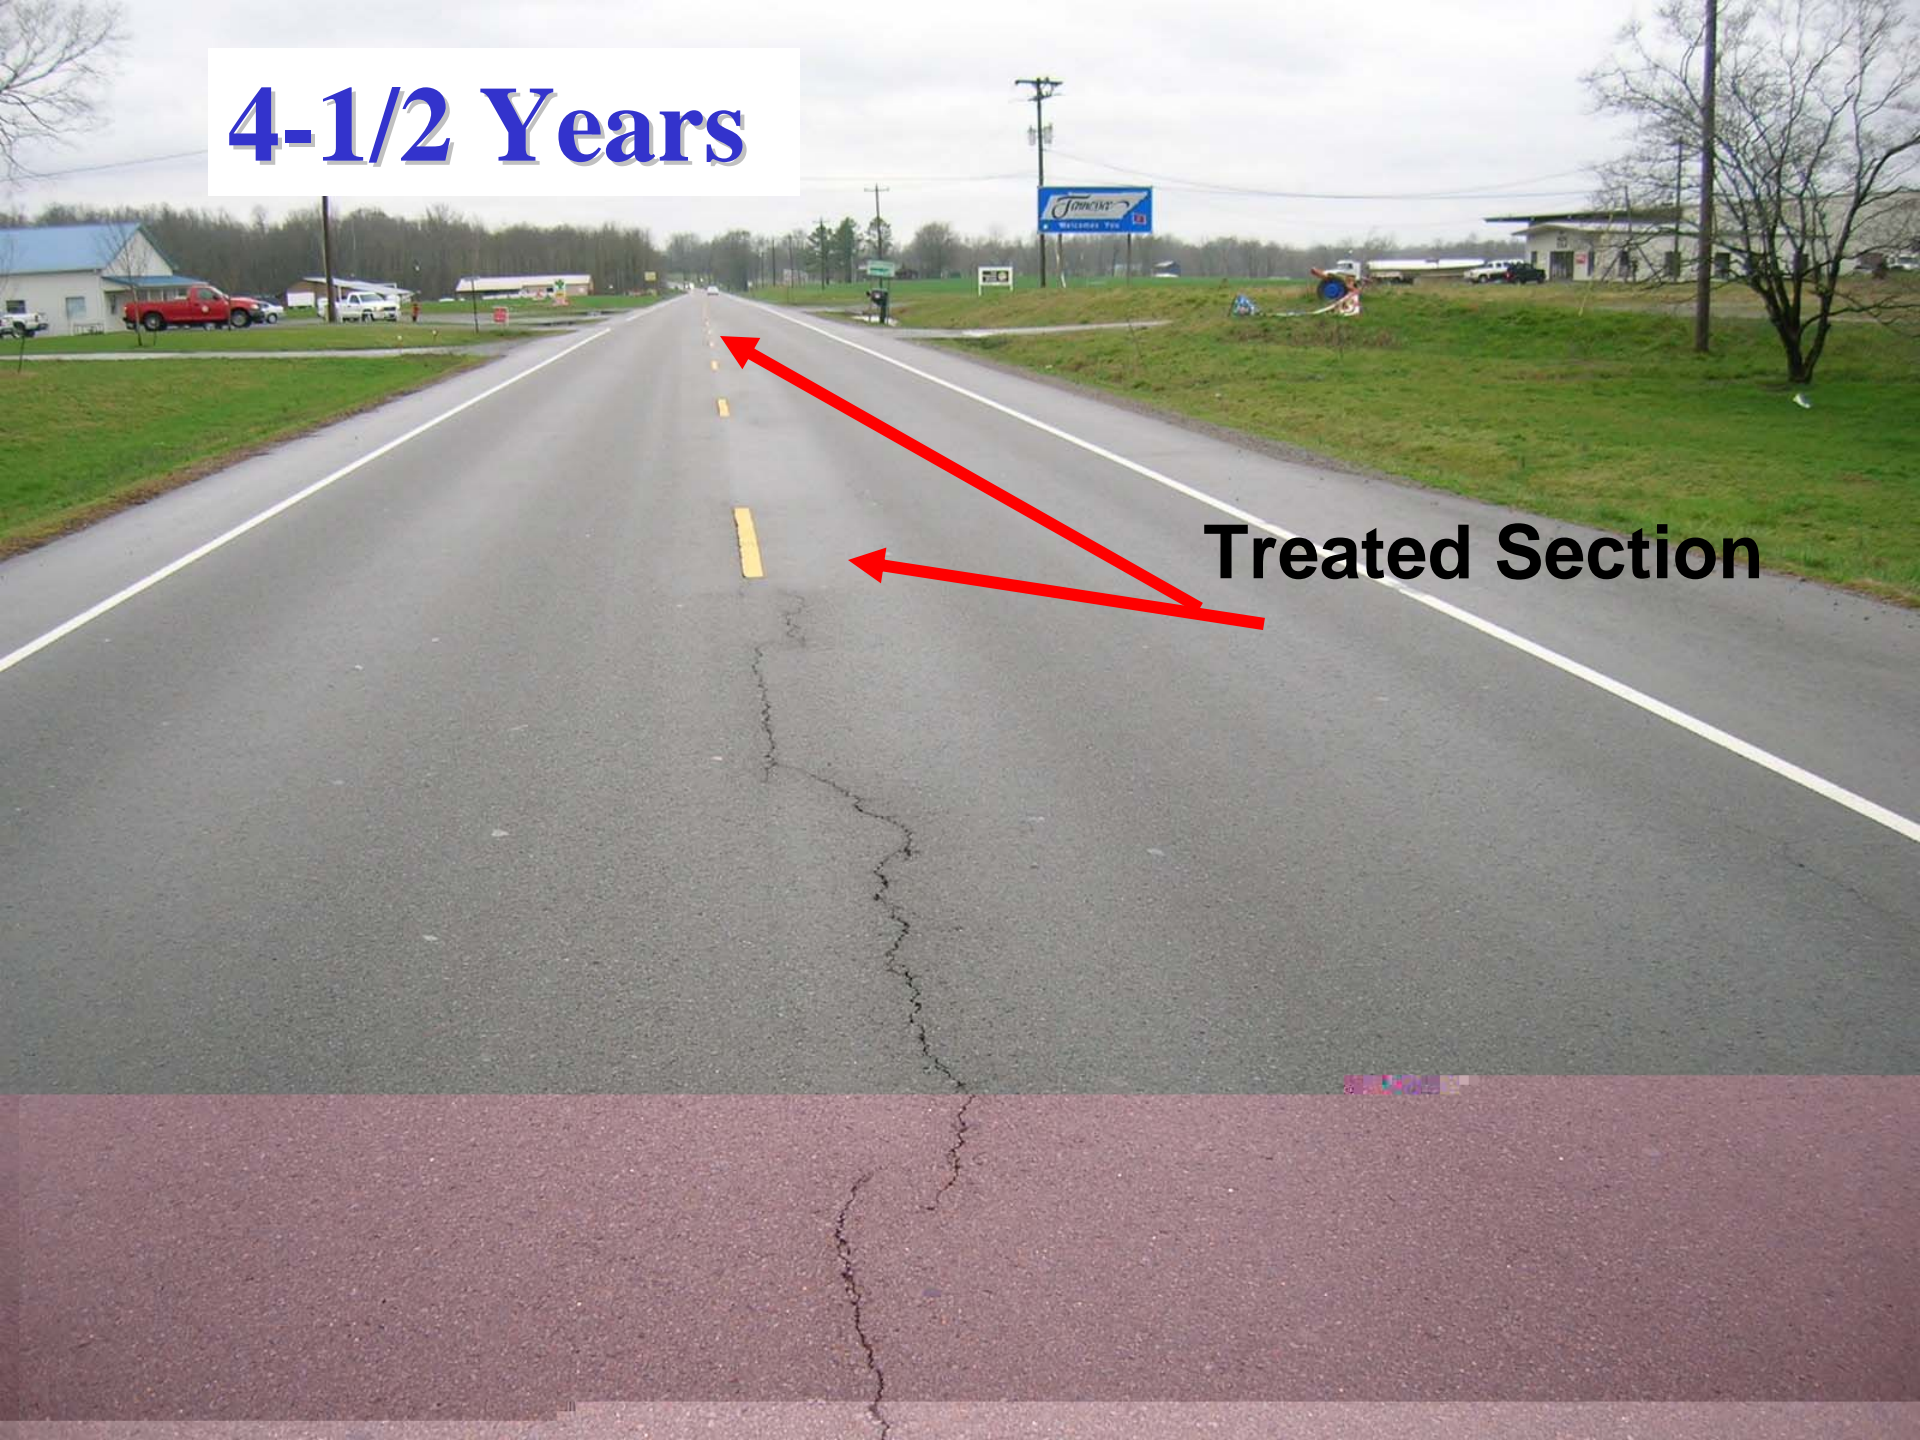
**4-1/2 Years**

**Treated Section**

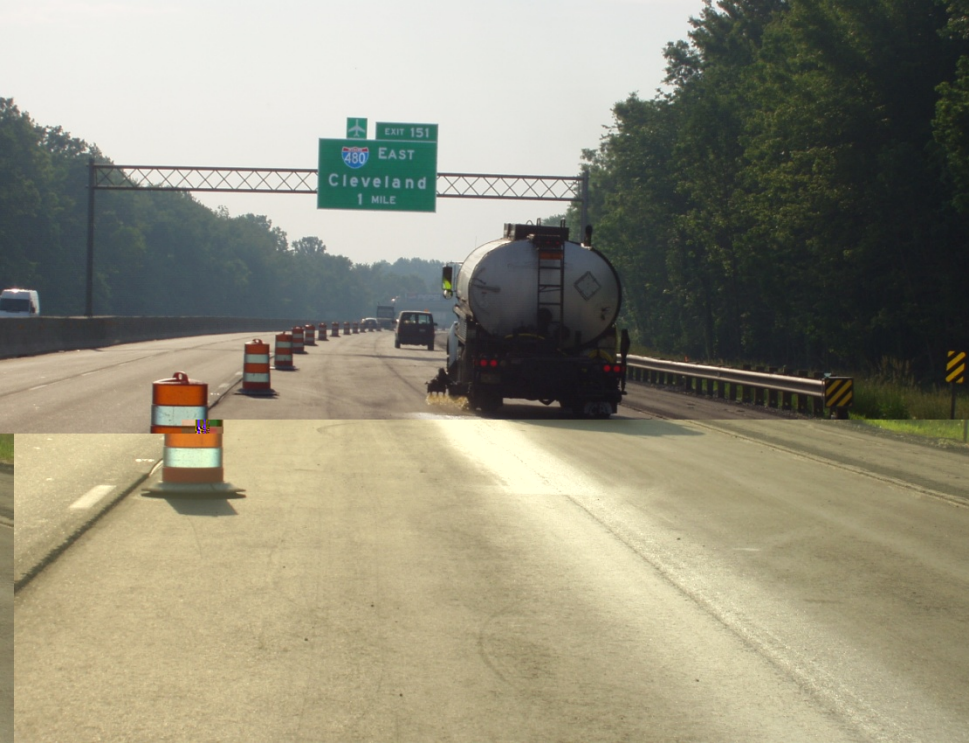
**LJ in the binder course and/or leveling course should be treated.**

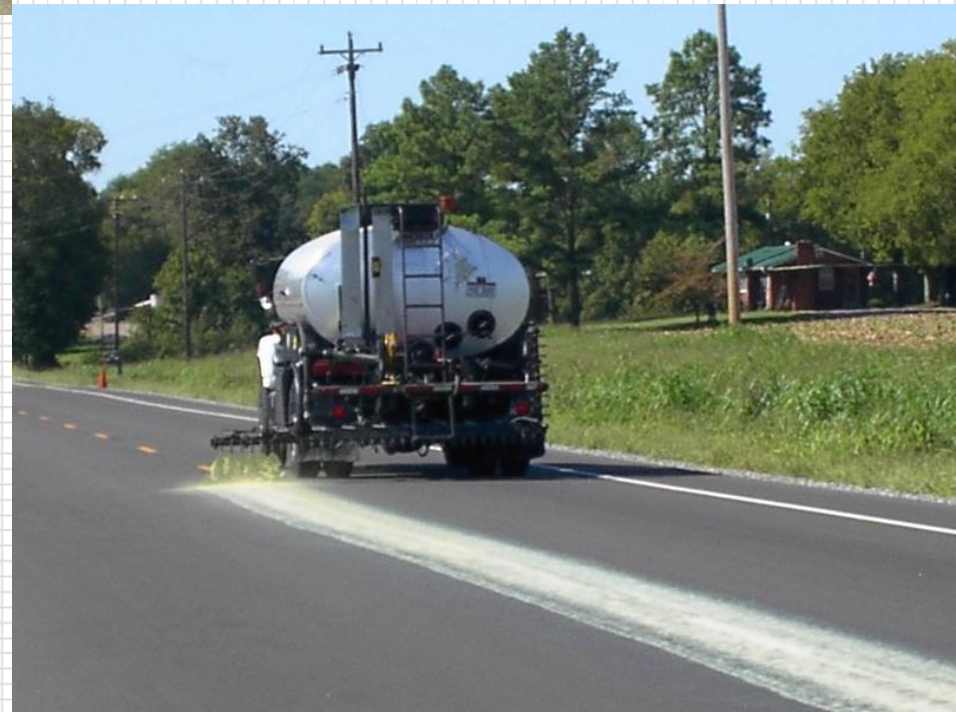
**At a minimum, the LJ in the wearing or surface course should be treated during the construction process or up to 18 months afterwards, before any separation occurs.**

**With today's technology, agencies can minimize the amount of longitudinal paving joint failures and work to prevent distresses such as these along their paving joints.**
