Gusset Plate Retrofit in Illinois

Jayme F. Schiff, P.E., S.E.
Repair Plans Unit Chief
Illinois Department of Transportation

Current Gusset Plate Retrofit Project:

- Cedar Street Truss Bridge in Peoria, Illinois. Built in 1932. Carries four lanes of traffic.
- 7 simple span deck truss units and one 3 span haunched cantilever deck truss unit.
- Structure was inspected in 2009 and gusset plate deterioration was found.
- Bridge has been posted for 15 tons due to the significant deterioration at two nodes. The current project will strengthen the gussets at the two nodes (and one floorbeam) so the posting can be removed. A much larger project is expected to follow, to strengthen many more gusset plates.

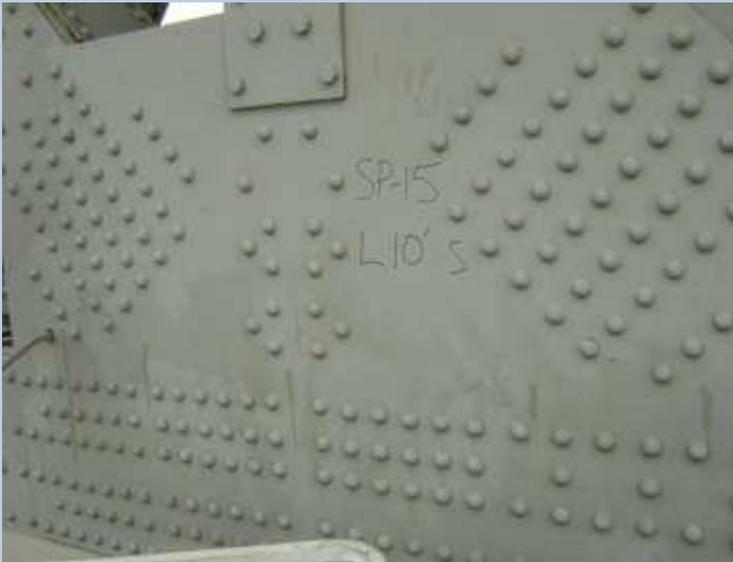
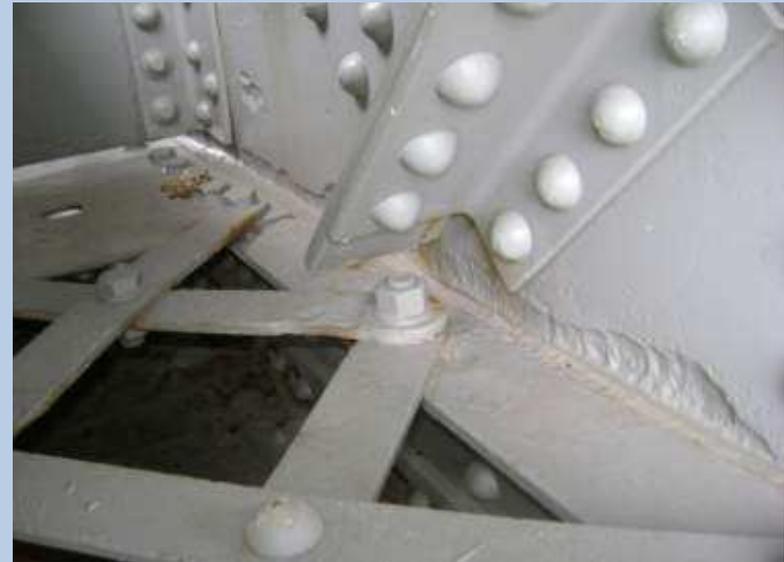
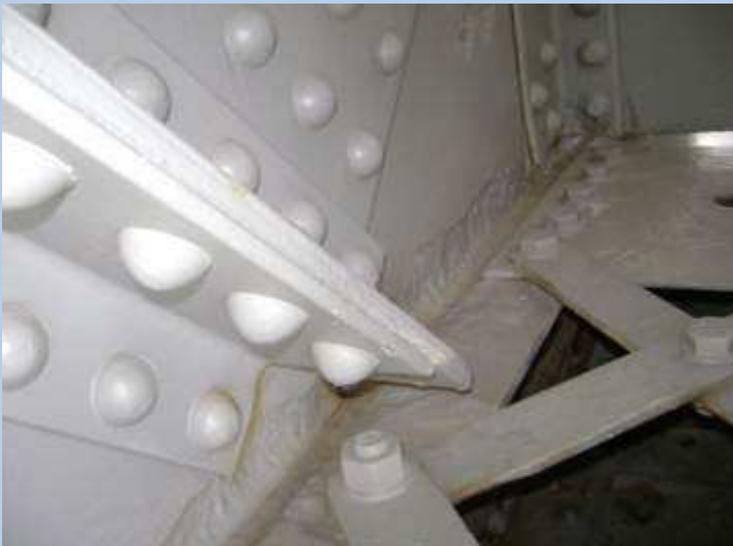
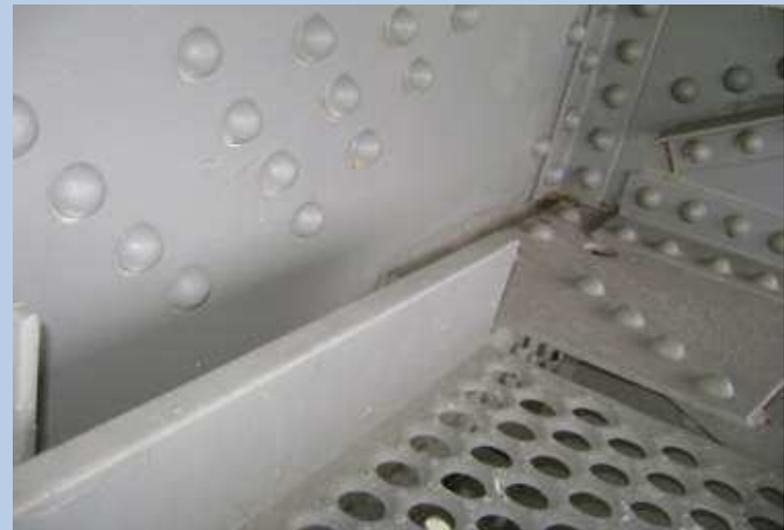
Field Inspection Photos at one node - Span 15 L10'S: (on bottom chord of anchor span)

Outside Gusset Plate

Inside Gusset Plate
