# Preservation of Pre-Stressed and Post-Tensioned Structures: Using Correct Tools to Save Costs

**Western Bridge Preservation Partnership  
Wednesday, December 1, 2010**

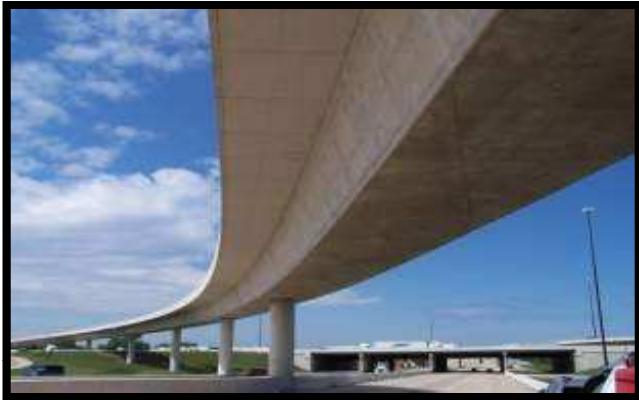
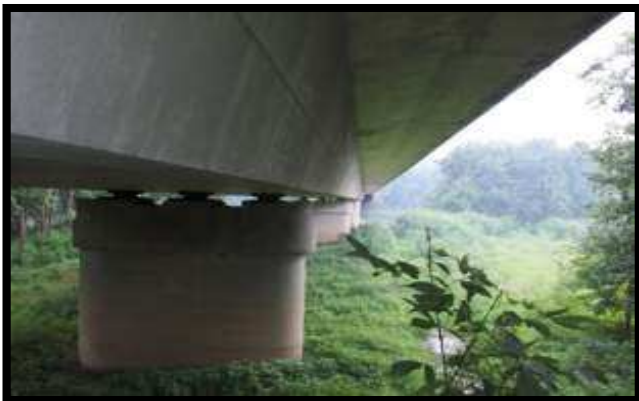
# Problems in PT

- Visual evaluation cannot quantify problems
- Low pH grout and high chloride content can increase the rate of corrosion of tendons
- Problematic voids need to be identified
- Cancerous corrosion can cause sudden failures as more wires/strands break

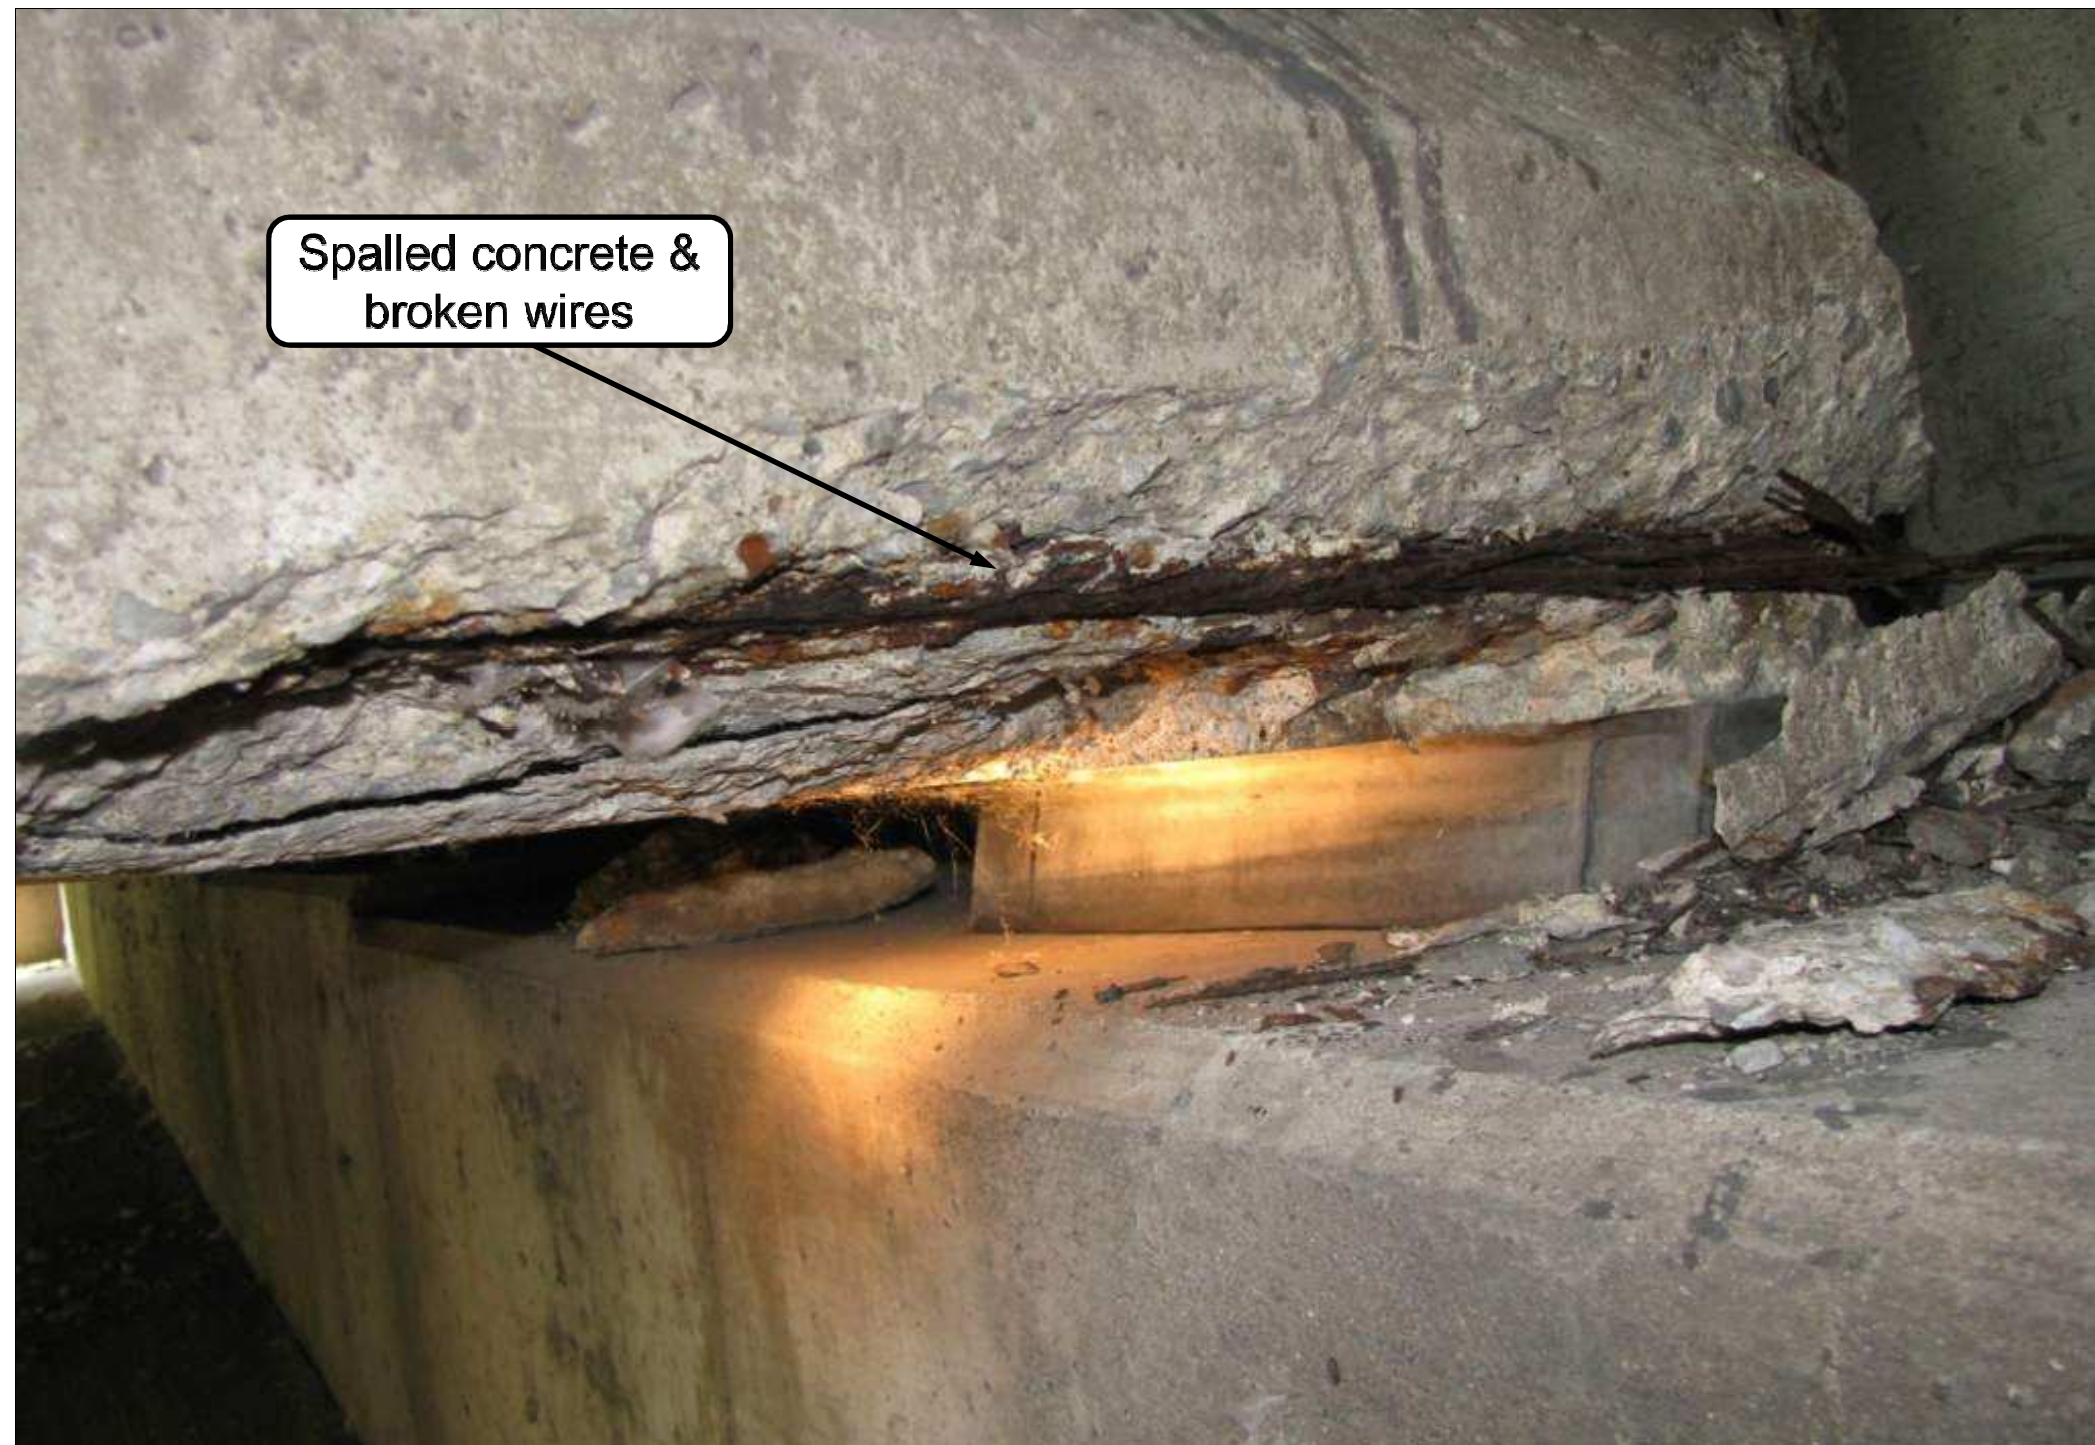
Spalled concrete &  
broken wires

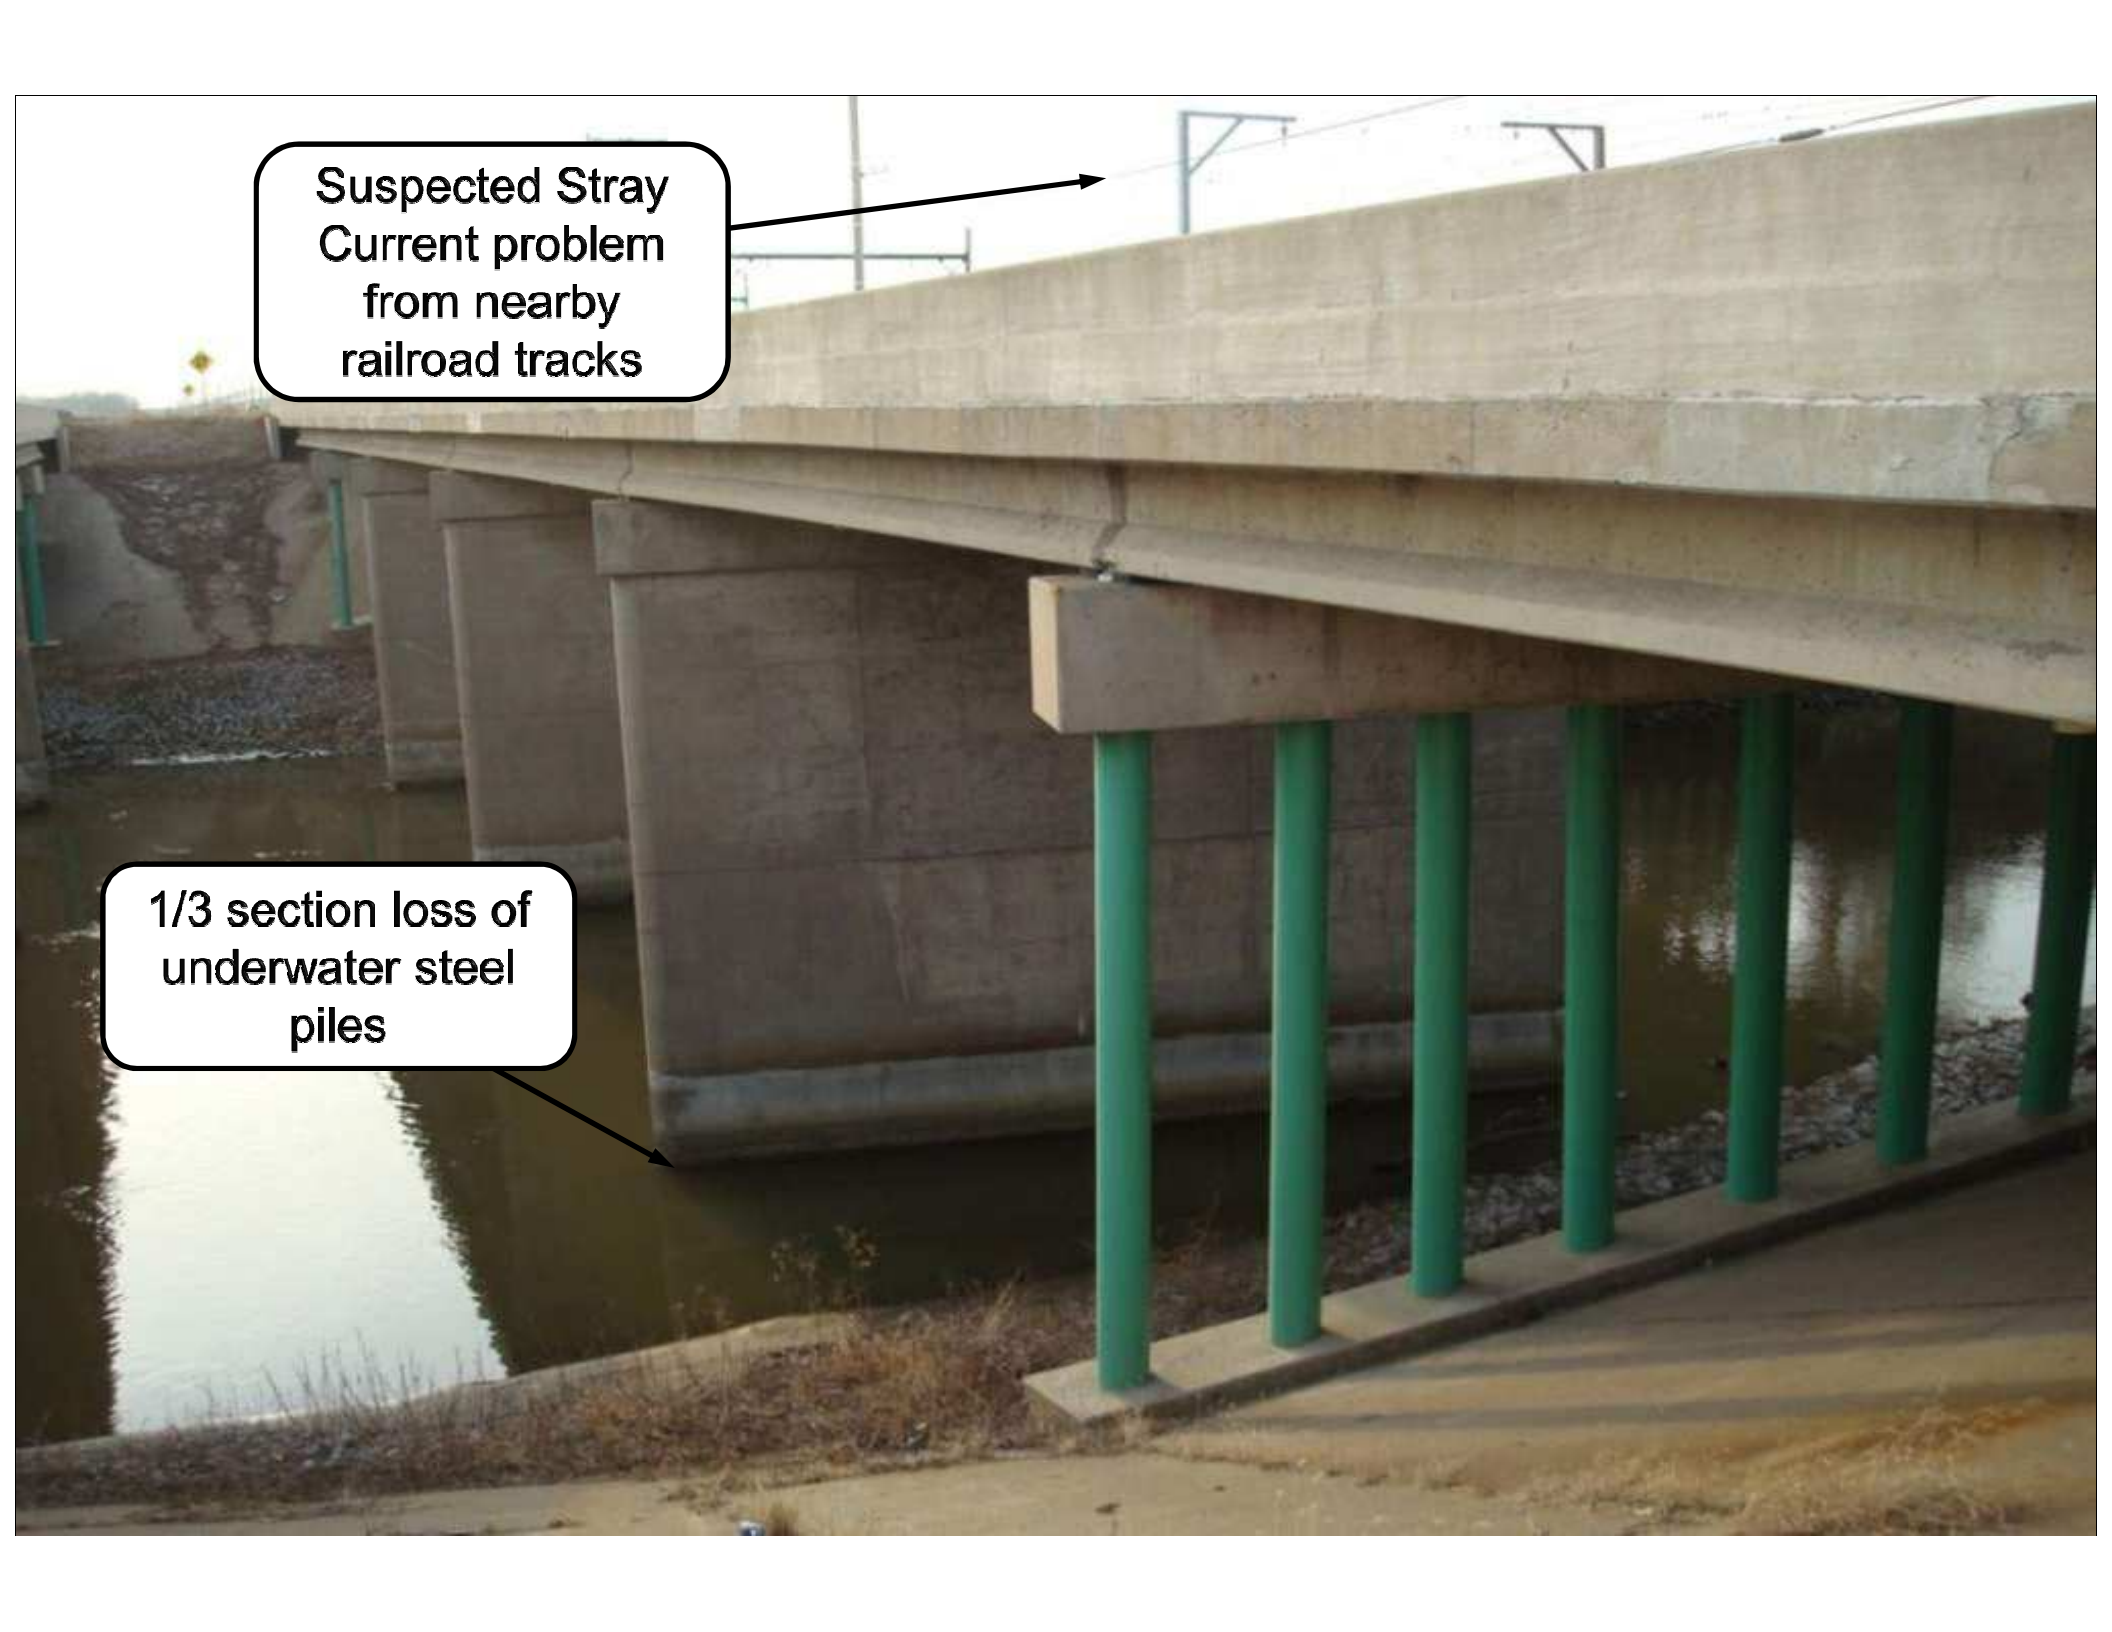
Suspected Stray  
Current problem  
from nearby  
railroad tracks

1/3 section loss of  
underwater steel  
piles

- SCS quantified the extent of deterioration at beam ends and steel piles
- We determined that the water and soil were corrosive
- We designed a corrosion mitigation system and developed plans to extend the service lives of pre-stressed beams and steel piles

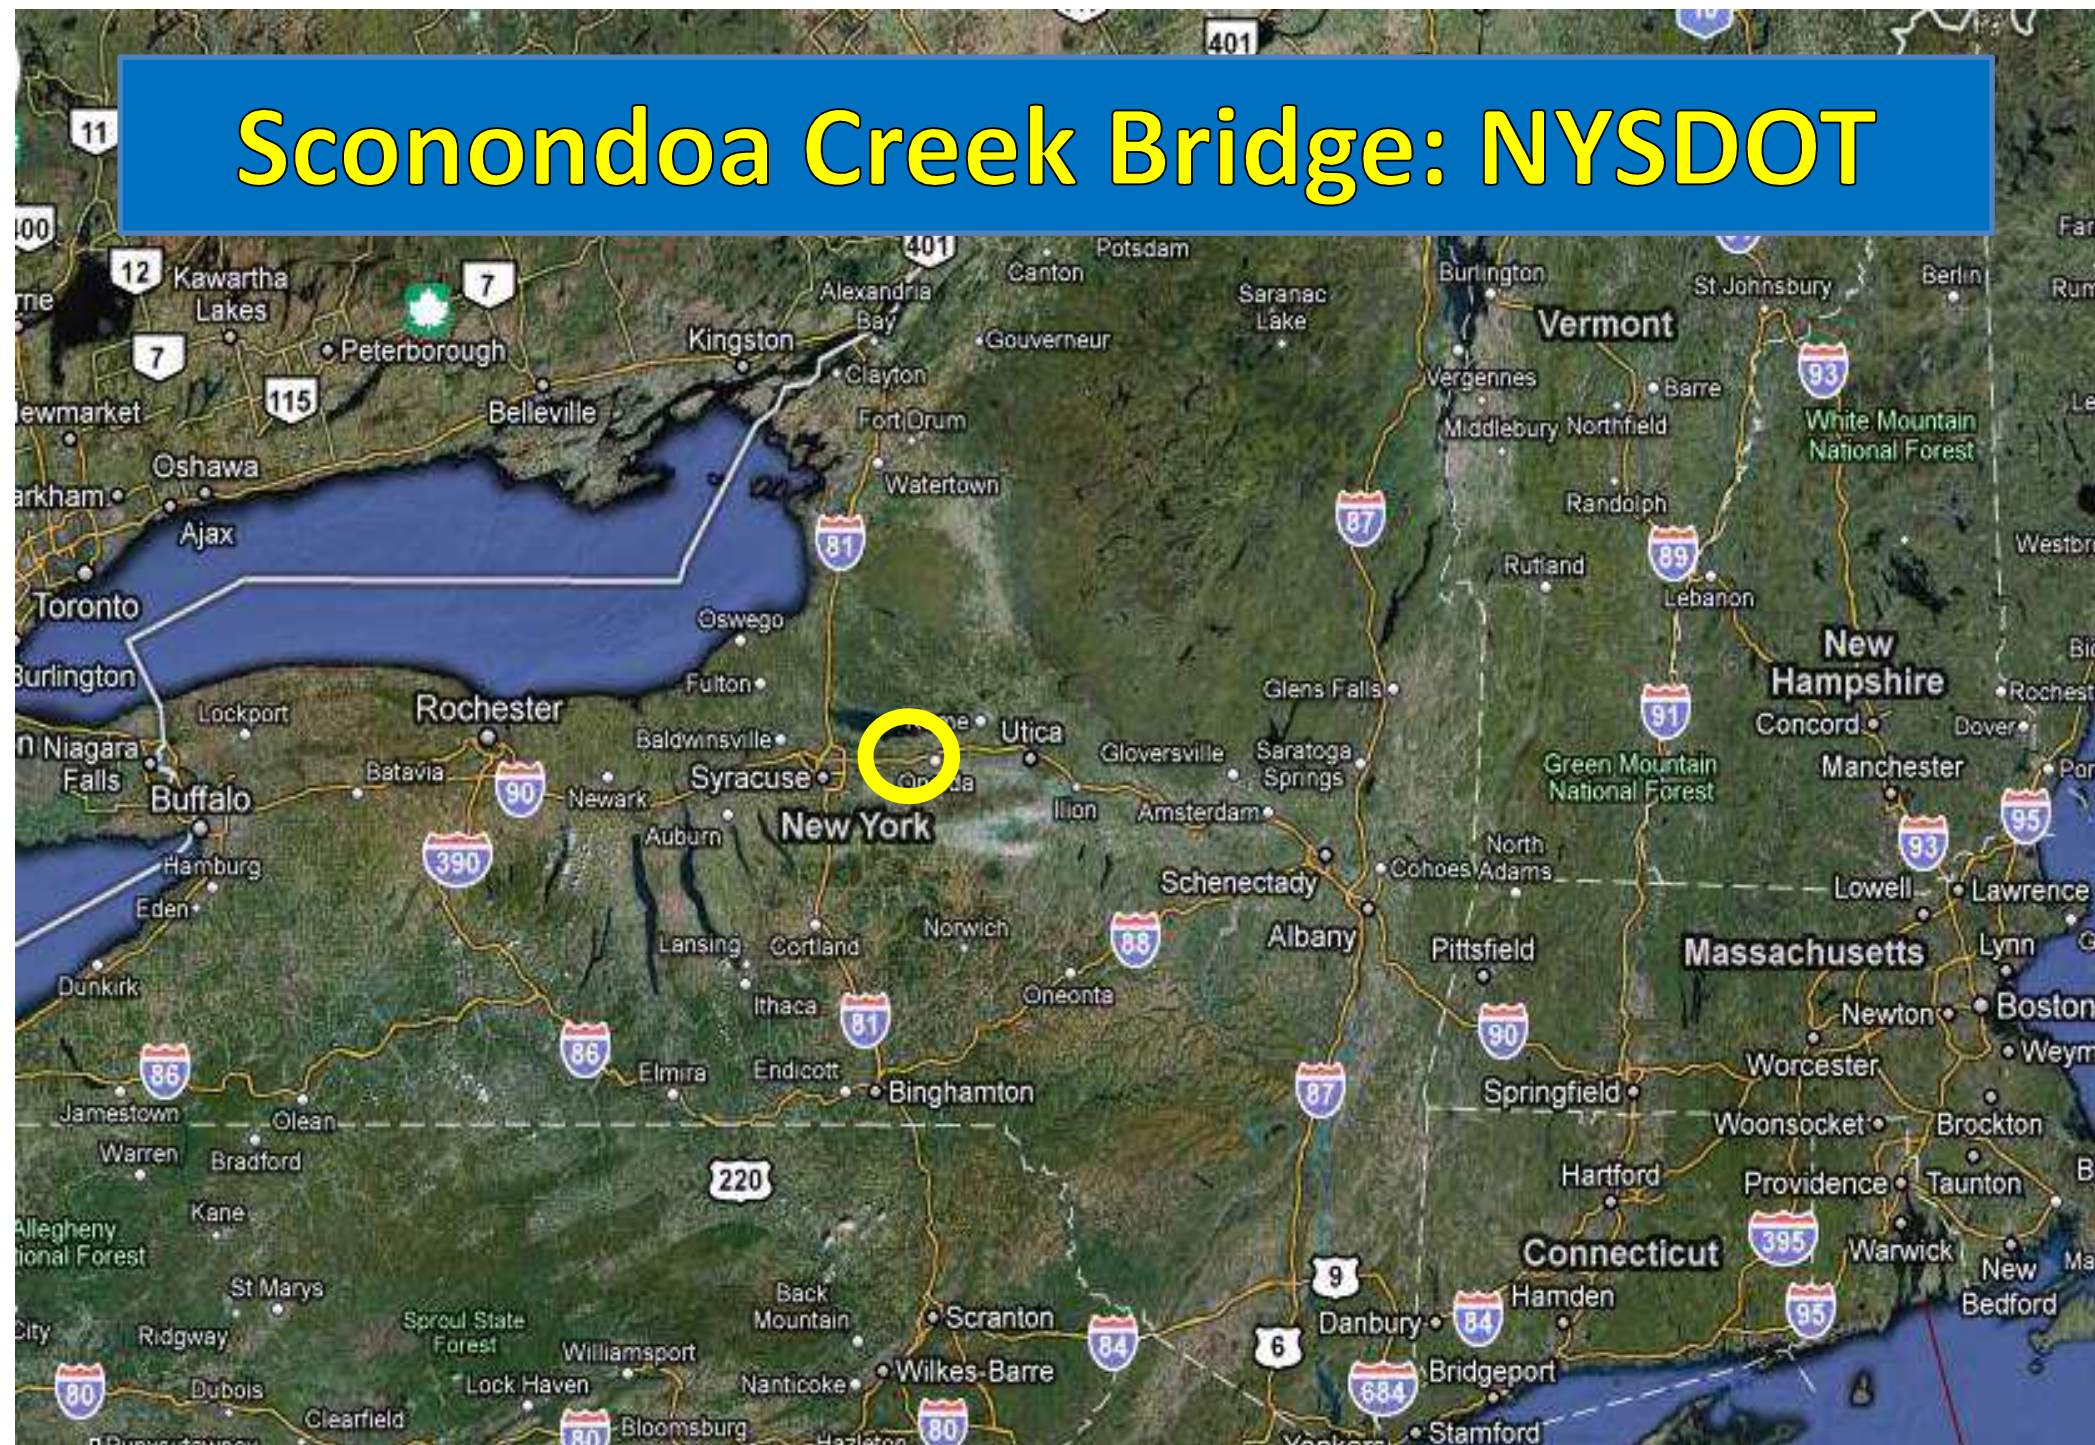
- Significant cracking, spalls and delaminations
- Visible strand corrosion - more not yet visible?
- Are there tools that can accurately quantify the condition?
- Is preservation possible in this case?

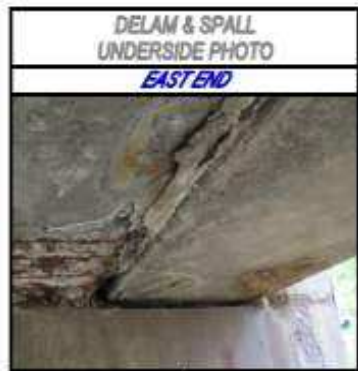
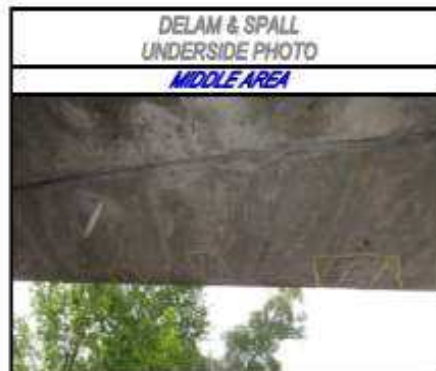
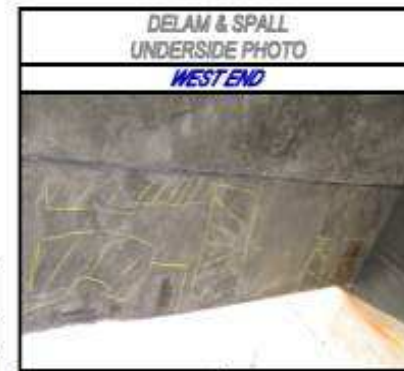
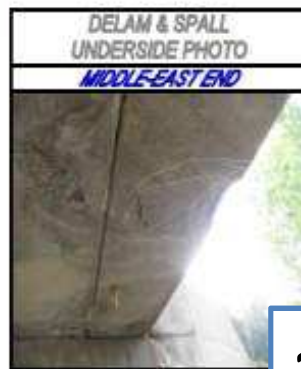
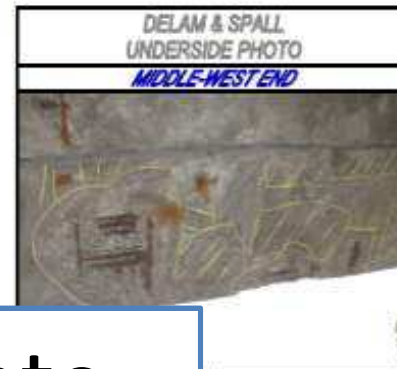
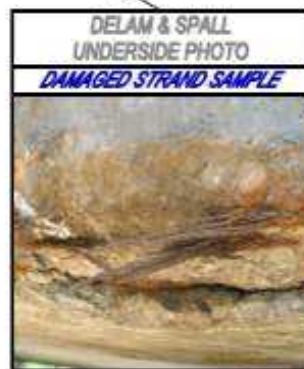
*BEAM 20 - UNDERSIDE  
BRIDGE #2 OVER SCONONDOA CREEK  
N.T.S.*

31% Concrete  
Damage

- Visual data – only a small percentage of the beam corroding
- Visual & delam data – 31% of the beam corroding
- Corrosion potential data – 67% of the beam corroding
- Evaluate before visual signs of distress to achieve and exceed service life goals

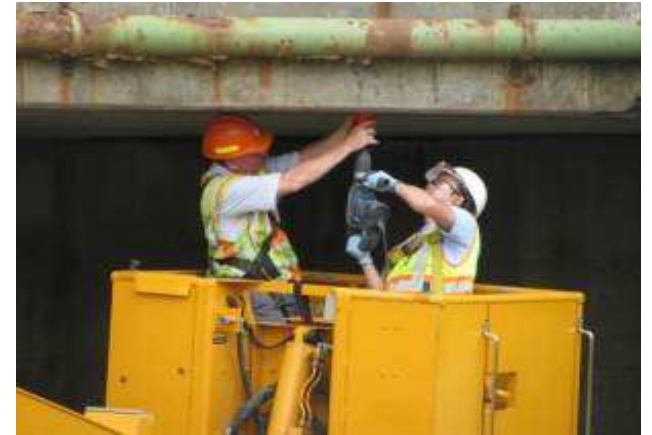
# Water in Beam

- Half-inch hole was drilled
- Water drained for a few hours
- Chloride concentration of the water was very high
- Resistivity of the water was low

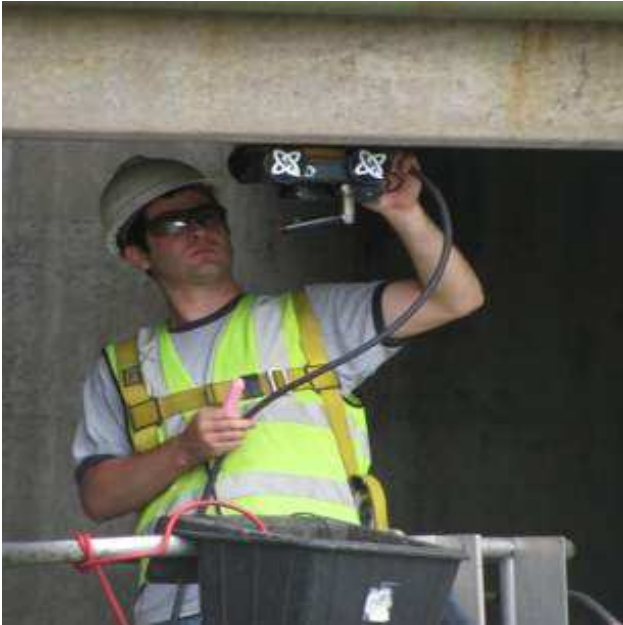
# GPR

- Difficult to identify early stage delaminations by sounding
- GPR can rapidly identify early stage delaminations
- GPR can identify reinforcement location/depth and member dimensions

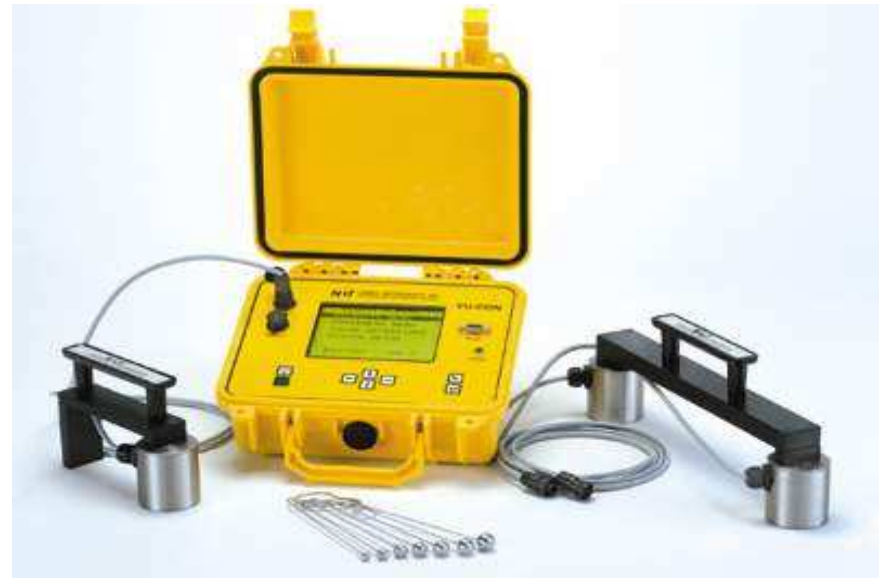
# Impact Echo

- Can find flaws not detectable by GPR and provide more information about those flaws
- Well suited for flaw determination on structures with difficult access or multiple layers of materials (e.g. overlays)
