Use of Hand-Held Thermographic Camera for Condition TPF-5(152)

Glenn A. Washer, Ph.D.

Midwest Bridge Preservation Partnership 2010

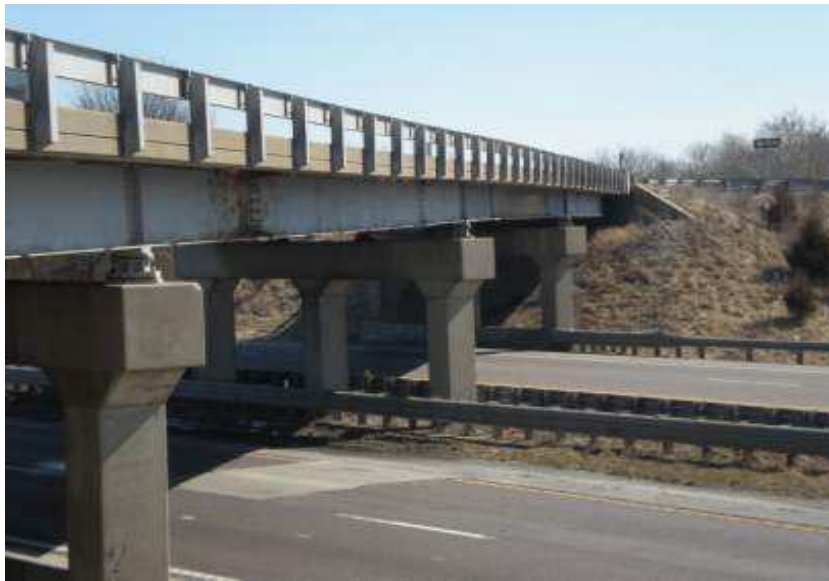
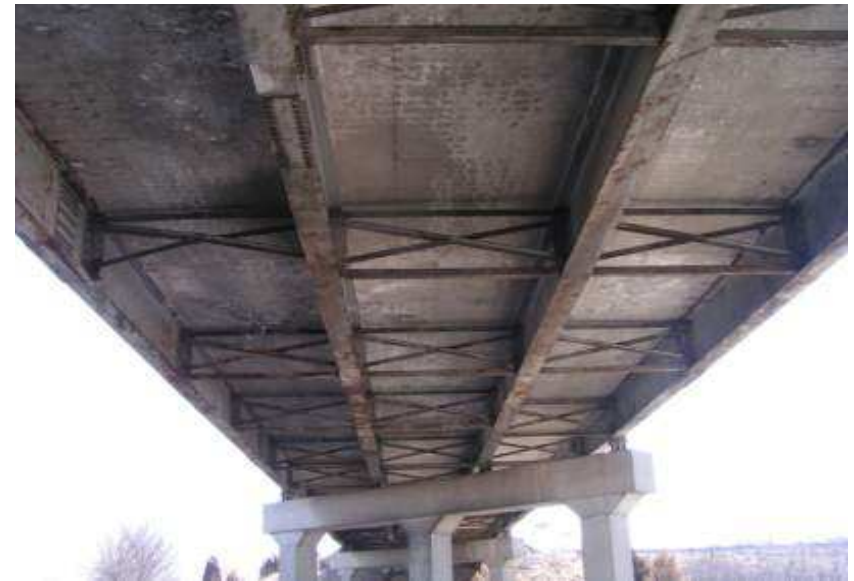
Example: Typical Overpass

I-70, Columbia

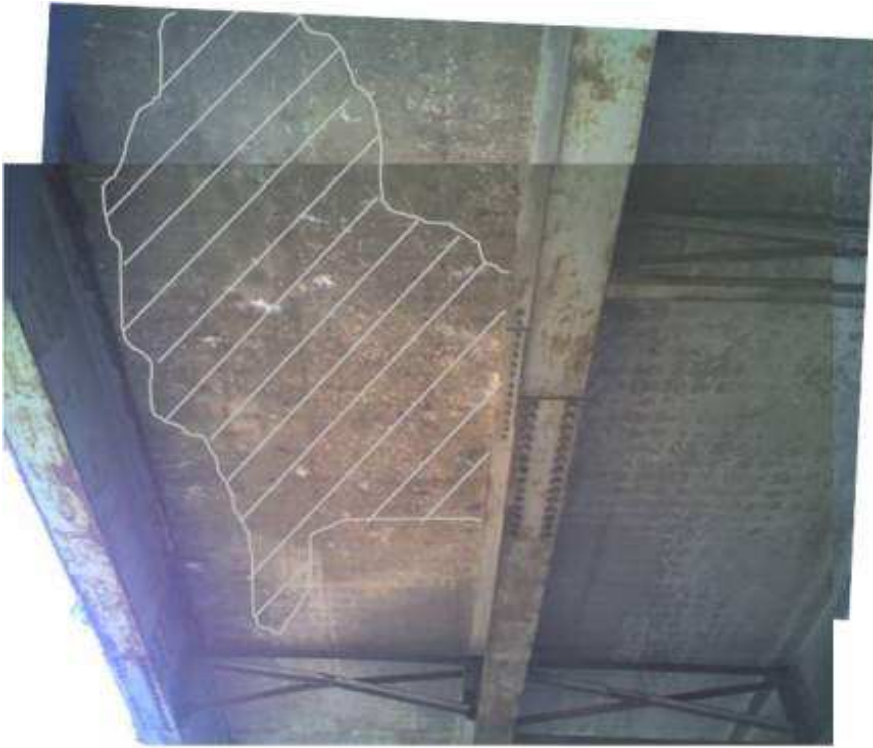
Soffit – inner bay

- Over I-70 E

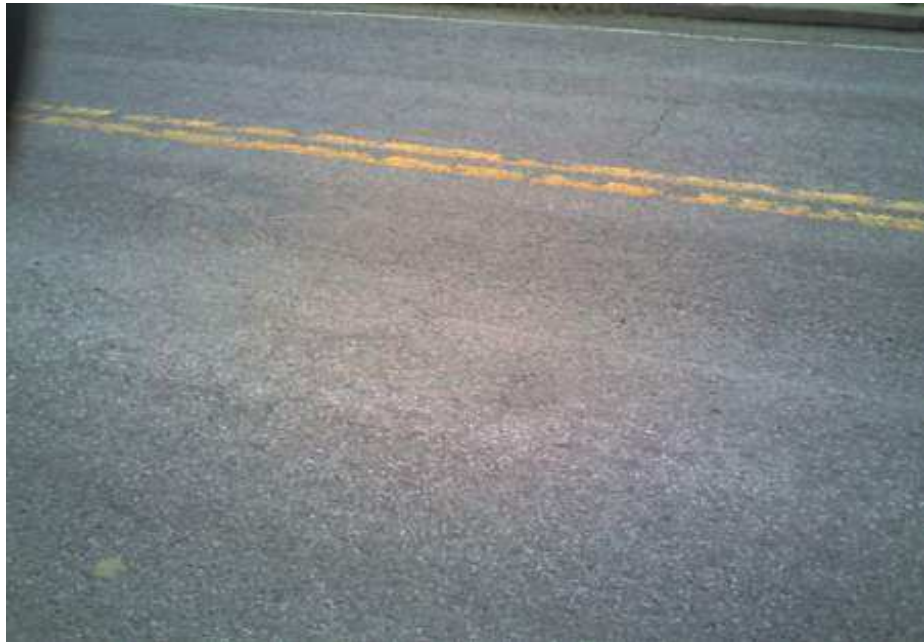
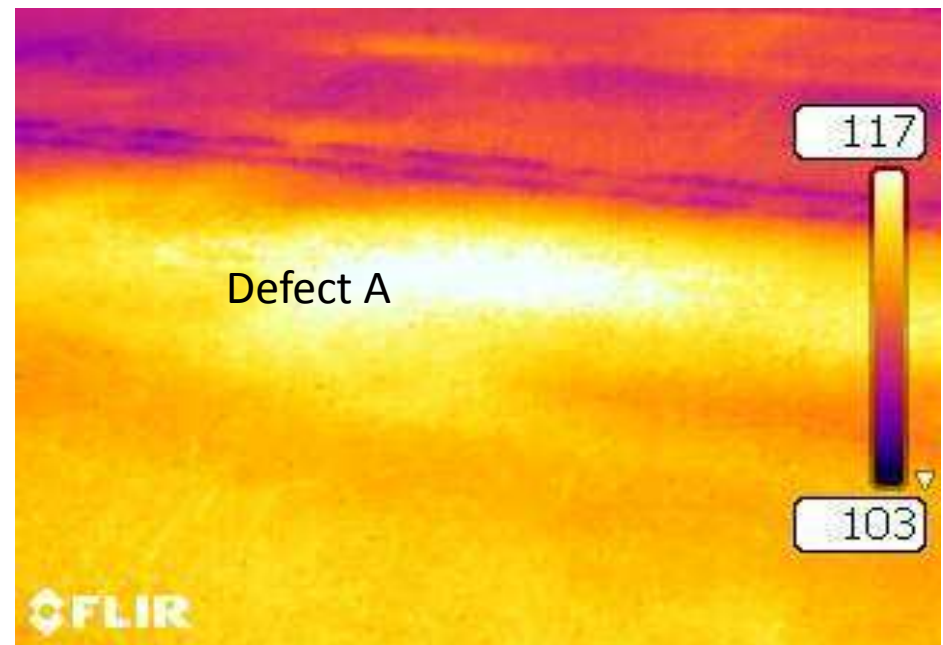
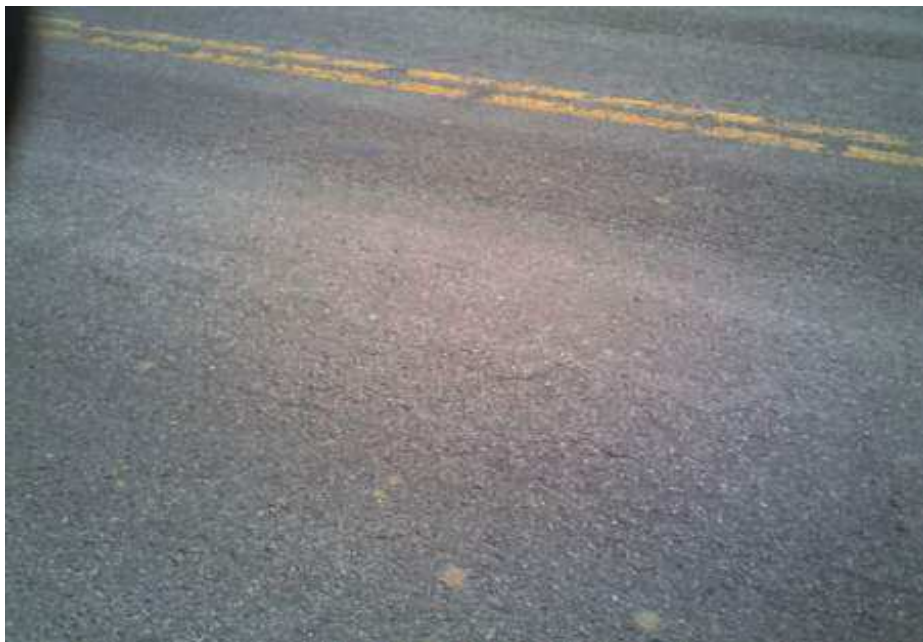
Two different defects in asphalt covered bridge deck from shoulder

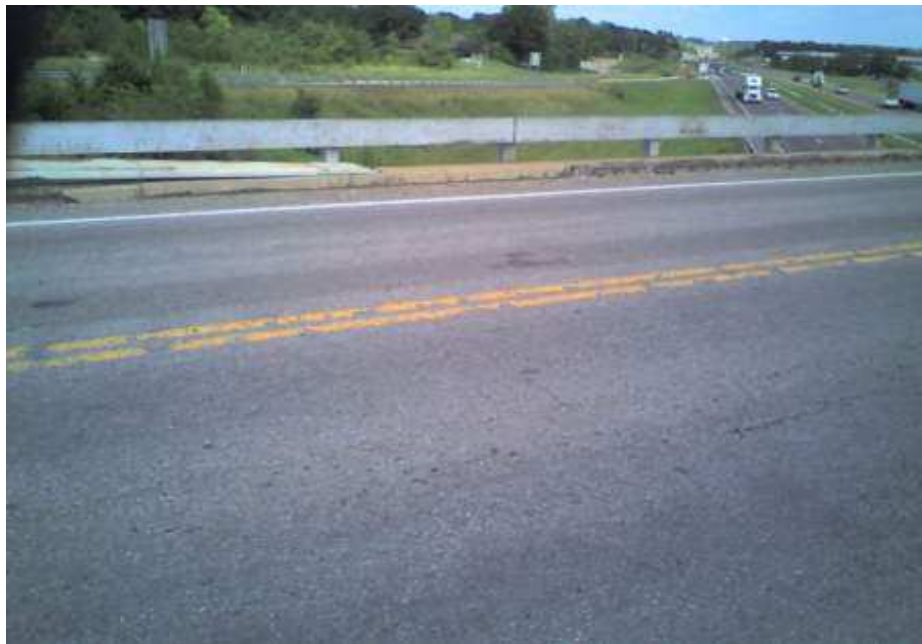
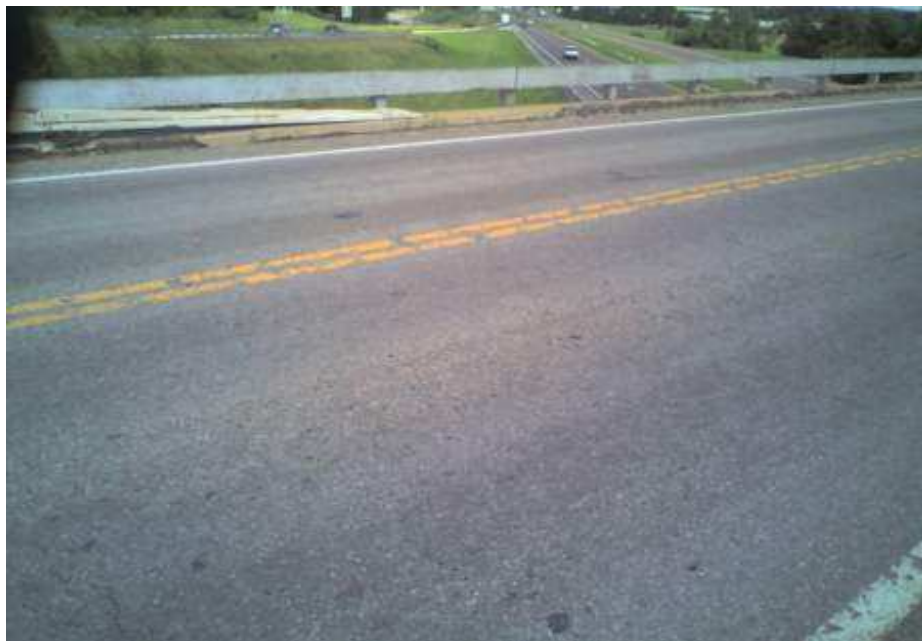
Defect A and B in asphalt covered bridge deck from shoulder, opposite side of road

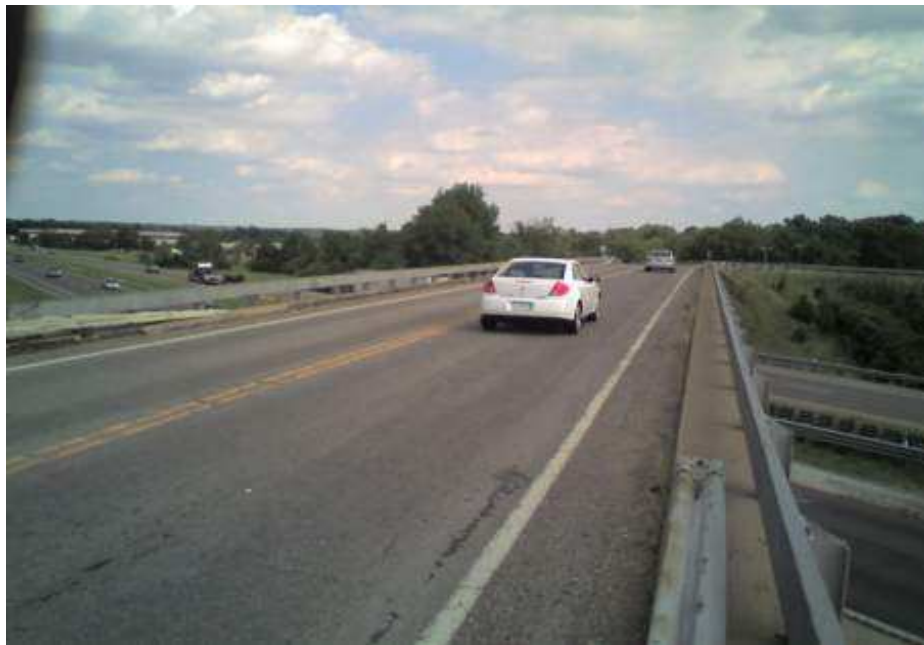
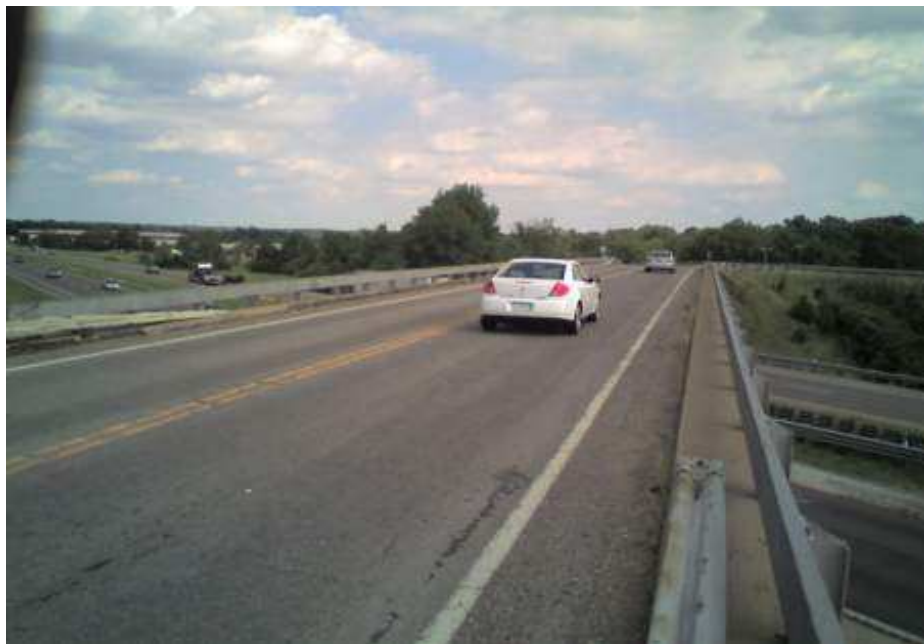
Defect under live traffic Field data (top), scale adjusted in office (bottom)

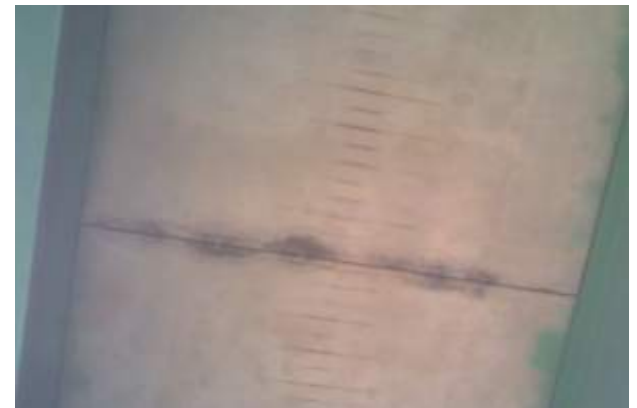
Prestressed deck panels

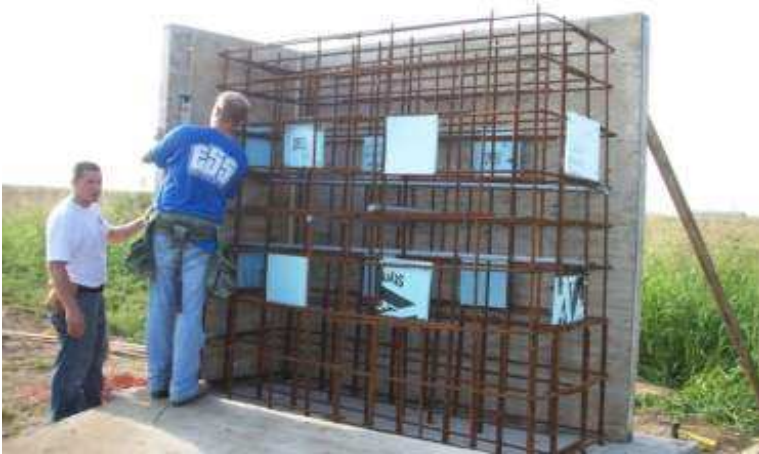
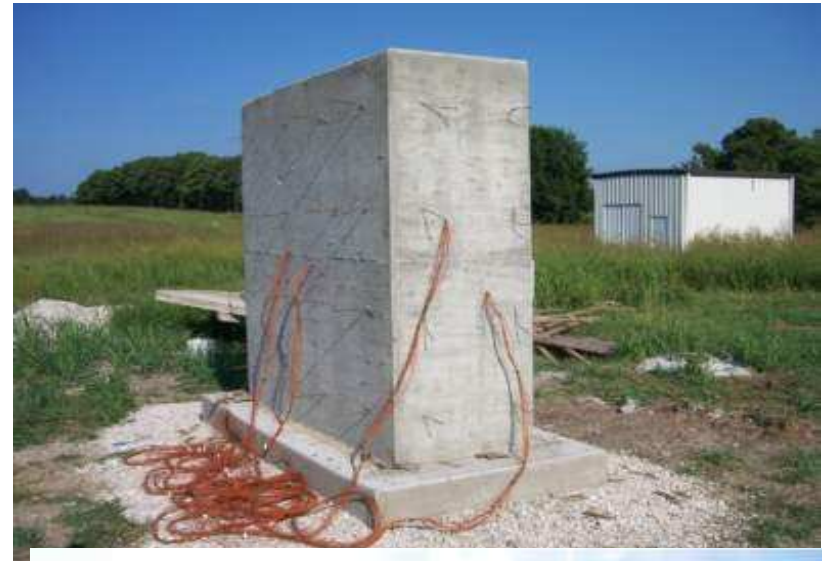
Test Block

- Construct a large concrete block with simulated defects (targets) at different depths
 - Simulated defects will provide a uniform response to environmental effects
 - Different depths of targets will measure the time delay and contrast variations that could be anticipated in the field
- Demonstrate applications in field with state forces

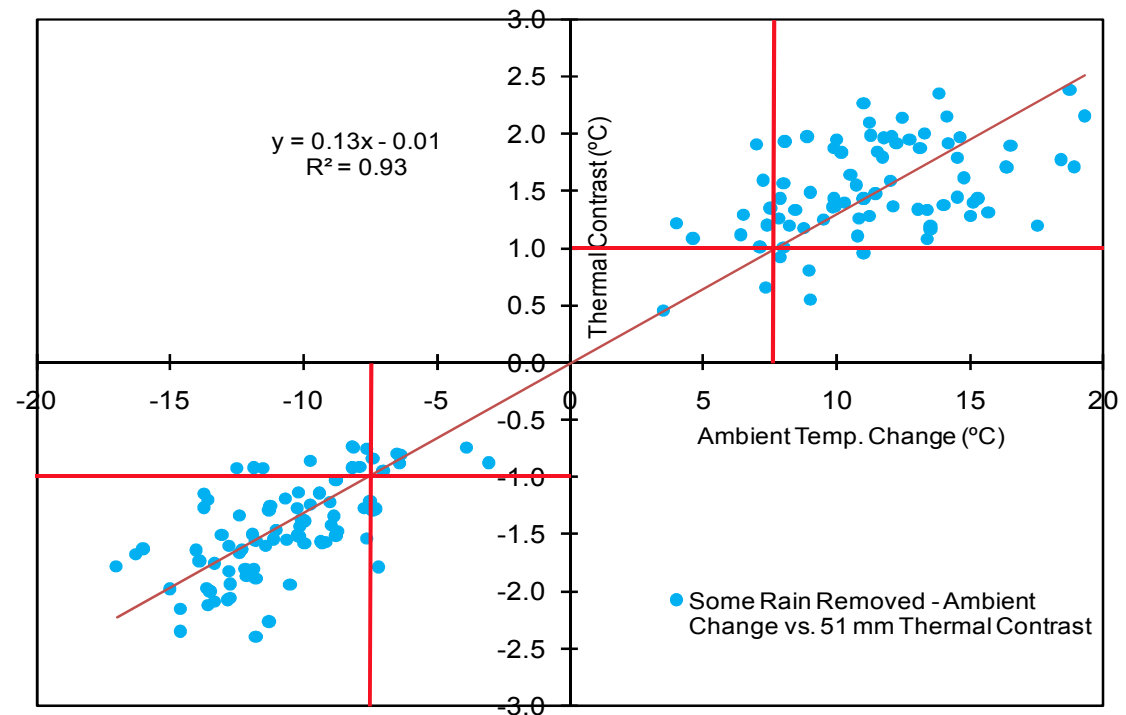
Ambient Temperature Change vs. Thermal Contrast – shady side of block

- On average, 1.4 °C of contrast either positive (day) or negative (night)
