**SR 19 OVER LITTLE LAKE HARRIS
BRIDGE I 10026 SUBSTRUCTURE REPAIR
LAKE COUNTY, FL**

Little Lake Harris Bridge

GEOTECHNICAL ENGINEERING EVALUATION

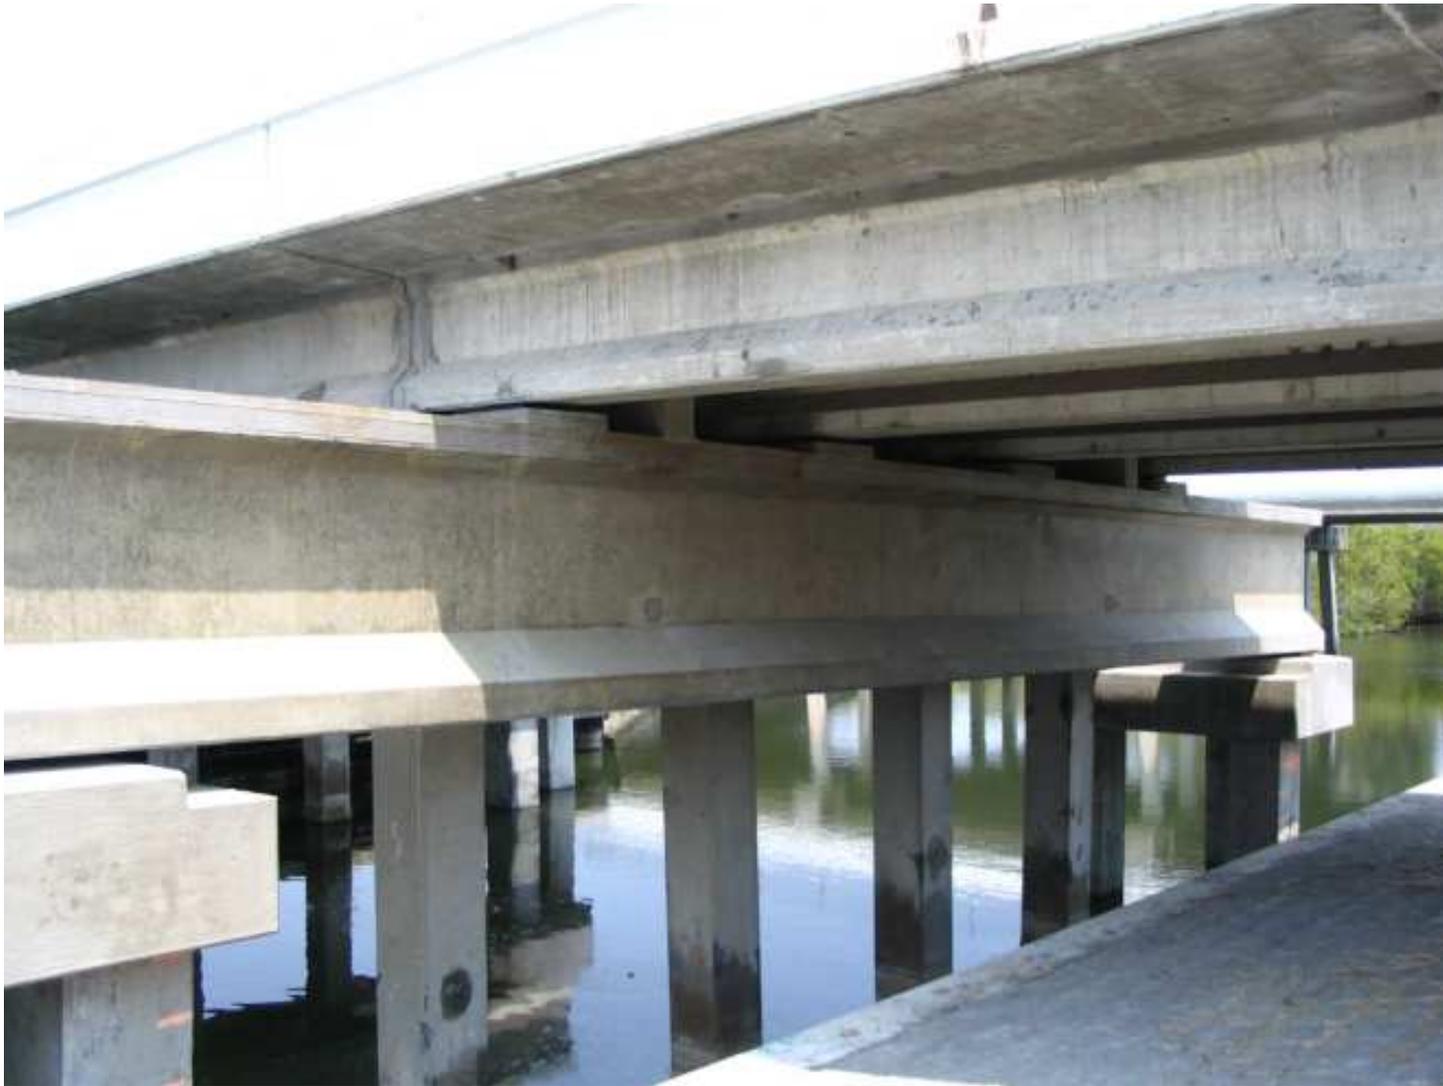
Sample Helper Bent

SR 528 over Sykes Creek

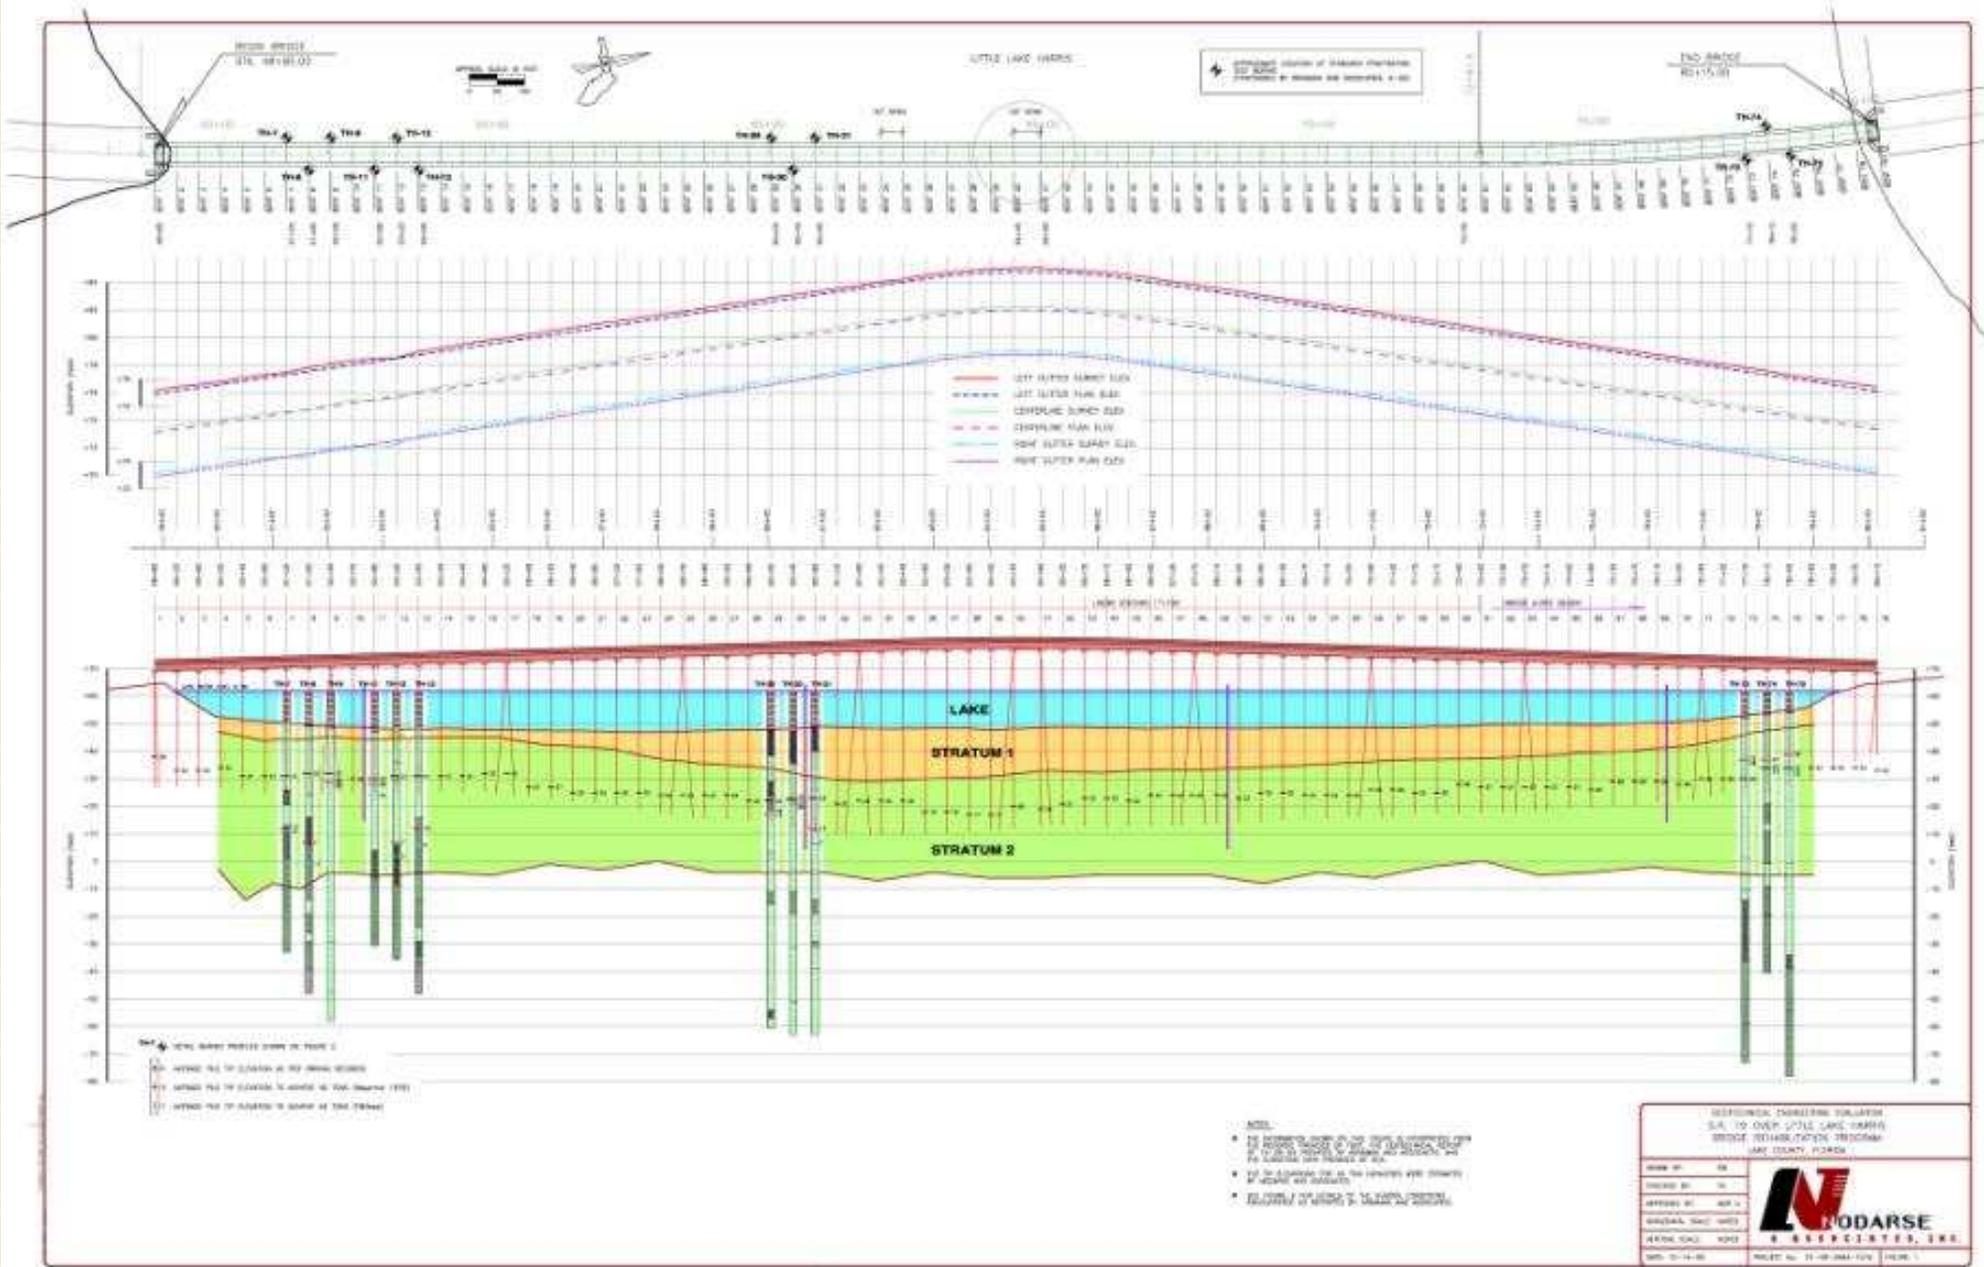
Bent #	7				8				9					
F.G. Elevation at Lt. Gutter (Plan)	74.31				74.55				74.79					
F.G. Elevation at Lt. Gutter (Survey)	74.47				74.81				75.09					
Difference in Settlement (inches)	1.92				3.12				3.60					
F.G. Elevation at CL (Plan)	74.53				74.77				75.01					
F.G. Elevation at CL (Survey)	74.62				74.74				75.27					
Difference in Settlement (inches)	1.08				-0.36				3.12					
F.G. Elevation at Rt. Gutter (Plan)	74.31				74.55				74.79					
F.G. Elevation at Rt. Gutter (Survey)	74.33				74.32				74.97					
Difference in Settlement (inches)	0.24				-2.76				2.16					
Pile Number within the bent	1	2	3	4	1	2	3	4	1	2	3	4	5	6
Design Pile Length, feet	38	38	38	38	38	38	38	38	38	38	38	38	38	38
Pile Cut Off Elevation, feet	69.45	69.45	69.45	69.45	69.73	69.69	69.69	69.70	70.00	69.93	69.94	69.98	69.98	70.00
Pile Tip Elevation (Driving Records)	31.45	31.45	31.45	31.45	31.73	31.69	31.69	31.70	32.00	31.93	31.94	31.98	31.98	32.00

Pile Tip Elevation (Plans)	24.58				25.00				25.83					
Tip to provide 40 tons (FBDeep)	11.00				-1.00				28.00					
Tip to provide 40 tons (Meyerhof 76)	11.00				7.00				30.00					
Ground Elevation, feet	50.82	50.82	50.82	50.82	50.30	50.30	50.30	50.30	50.00	50.00	50.00	50.00	50.00	50.00
Length of Pile Embedment, feet	19.37	19.37	19.37	19.37	18.57	18.61	18.61	18.60	18.00	18.07	18.06	18.02	18.02	18.00
Pile Capacity per Driving Records	42	42	48	48	42	42	48	48	75	54	67	75	54	55

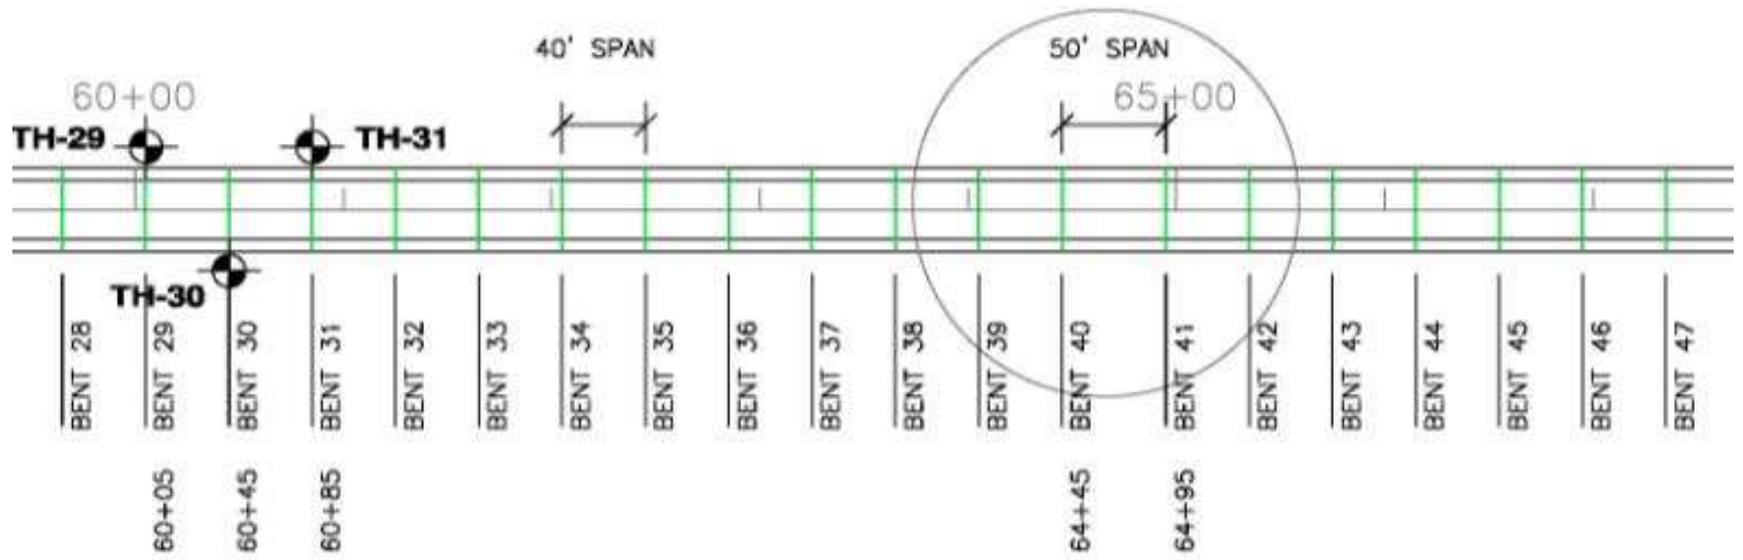
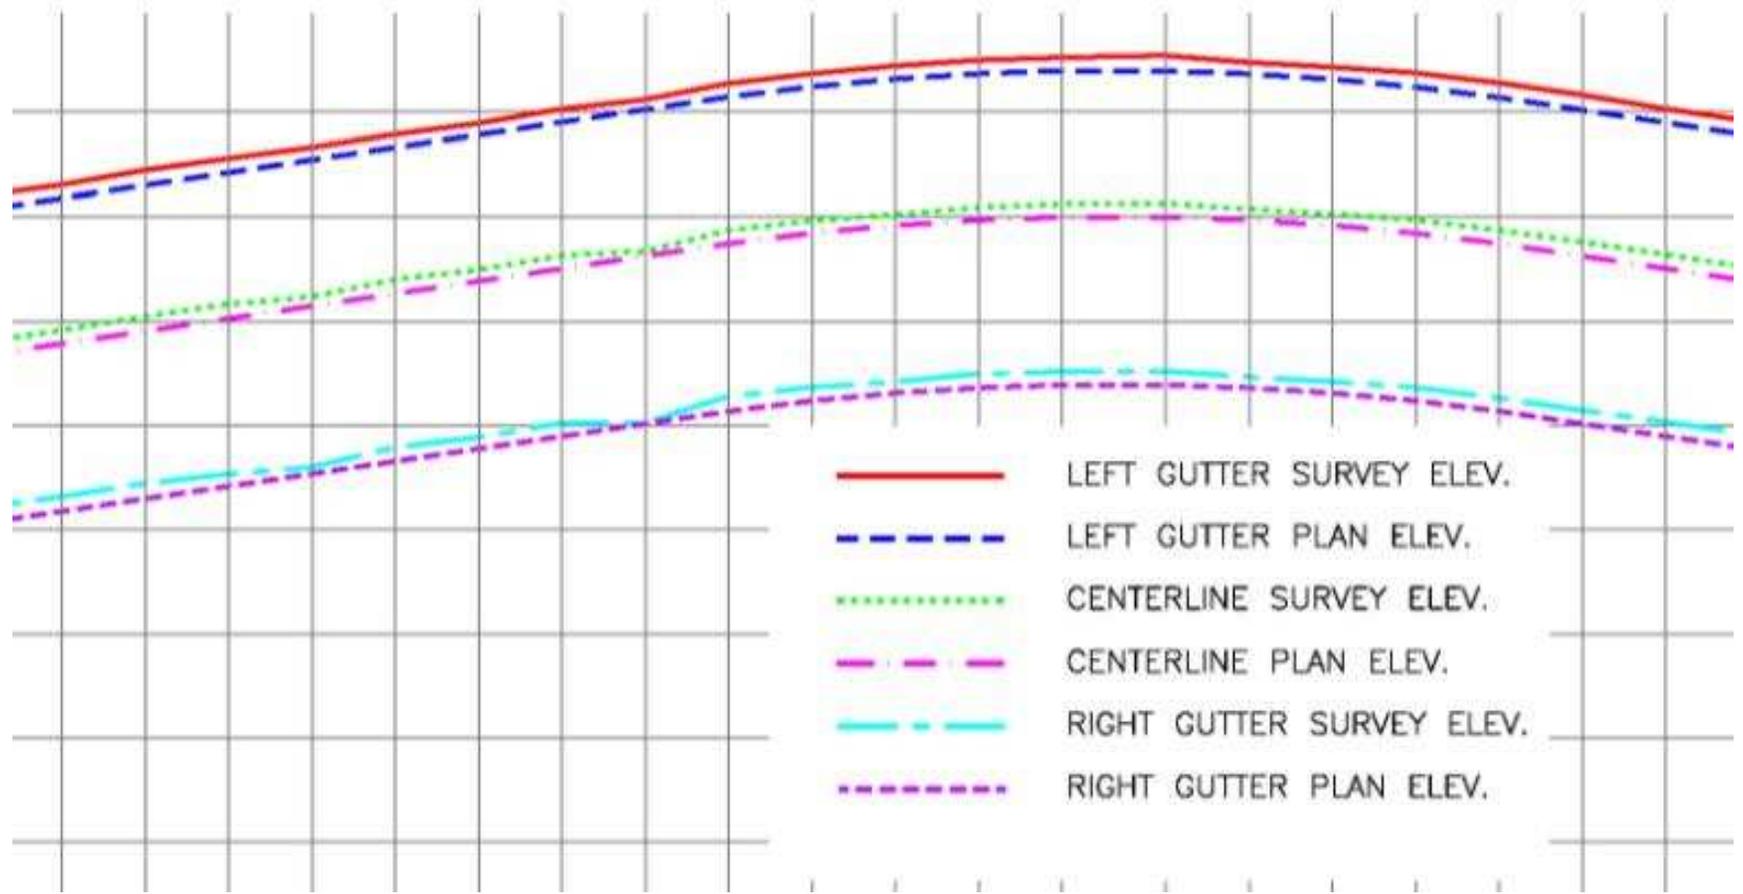
Survey & Settlement

Bent #	Scenarios	Settlement in inches (Heave in positive)		
		No shift in bench marks	Current bench mark is about 3 inches higher	Current bench mark is about 6 inches higher
7	Left gutter	1.92	-1.08	-4.08
	Centerline	1.08	-1.92	-4.92
	Right gutter	0.24	-2.76	-5.76
8	Left gutter	3.12	0.12	-2.88
	Centerline	-0.36	-3.36	-6.36
	Right gutter	-2.76	-5.76	-8.76
9	Left gutter	3.60	0.60	-2.40
	Centerline	3.12	0.12	-2.88
	Right gutter	2.16	-0.84	-3.84
11	Left gutter	2.64	-0.36	-3.36
	Centerline	-0.72	-3.72	-6.72
	Right gutter	-3.48	-6.48	-9.48
12	Left gutter	0.12	-2.88	-5.88
	Centerline	-1.80	-4.80	-7.80
	Right gutter	-3.60	-6.60	-9.60
13	Left gutter	3.00	0.00	-3.00
	Centerline	1.92	-1.08	-4.08
	Right gutter	0.60	-2.40	-5.40
29	Left gutter	3.48	0.48	-2.52
	Centerline	3.36	0.36	-2.64
	Right gutter	3.48	0.48	-2.52
30	Left gutter	3.24	0.24	-2.76
	Centerline	3.36	0.36	-2.64
	Right gutter	2.76	-0.24	-3.24
31	Left gutter	2.88	-0.12	-3.12

Centerline	2.16	-0.84	-3.84
	Right gutter	1.44	-1.56	-4.56
73	Left gutter	3.36	0.36	-2.64
	Centerline	3.12	0.12	-2.88
	Right gutter	3.24	0.24	-2.76
74	Left gutter	3.36	0.36	-2.64
	Centerline	3.76	0.76	-2.24
	Right gutter	3.36	0.36	-2.64
75	Left gutter	2.76	-0.24	-3.24
	Centerline	2.64	-0.36	-3.36
	Right gutter	2.88	-0.12	-3.12

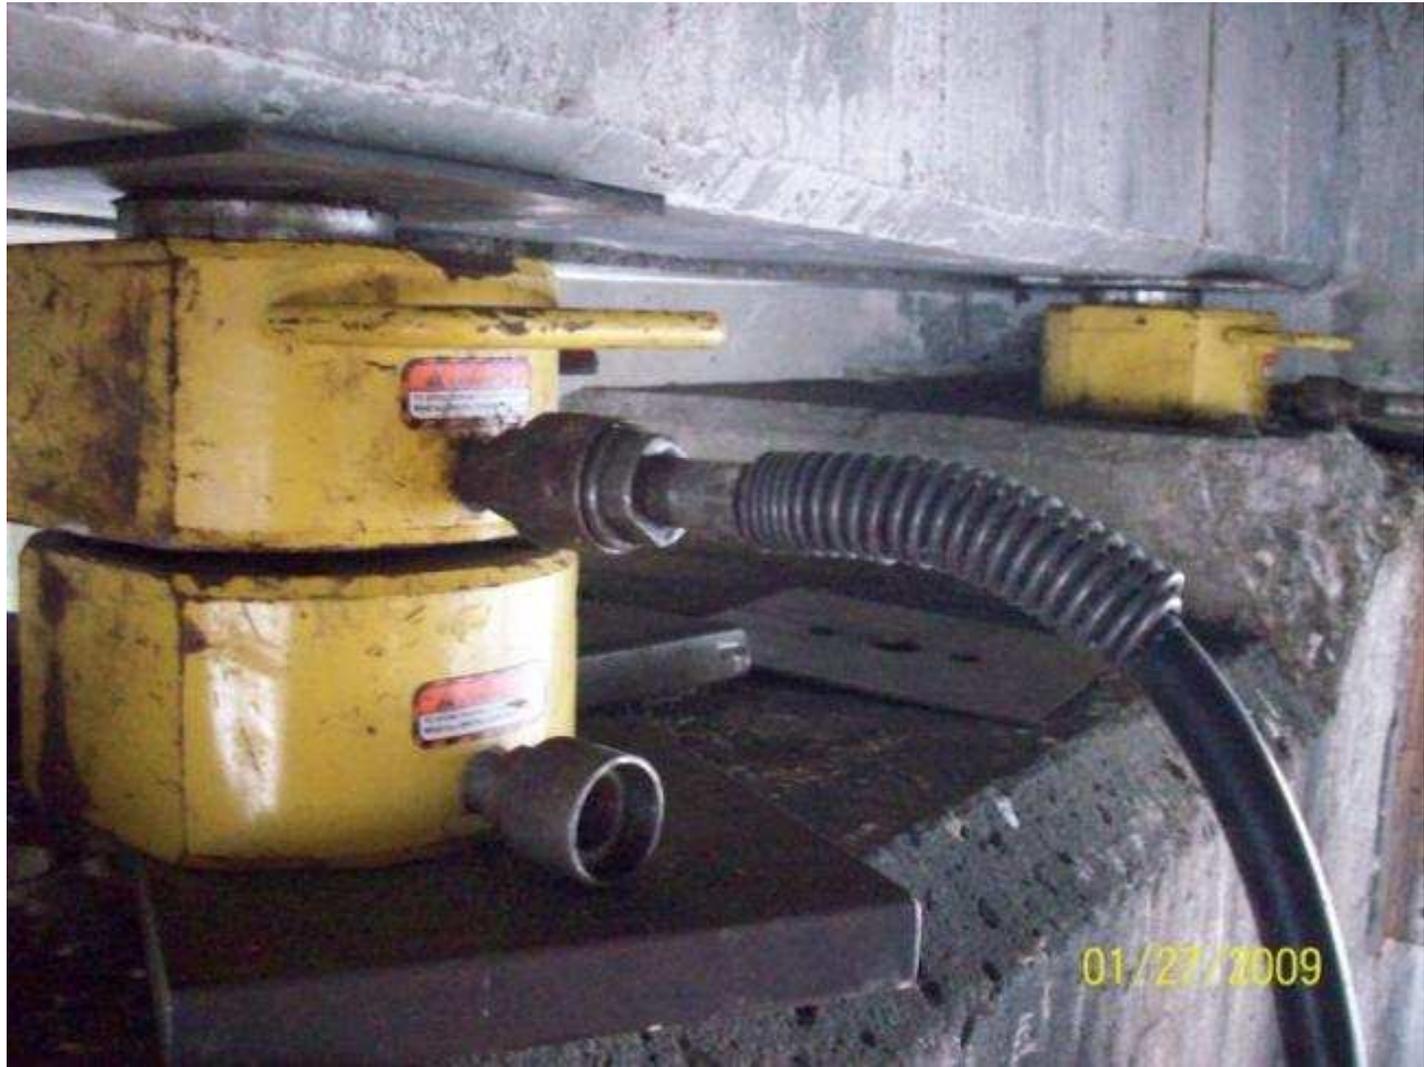
Sample Jacking

56th St over the Hillsborough River

- Based on the geotechnical assessment, KCA followed up with a repair design to correct the dips in the riding surface by jacking of the superstructure and shimming to original elevations
- Estimated cost of shimming ~ \$350,000
