# Cost-Effectively Extending Service Lives of Severely Deteriorated Concrete

**Substructures**  
NE Bridge Preservation Partnership  
September 29, 2010

***Siva Venugopalan***  
*Principal Engineer*  
*Siva Corrosion Services (SCS)*  
[Siva@SivaCorrosion.com](mailto:Siva@SivaCorrosion.com)  
[www.SivaCorrosion.com](http://www.SivaCorrosion.com)

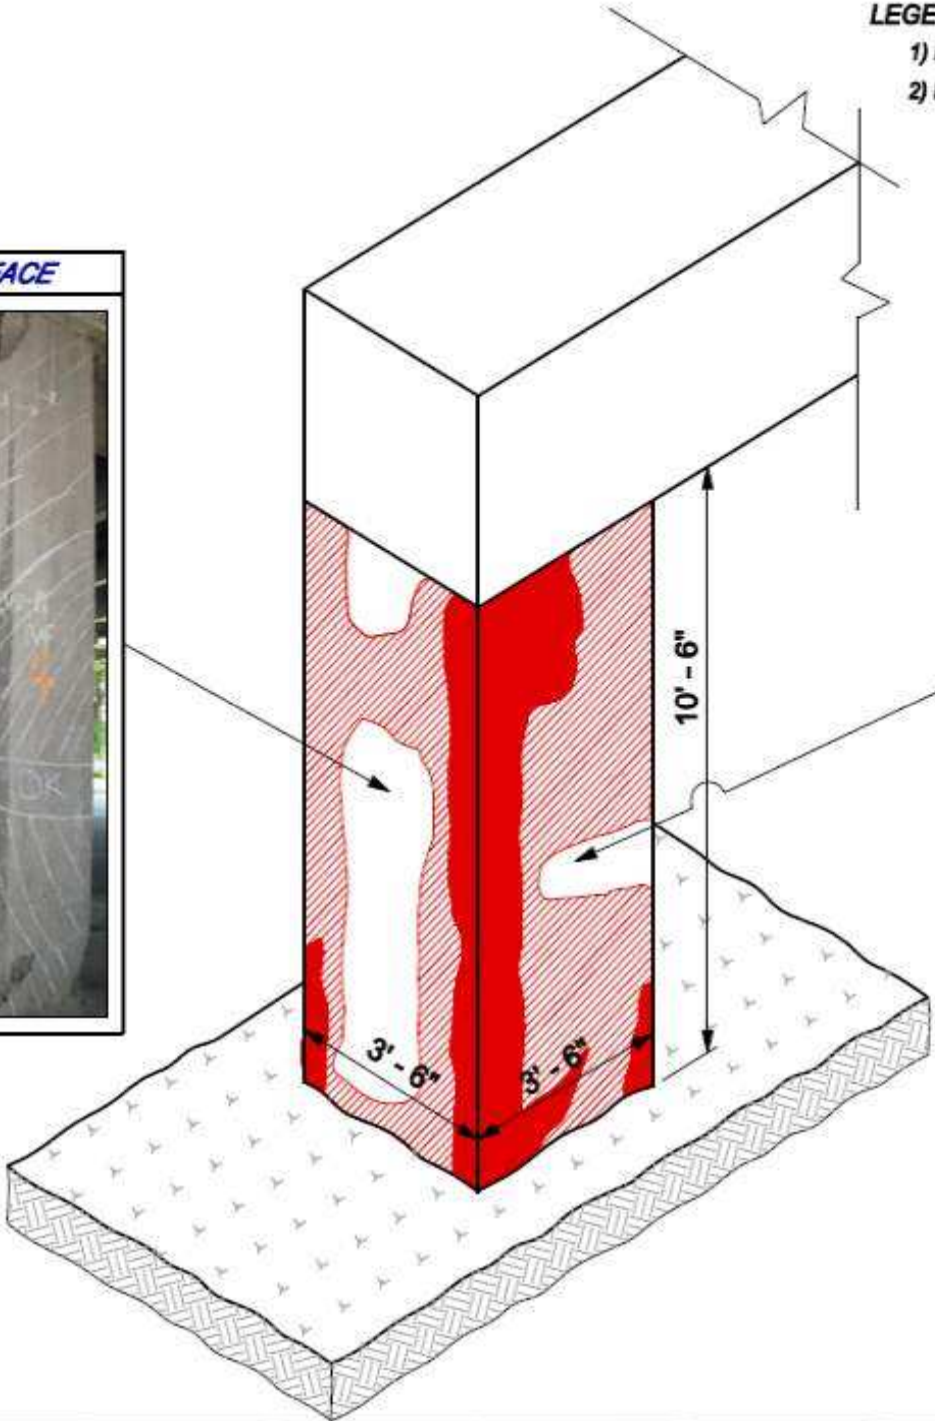
**PIER 1 COLUMN 2  
EAST/NORTH ELEVATION  
N.T.S.**

**PIER 1 COLUMN 2 EAST FACE**

COVER			HALF-CELL		
1.30	2.10	2.30	-333	-375	-390
2.30	2.15	1.85	-325	-307	-305
1.30	1.75	1.75	-391	-228	-342
2.60	1.65	2.00	-382	-178	-300
2.10	1.90	2.30	-255	-226	-268

**PIER 1 COLUMN 2 NORTH FACE**

COVER			HALF-CELL		
2.10	1.90	2.20	-370	-375	-347
2.15	1.90	2.35	-344	-258	-264
2.15	1.90	1.85	-328	-222	-240
2.15	1.90	1.90	-288	-233	-288
2.20	1.75	2.15	-300	-301	-248

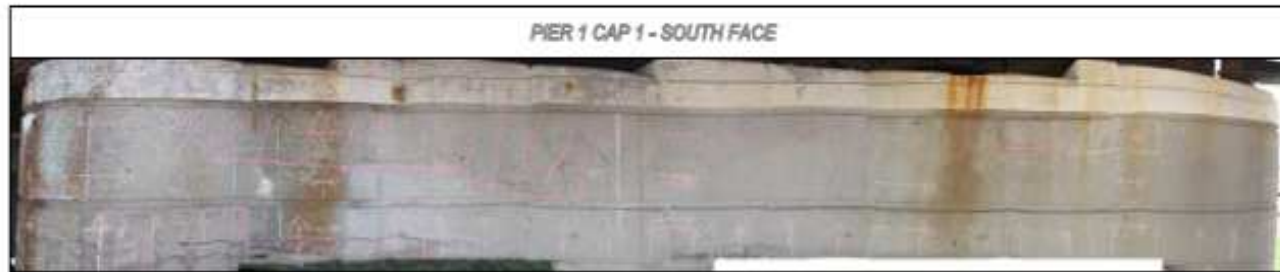
**PIER 1 CAP 1 - SOUTH FACE  
RAMP A OVER GARDEN STATE PARKWAY  
K.T.S.**

**WEST FACE**

**SOUTH FACE**

**EAST FACE**

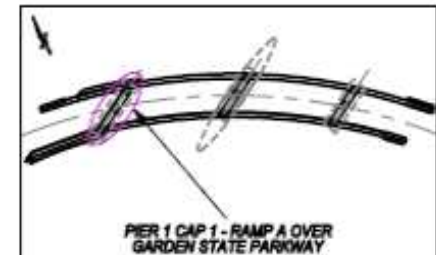
**PIER 1 CAP 1 - RAMP A OVER  
GARDEN STATE PARKWAY**

PIER 1 CAP 1 - RAMP A OVER GARDEN STATE PARKWAY														
COVER														
2.70	3.05	3.30	3.15	3.35	3.35	3.95	2.95	2.95	2.75	2.60	2.80	2.55	2.90	2.95
2.76	3.00	3.25	3.25	3.50	3.40	4.45	3.15	3.20	3.10	2.95	3.15	3.15	3.55	3.75
POTENTIAL														
-622	-386	-466	-432	-430	-433	-284	-249	-232	-223	-277	-517	-263	-82	-96
-541	-340	-450	-435	-305	-275	-206	-383	-298	-232	-218	-265	-130	-27	-109

\* NOTE: COVER & POTENTIAL READINGS TAKEN FROM CENTER LINE OF WEST FACE CAP END TO CENTER LINE OF EAST FACE CAP END.

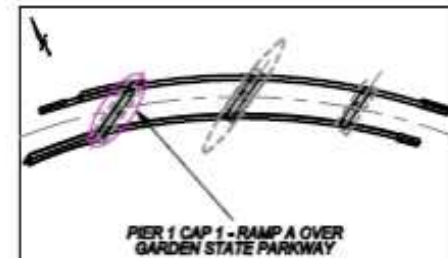
**PIER 1 CAP 1 - SOUTH FACE -  
RAMP A OVER GARDEN STATE PARKWAY**  
N.T.S.

**CHLORIDE TESTING LOCATIONS AND RESULTS**

LOCATION	DEPTH	Cl, WT % POWDER
SOUTH FACE - B2 - 1	0" - 1"	0.103
SOUTH FACE - B2 - 2	1" - 2"	0.038
SOUTH FACE - B2 - 3	2" - 3"	0.028
SOUTH FACE - B2 - 4	3" - 4"	0.011
SOUTH FACE - B2 - 5	4" - 5"	0.008
SOUTH FACE - B2 - 6	5" - 6"	0.007

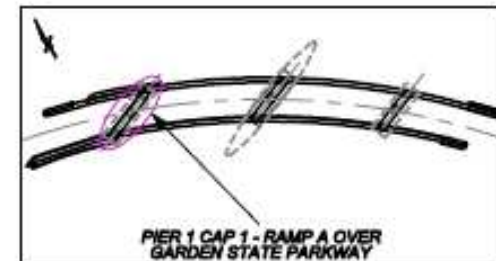
**PIER 1 CAP 1 - SOUTH FACE**  
**RAMP A OVER GARDEN STATE PARKWAY**  
 N.T.S.

\* NOTE: GPR READINGS TAKEN FROM CENTER LINE OF COLUMN 1 TO CENTER LINE OF COLUMN 3.
