Condition Assessment Guide for Bridge Coatings

Glenn A. Washer, Ph.D.

Midwest Bridge Preservation Partnership 2010

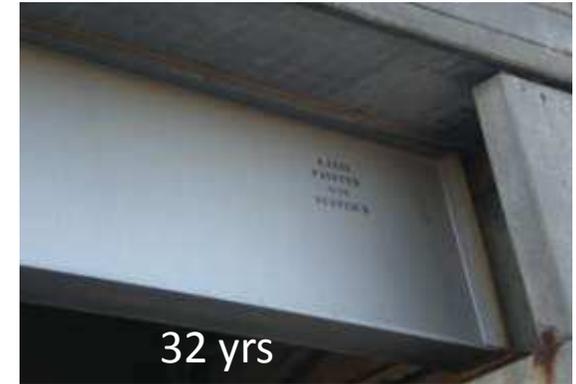
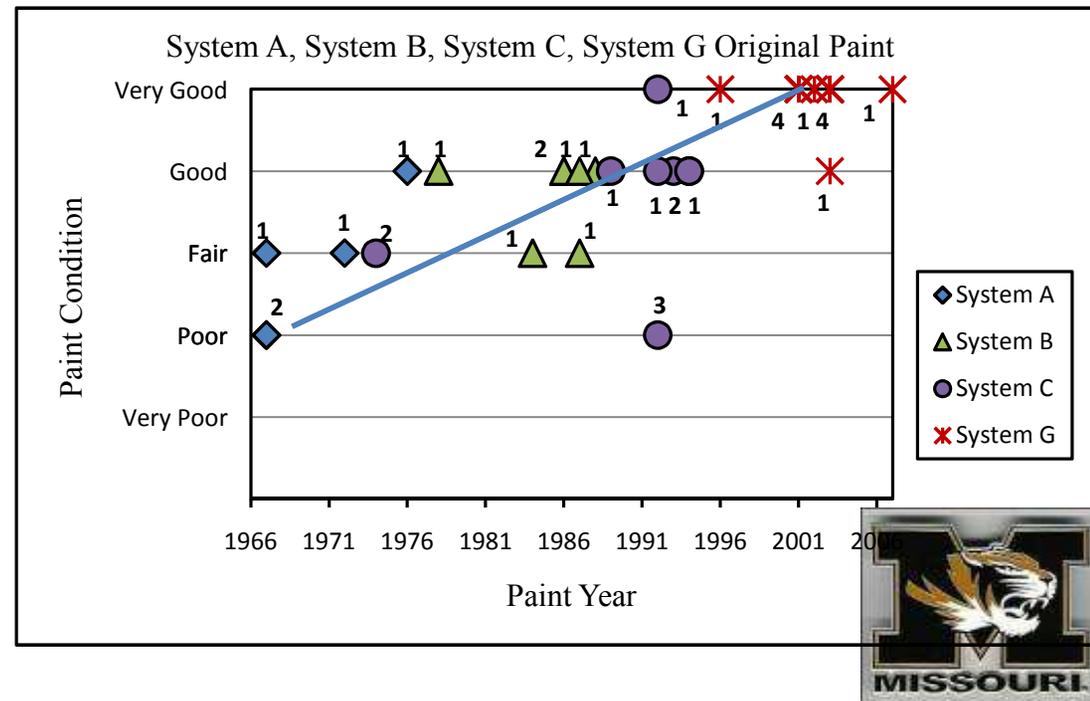
- System A, B and C
 - 33 system A, B or C
 - Worst are gone
- Systems with 35 to 40+ years of service in fair to good condition
- When in poor or very poor condition, correlates with direct drainage onto the structure
 - Deck drains, deteriorated saturated decks, joints

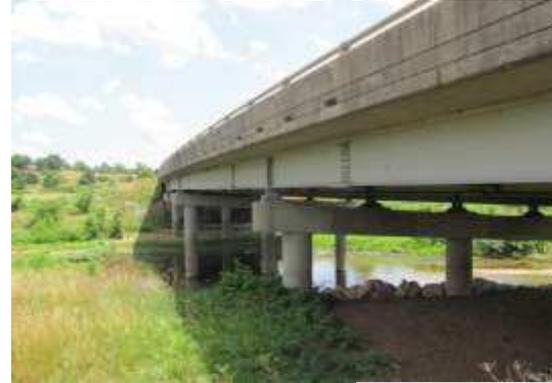
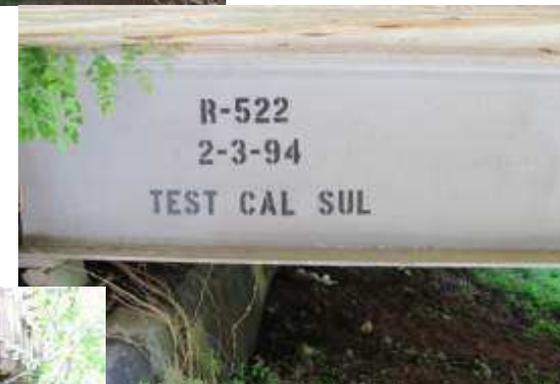
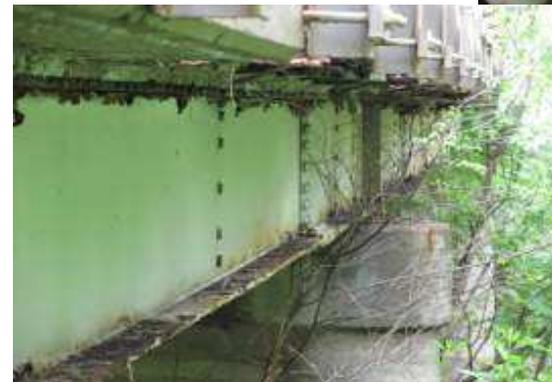
- System S coatings more than 5 years old (21)
- **81%** were in fair to good condition
- Poor condition = poor drainage
