# The Longevity and Performance of Diamond-Ground Pavements

by Shreenath Rao, H. Thomas Yu, and Michael I. Darter

Research & Development Bulletin RD118

**REFERENCE:** Rao, Shreenath, Yu, H. Thomas, and Darter, Michael I., *The Longevity and Performance of Diamond-Ground Pavements*, Research and Development Bulletin RD118, Portland Cement Association, Skokie, Illinois, U.S.A., 1999, 112 pages.

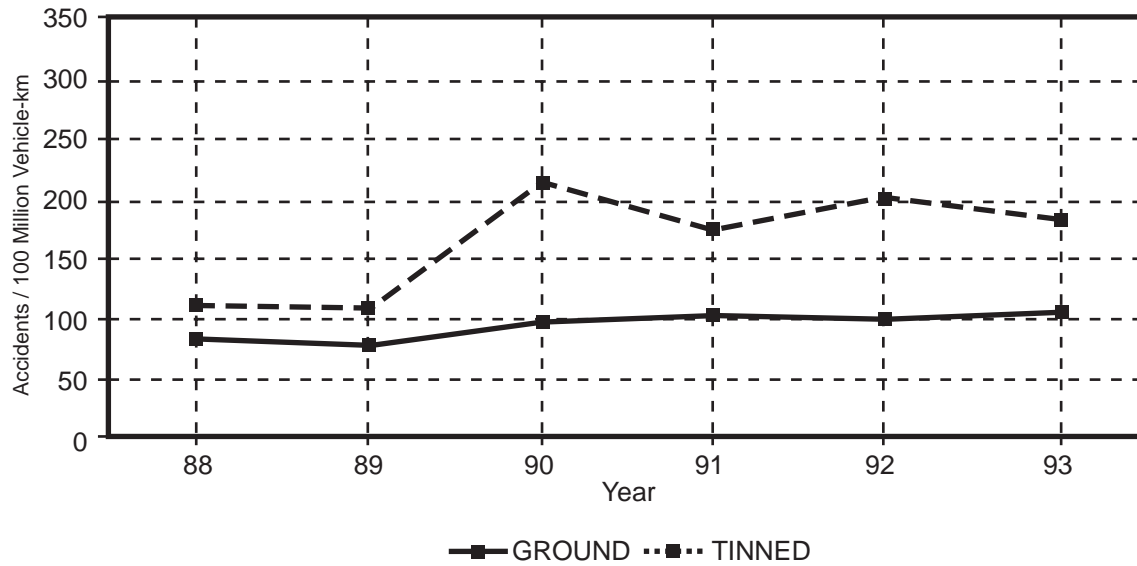
Figure 3. Wet pavement accident rates between 1988 and 1993 for diamond-ground and tined pavements (Drakopoulos et al. 1998)

The overall accident rates at diamond-ground sites were 60 percent of those at tined sites. For all types of pavement, diamond-ground pavements had significantly lower accident rates than tined pavements under all conditions. Figures 2 and 3 show all condition accident rates and wet-pavement accident rates for the 6-year period. No consistent trend in the deterioration of accident rates with time was observed. In

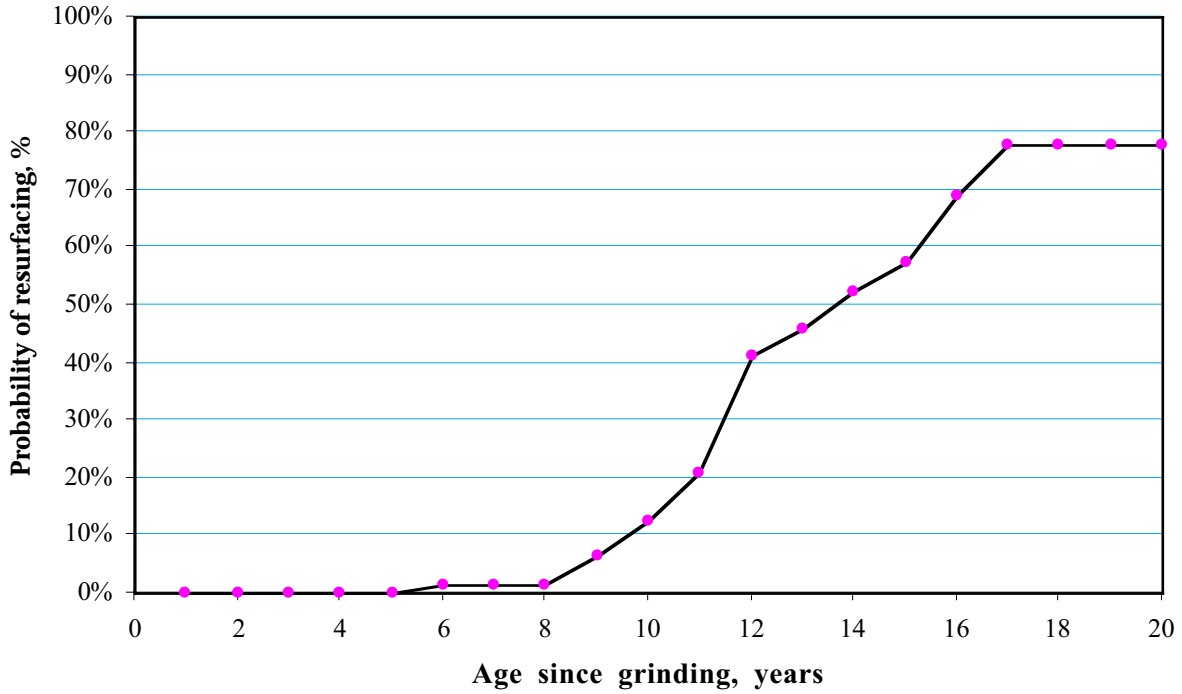
Figure 15. Survival curve showing probability of resurfacing (overlying, reconstruction, or regrinding) vs. age since first grind for diamond-ground pavements.

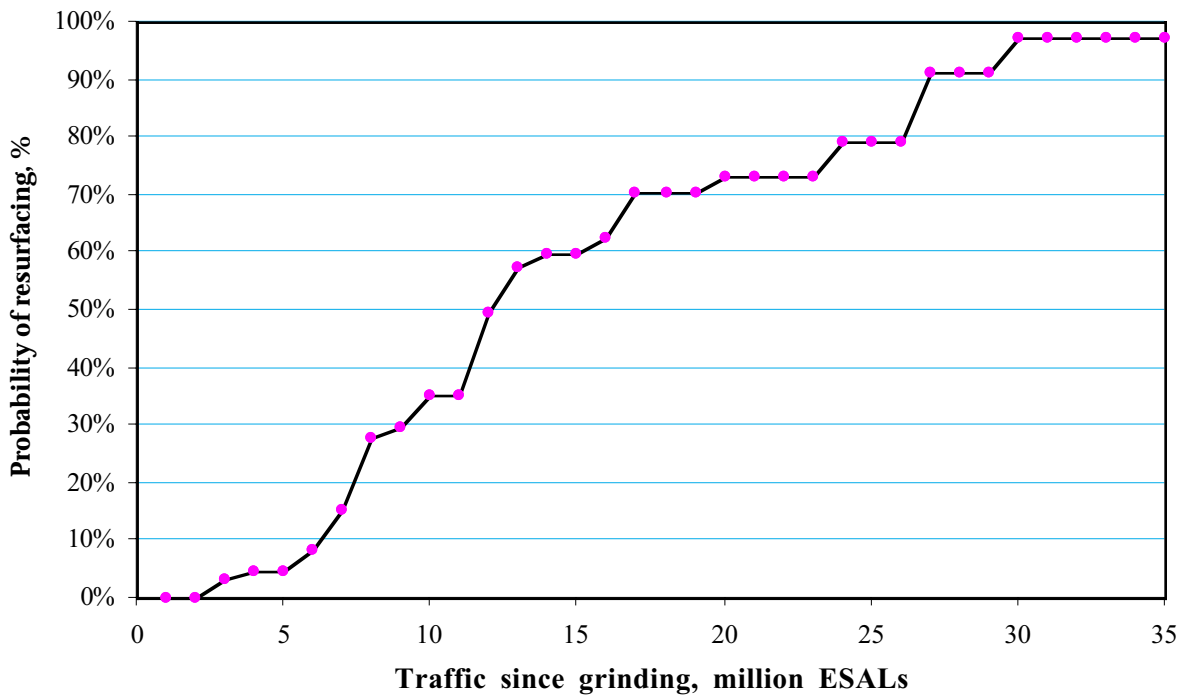
Figure 16. Survival curve showing probability of resurfacing (overlying, reconstruction, or regrinding) vs. traffic since first grind for diamond-ground pavements.

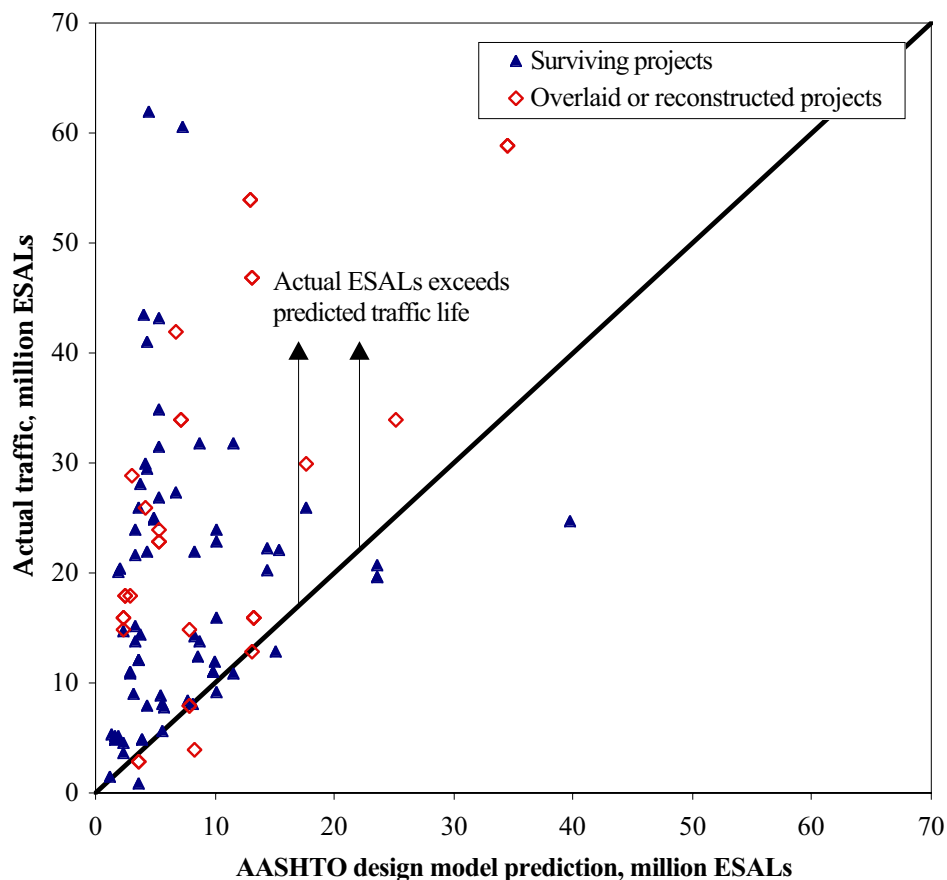
Figure 17. Actual cumulative traffic since initial construction vs. predicted traffic based on the AASHTO design procedure (50% reliability) for diamond grinding projects.

capacity for all pavements included in this study. Figure 17 shows a plot of predicted traffic based on the AASHTO procedure versus actual traffic carried by the diamond-ground pavements since initial construction. The 45-degree line shown in the graph corresponds to when the actual traffic carried by a pavement is equal to traffic predicted using the AASHTO design equations.

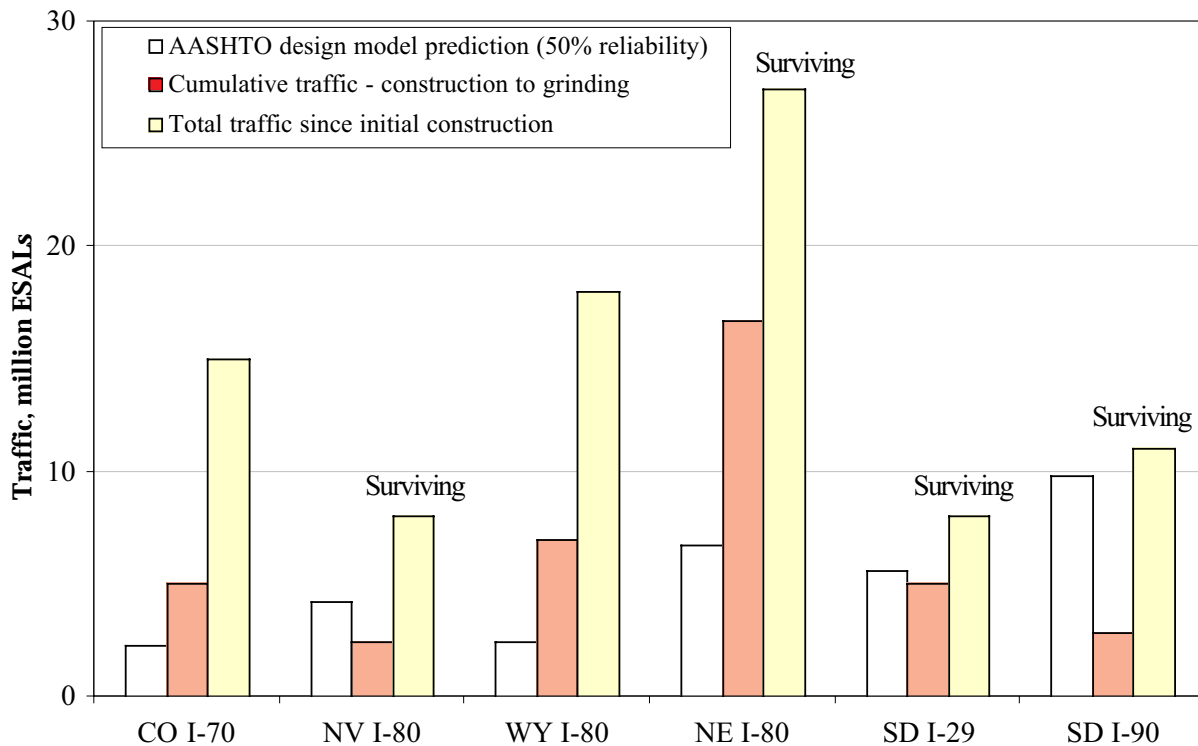
Figure 19. Predicted traffic based on the AASHTO design procedure and actual traffic since initial construction on diamond-ground projects in dry freeze climatic region.

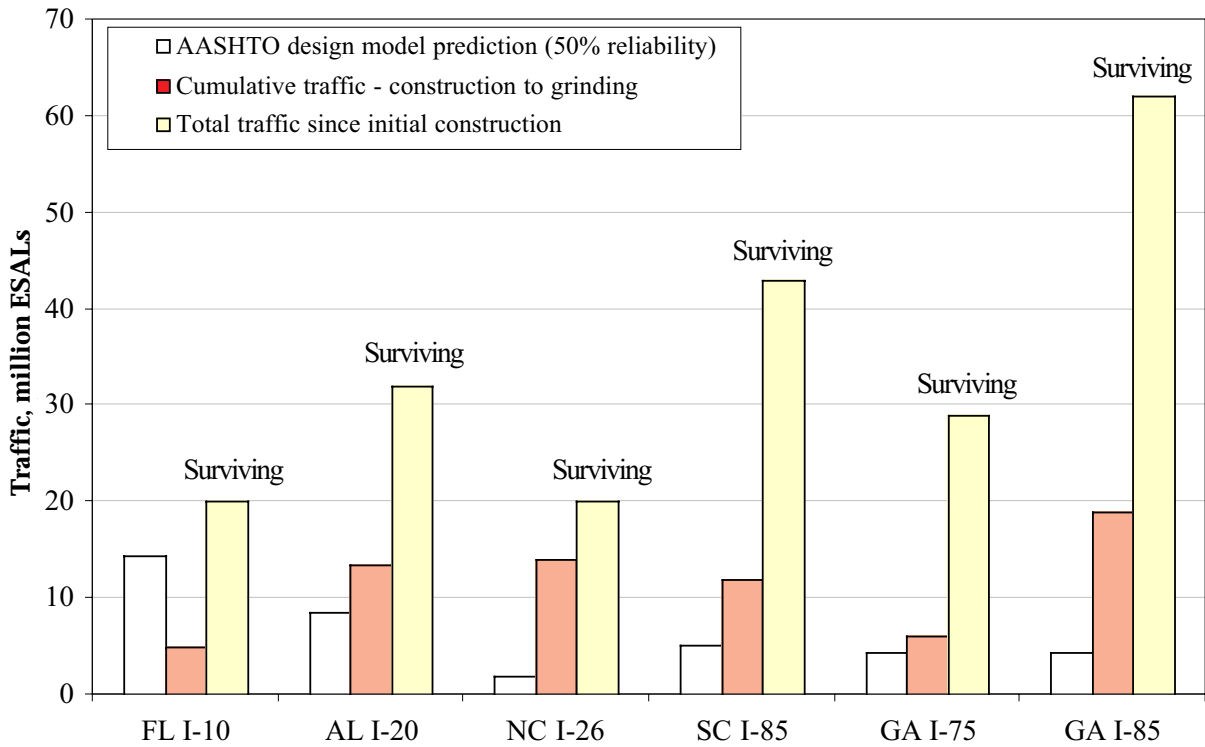
Figure 21. Predicted traffic based on the AASHTO design procedure and actual traffic since initial construction on diamond-ground projects in wet non-freeze climatic region.

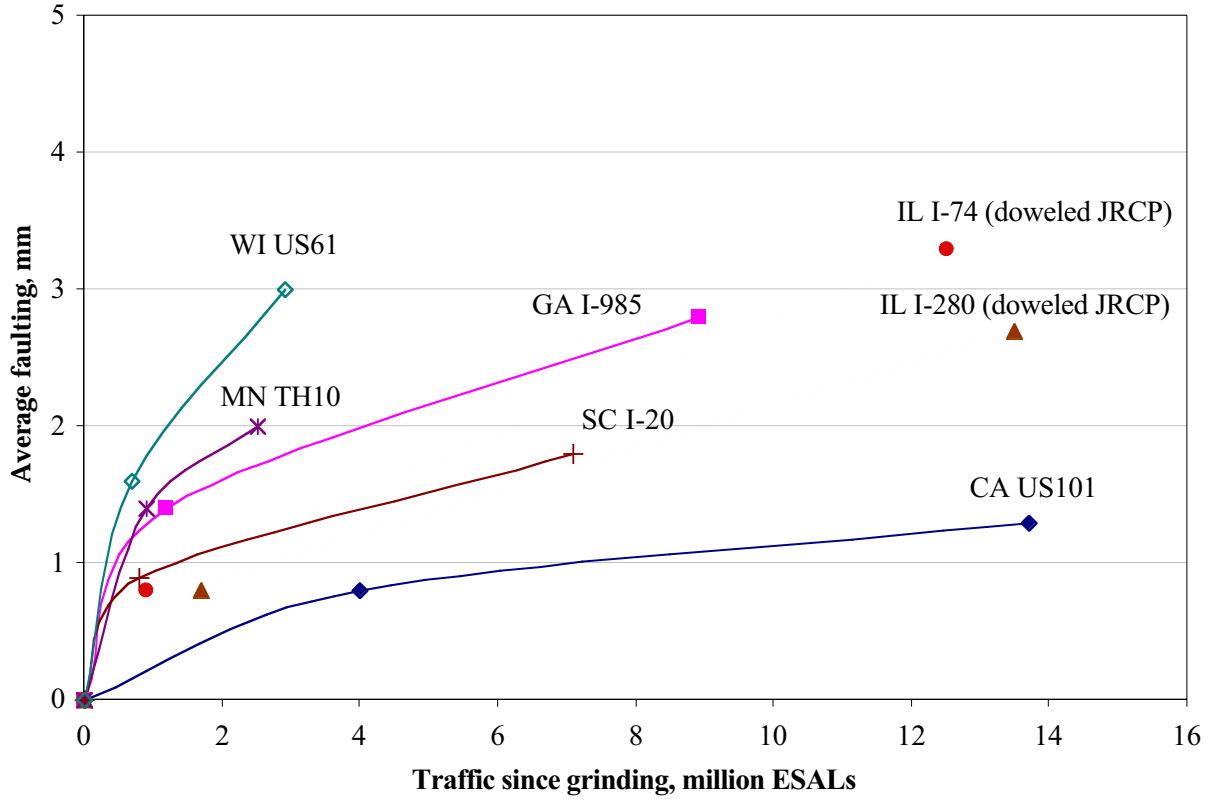
Figure 25. Time history faulting data (since diamond grinding) for projects surveyed for the 1986 FHWA study and resurveyed in 1997.

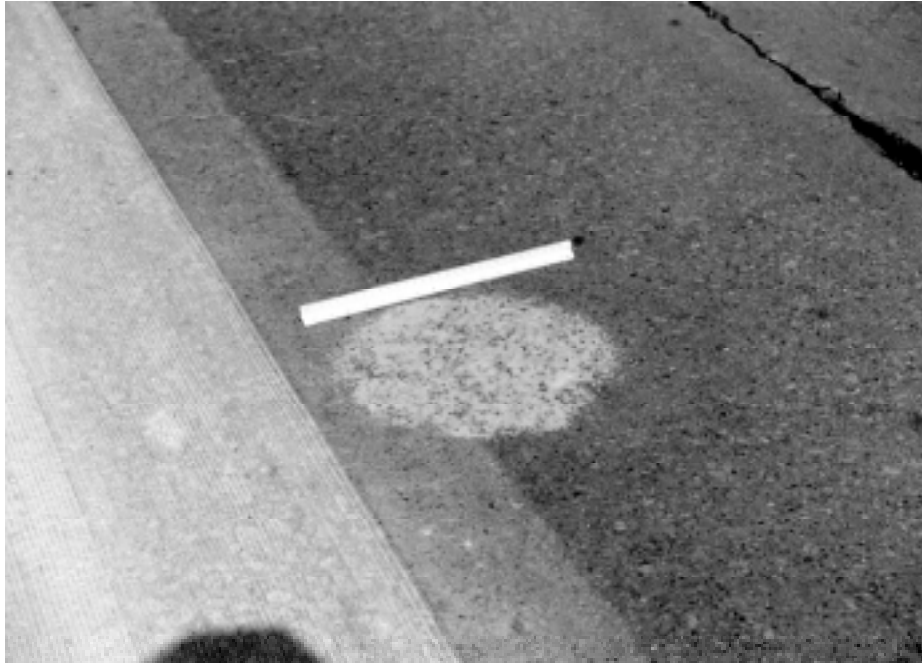
**Figure 32. Sand-patch measurement for nonground pavement.**

involves spreading a known volume of material (uniformly graded round glass beads) on a clean and dry pavement surface and measuring the area covered. The material spread on the surface completely fills the surface voids to the tips of the surface aggregate particles. The area covered by the material is related to the surface macrotexture, and the average depth between the bottom of the pavement surface and the tops of surface aggregate particles (the average macrotexture depth) can be determined from the known volume and the measured area. Figures 32 and 33 show the sand patch for typical ground and nonground pavements.

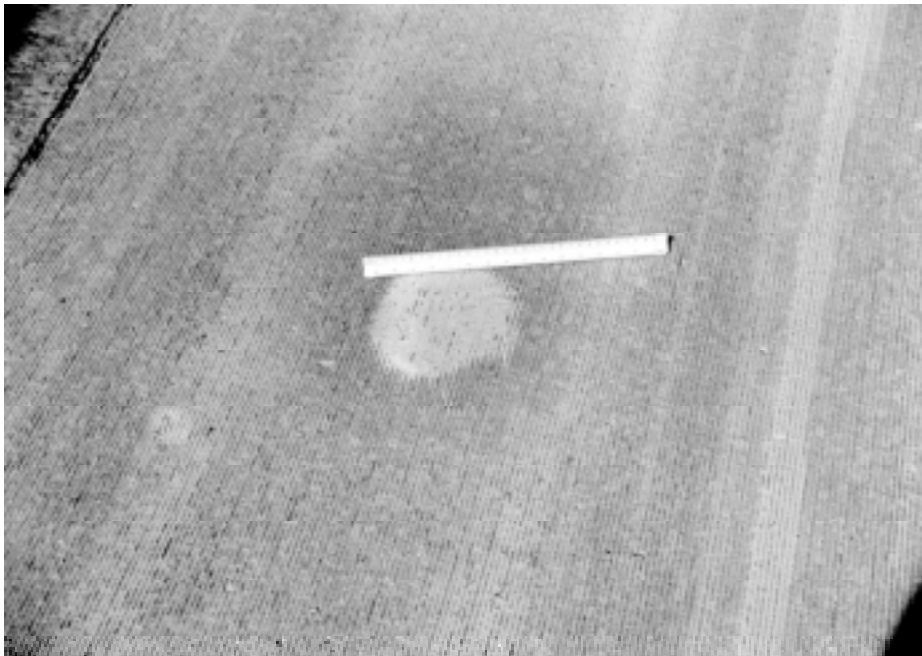
**Figure 33. Sand-patch measurement for newly ground pavement.**

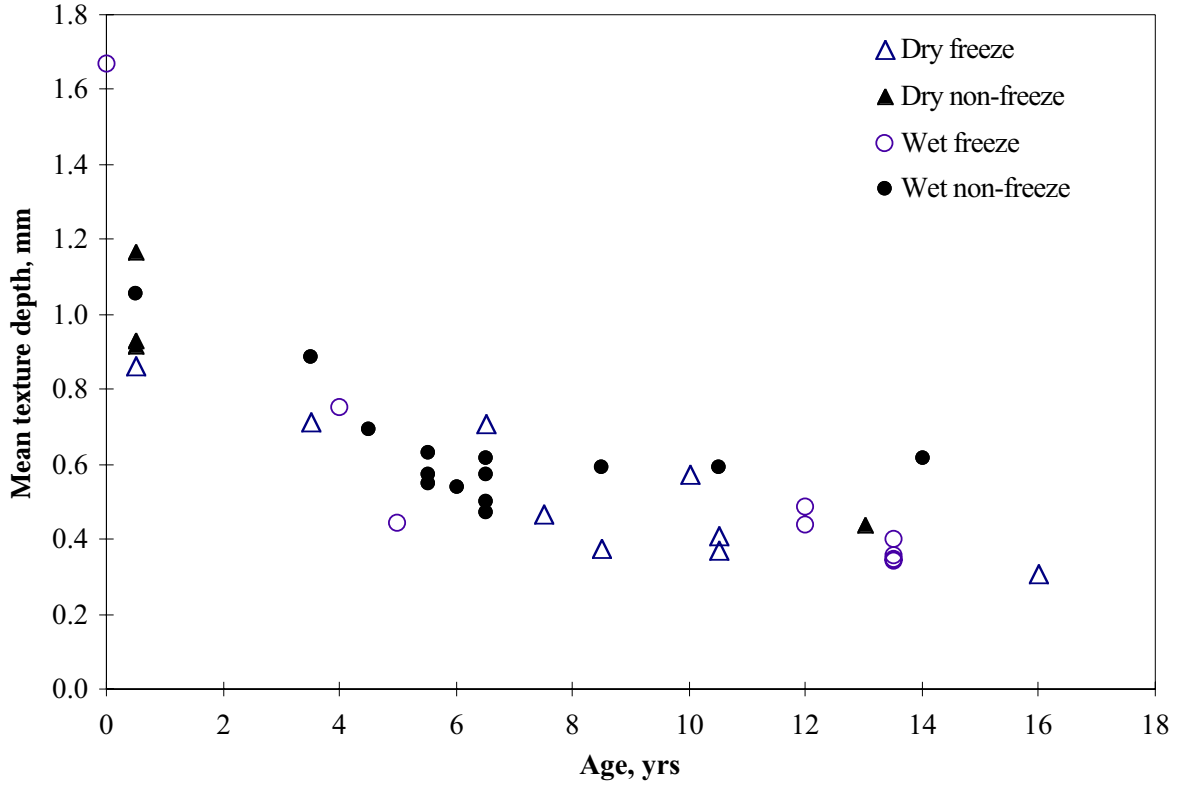
Figure 40. Mean texture depth vs. age since grinding, sorted by climatic region.

The mean texture depth for the 36 sections varied from a low value of 0.31 mm (0.012 in.) to a high value of 1.67 mm (0.066 in.) for a newly ground pavement. The average macrotexture value for the 36 pavements was 0.62 mm (0.024 in.), with an average age since grinding of 7.36 years. Figures 40, 41, and 42 show the measured mean texture depth versus age since grinding, ESALs since grinding, and cumulative vehicle passes since grinding, respectively, sorted by climatic

Figures 40 through 44 suggest that mean texture depth is strongly dependent on age since grinding (and, to a lesser extent, traffic since grinding). The mean texture depth for diamond-ground pavements is also evenly distributed between wet and dry climatic regions. However, many diamond-ground pavements in both the wet freeze and dry freeze climatic regions seem to have lower macrotexture than those in the non-freeze climatic regions, especially for pavements with grinding more than 8 years old. The use of winter mainte-

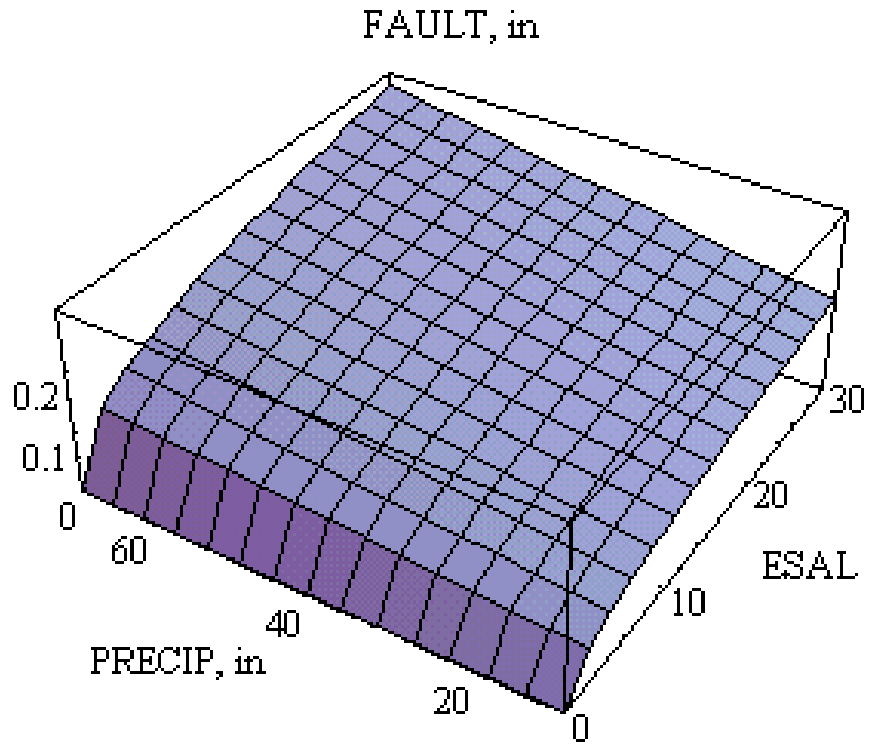
Figure A-5. Effect of traffic and precipitation on joint faulting (fine subgrade).

Figures A-3 through A-6 show sensitivity analyses of key variables in the faulting model for diamond-ground pavements. The plots show that faulting always increases with traffic; an increase in PCC thickness decreases predicted faulting, whereas increases in joint spacing and precipitation increase faulting.
