# Rehabilitating Bridge Substructures with FRP Materials

Midwest Bridge Preservation Partnership 2010 Annual Meeting, Detroit, MI

Presented by: William J. Gold, P.E. Engineering Services Manager BASF Corporation

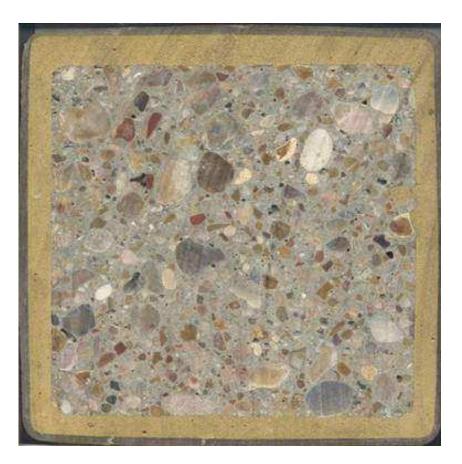
#### **Complete Encapsulation**

FRP Jacket Epoxy Grout Infill Complete Coverage of Grout Well Bonded to the Pile

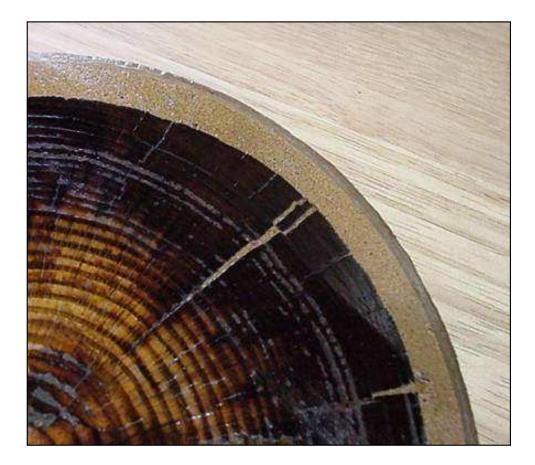
#### **Complete Encapsulation**

Epoxy Grout is pumped under pressure Grout penetrates into cracks and voids in the substrate

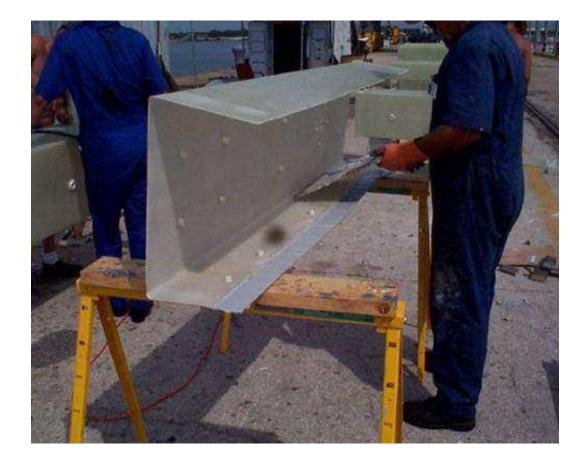
## **Purpose Designed FRP Jackets**

- Appropriately sized FRP Jackets Delivered to Site
- Polymer Stand-offs
- Seam adhesive applied on deck

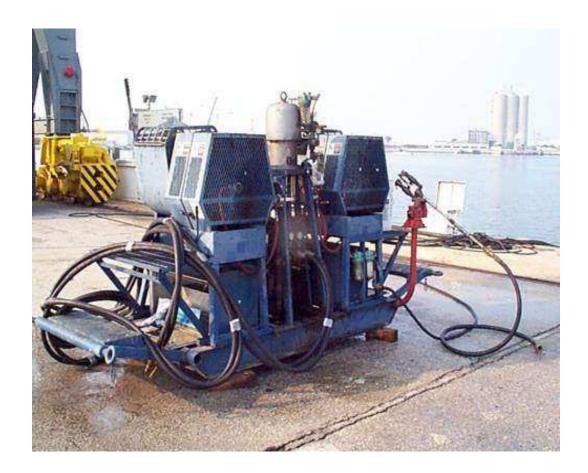
- Plural component grout plant
- Part A & Part B mixed with sand in each hopper

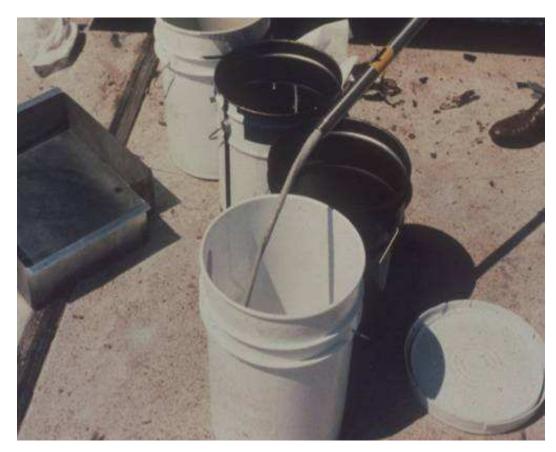
Fluid sand-filled epoxy grout is dispensed out of the mixer

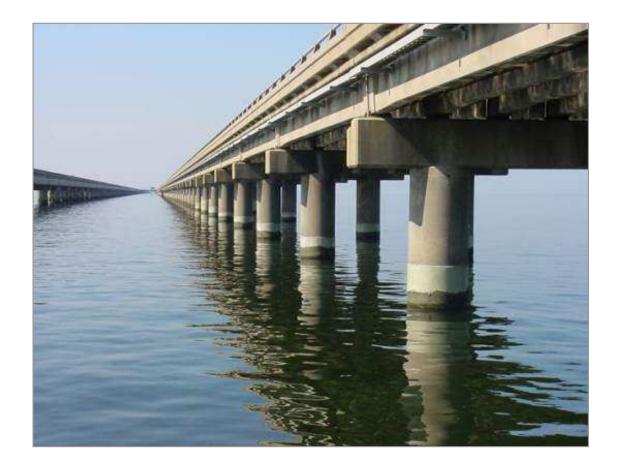
#### **Pile Encapsulation**

- Started in 1988 still ongoing
- 26 mile long bridge
- 54" diameter concrete cylinder piles

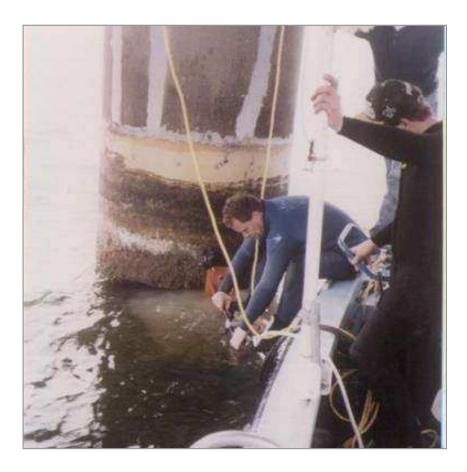
Coring 13-year old encapsulations

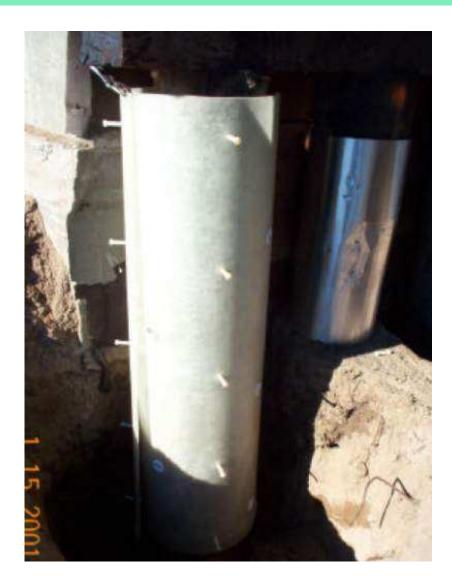
### **Stockton California Bridge**

FRP Jackets with adjustable standoffs

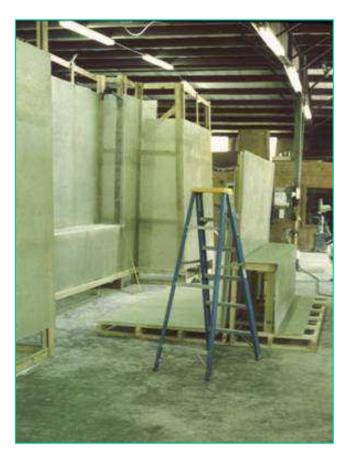
## Warren Road Bridge, Baltimore, Maryland

#### **Pier Encapsulation:**

- Large concrete pier
- Jacket Fabrication
