Evaluation & Life Extension *of Cable Stayed Bridges*

*Southeast Bridge Preservation
Partnership – April 28, 2010*

CABLE STAYED BRIDGE – KENTUCKY / INDIANA

MID-BAY BRIDGE – FLORIDA

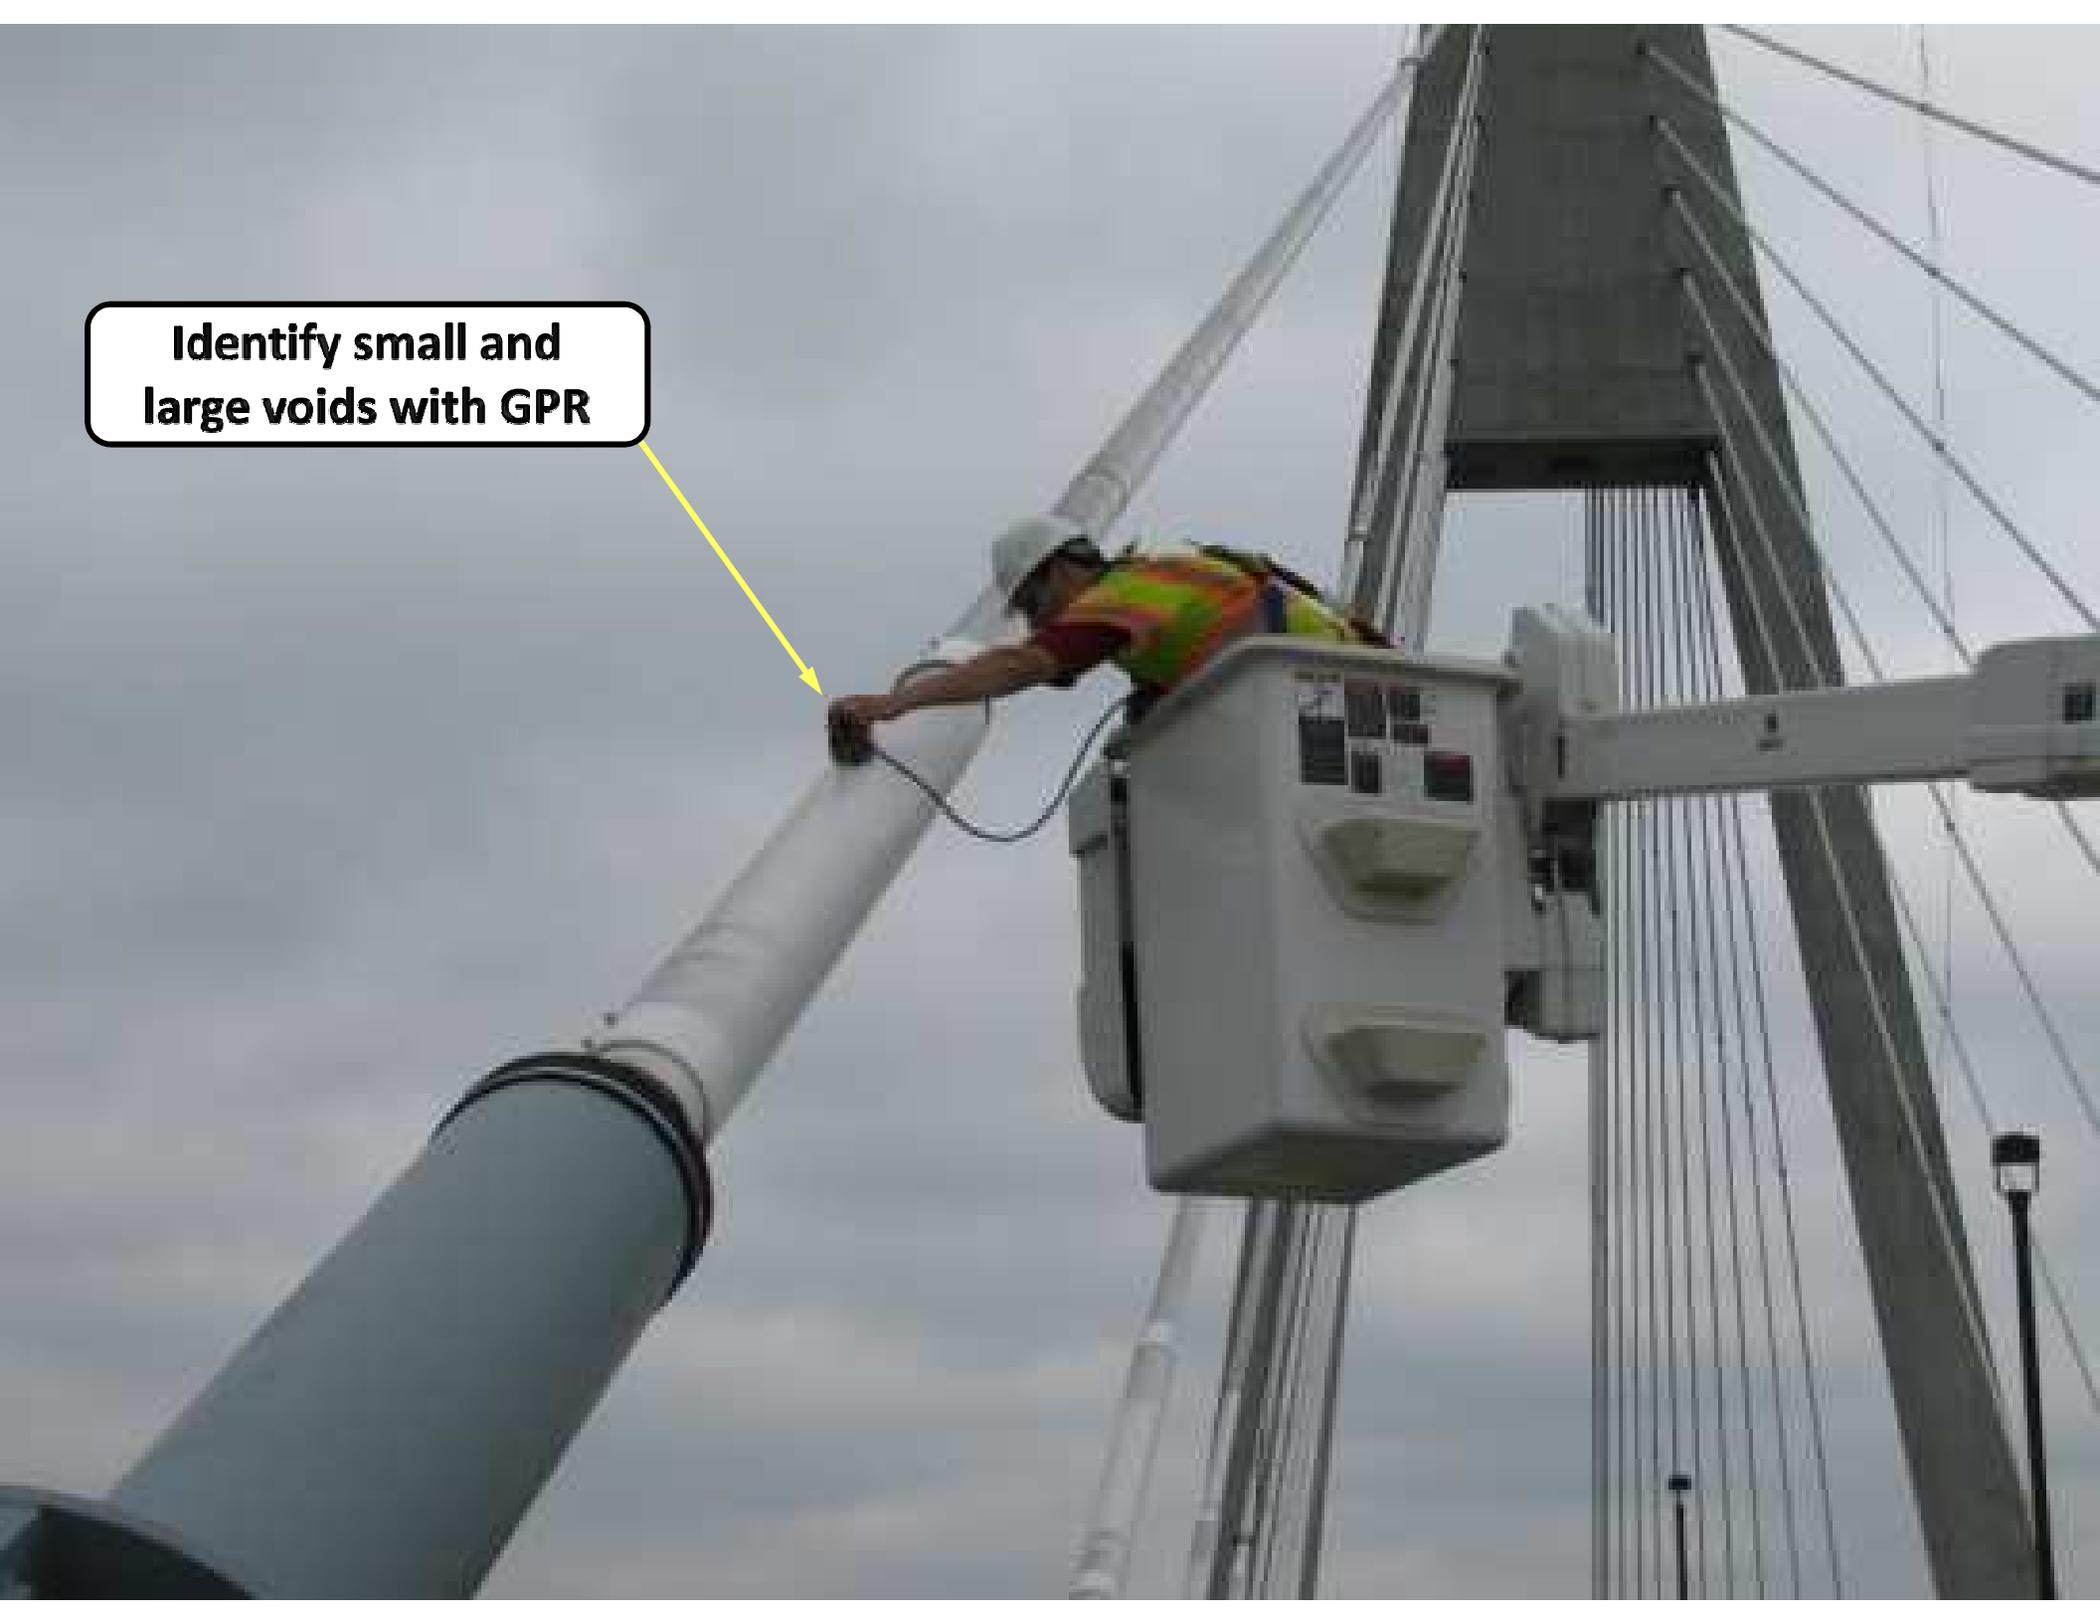
Identify small and large voids with GPR

- **Electrical continuity of strands**
- **Void locations using GPR and thermography**
- **Grout quality and protective properties using corrosion rate tests and specific laboratory tests**
- **Determine wire/strand break using Magnetic Flux Leakage – then visual confirmation at select locations**
