Route 26 Bridge Patch May Have Big Consequences

Bridge Maintenance Experts Repair Technology Applied

How to Evaluate MALP Concrete to Route 26 Span

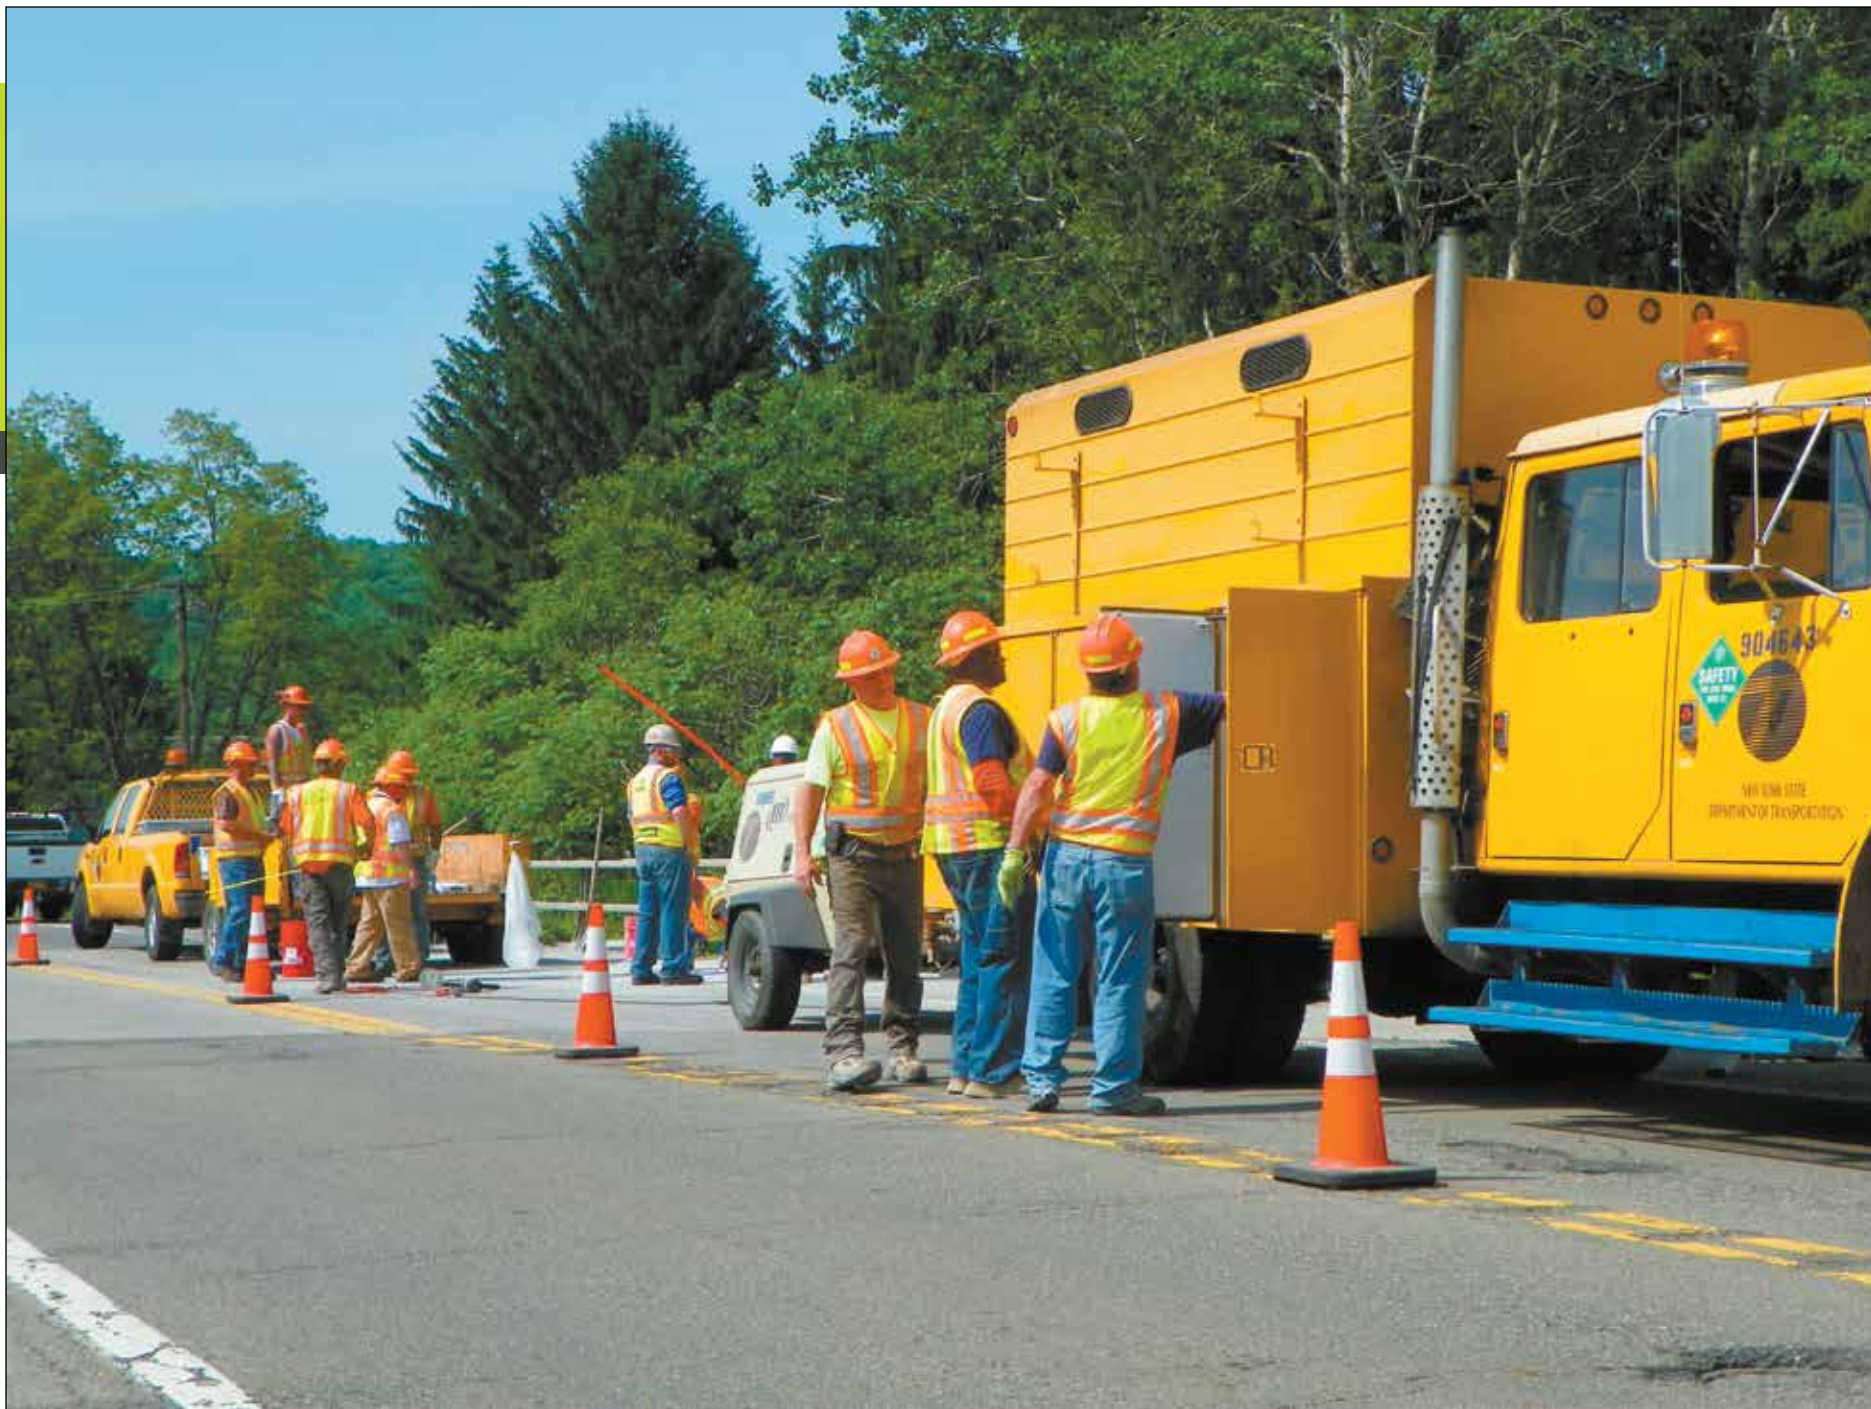
Maintenance crew prepares for demonstration of MALP concrete repair technology on Route 26 bridge over Nanticoke Creek in Maine, New York.

Using a repair product based on magnesium aluminum liquid phosphate (MALP) binder technology, Region 9 maintenance workers patched a deteriorated section of deck of a small bridge carrying Route 26 over Nanticoke Creek.

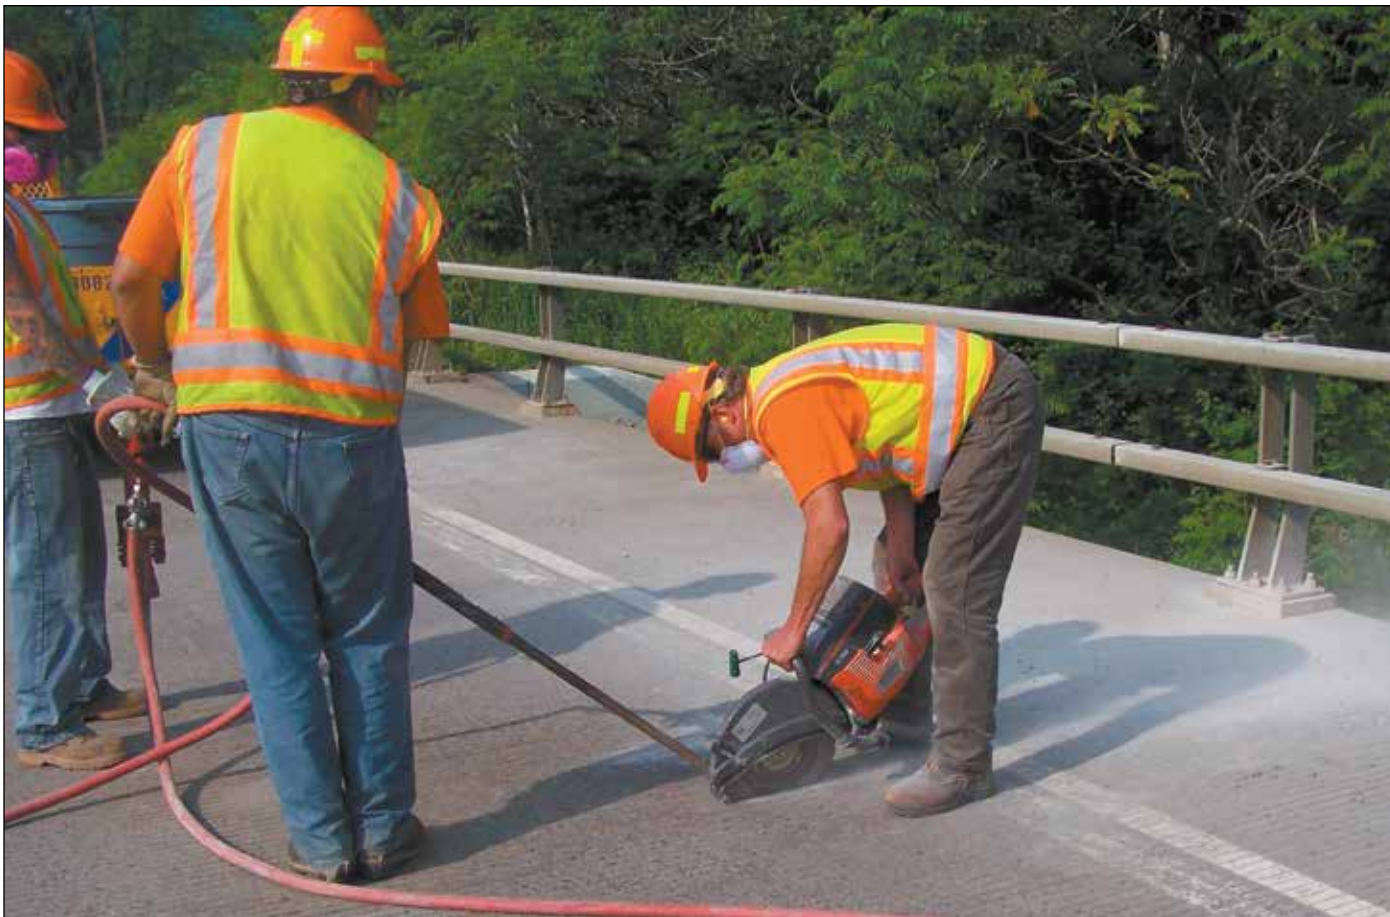
Sawcut is made delineating deteriorated section of concrete deck to be removed for patching demonstration.

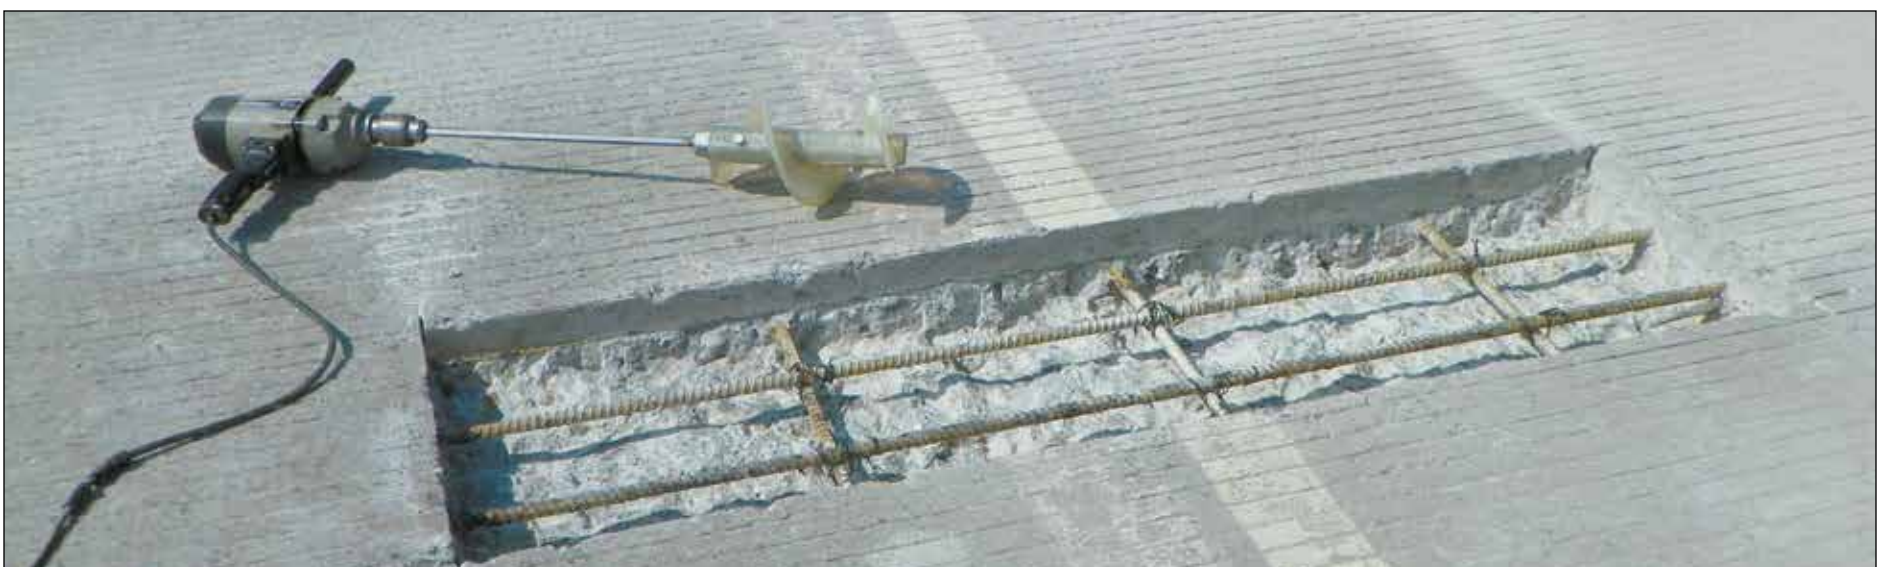
With loose and damaged concrete removed, the section is ready for patching material. Note heavy-duty drill and auger used to mix two patching ingredients.

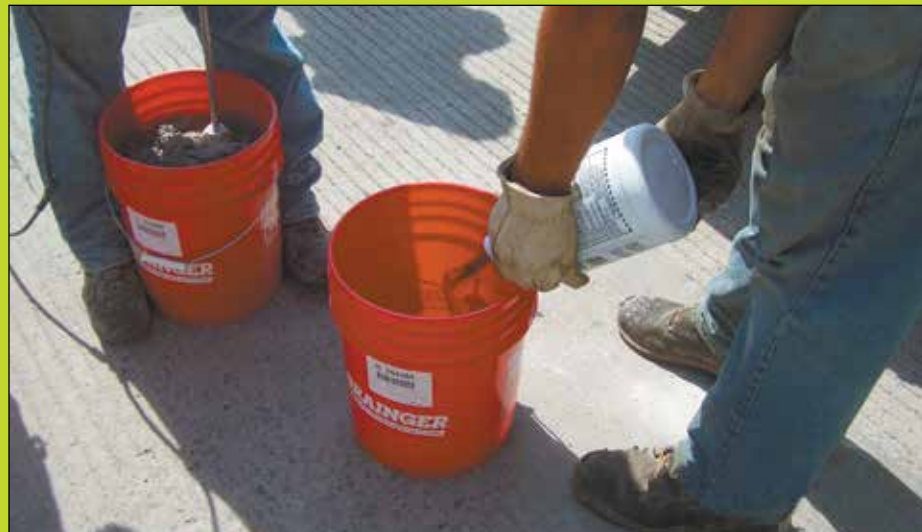
While one 5 gallon pail of powder and liquid activator are mixed with auger, a second pail receives activator for second batch.

Phoscrete's products incorporate a pre-packaged magnesium-alumina-aggregate dry powder and a mono-aluminum-liquid phosphate activator. The two ingredients are mixed at the job site in 5 gallon pails or with paddle-style mortar mixers, or it is pre-mixed and introduced to shotcrete apparatus for spraying on vertical, slanted or overhead surfaces. No water is used in MALP concrete.

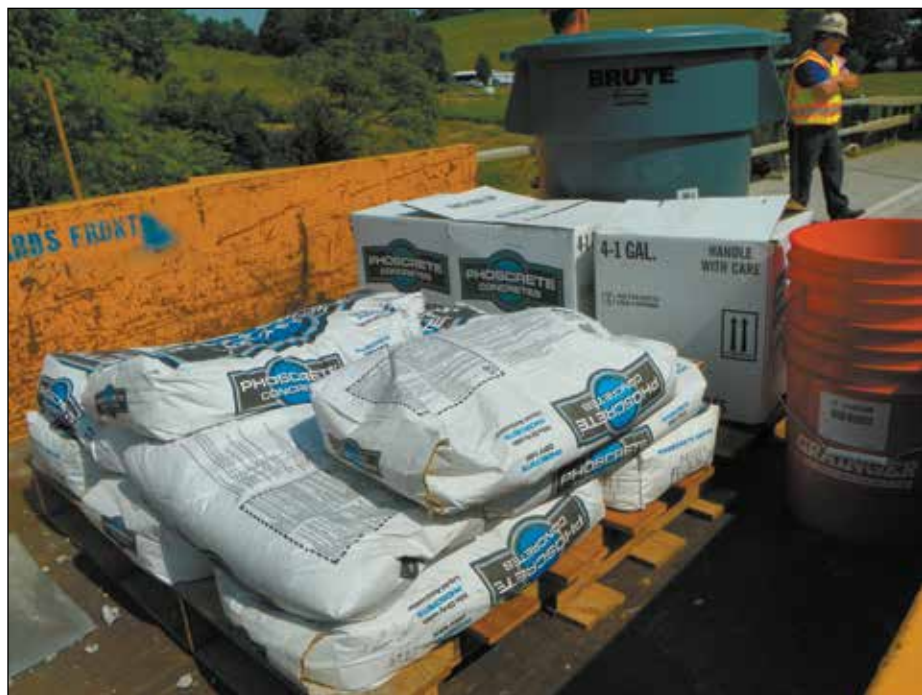
Pallet of magnesium-alumina-aggregate dry powder and containers of mono-aluminum-liquid phosphate activator are stored on trailer till needed for job-site mixing.

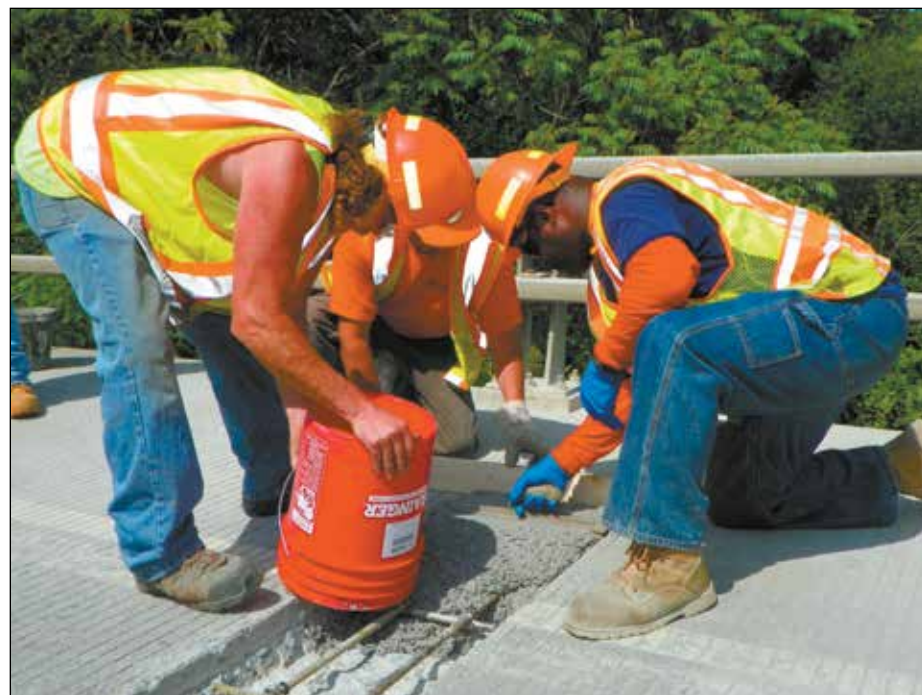
A worker deposits MALP concrete into the repair section as two others screed the fast-setting material.

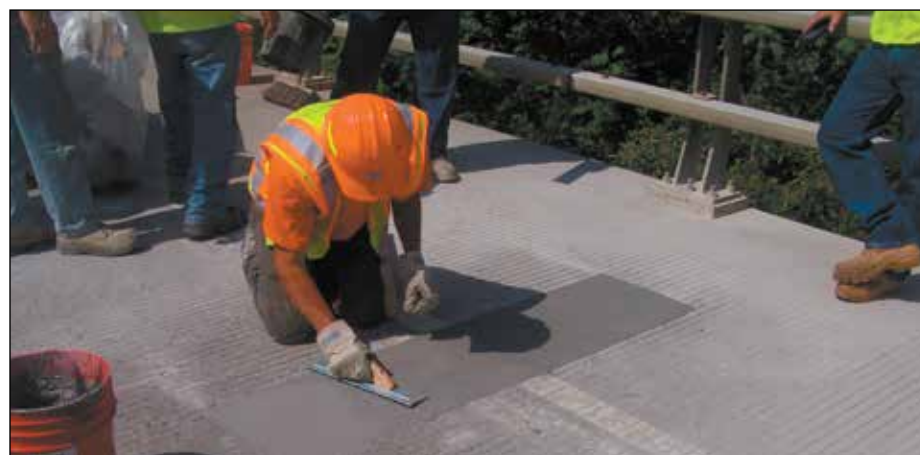
Standard trowels and floats are used to finish the material, which will set up to a compressive strength of 4,000 psi in one hour and more than 7,000 psi in 7 days.

Physical properties determined by ASTM standard testing procedures of MALP technology concrete include a compressive strength of 4,000 psi in one hour and more than 7,000 psi in 7 days (ASTM test C109); and flexural strength modulus of rupture of 450 psi in one day and 500 psi in 7 days (C78). Results of other ASTM tests show the material doesn't exhibit shrinkage cracking, with a negligible percentage of length change after 28 days of .05 or -0.05 depending on water-curing or air-curing methods (C157); in addition, it has a low chloride ion permeability of 0.32 (C1152); and high bond strength by slant shear testing of 1,000 psi after 7 days (C882).
