CONCRETE PAVEMENT REHABILITATION

Guide for Load Transfer Restoration

Federal Highway Administration

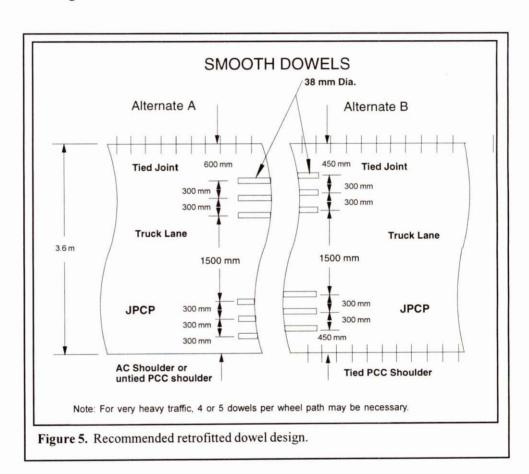
Recommended layouts for retrofitted dowels with and without tied PCC shoulders is depicted in figure 5. [2] The dowel bars, including the ends, should be epoxy coated for corrosion resistance. The first dowel should be placed no more than 300 mm from the edge of the truck lane when there are asphalt shoulders. If tied concrete shoulders with

high deflection load transfer are present, the distance from the first dowel bar to the longitudinal joint can be increased to a maximum of 450 mm. This will also help avoid cutting the existing tie bars.

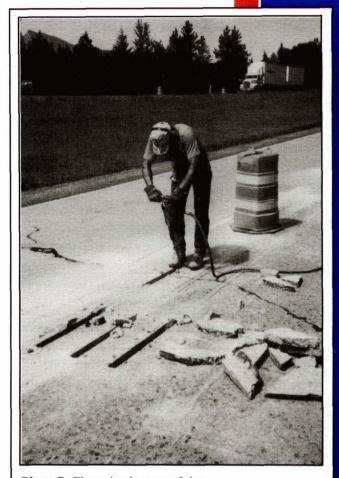
Photo 7. Flattening bottom of slot.

Preparation of slots constructed with diamond saws consists of removing the concrete fins, flattening the bottom, slot cleaning, and caulking the joint or crack in the slot. Small hand-held jackhammers (15 kg or less) should be used to remove the fins. Larger jackhammers may break through the concrete. If the concrete is broken, the joint or crack will require full-depth repair.

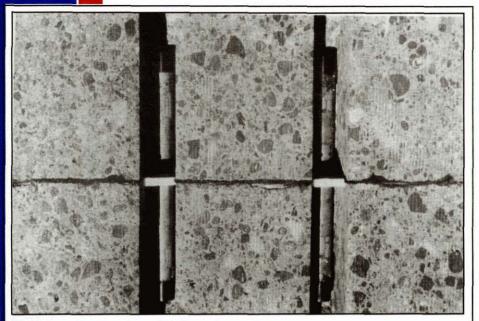
Photo 8. Dowels in place ready for concrete placement.

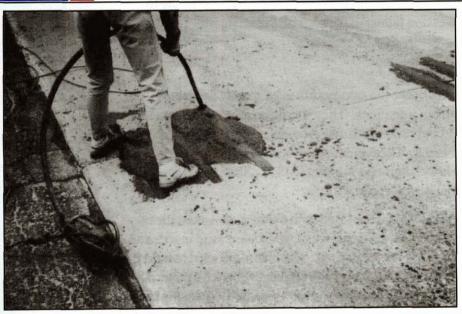
Photo 9. Consolidating the backfill material.

The backfill material should be placed into the slots and consolidated with a small spud vibrator. Care must be taken not to hit the dowel with the vibrator. After consolidation, a curing compound should be placed on the backfilled slots to reduce shrinkage. The finish of

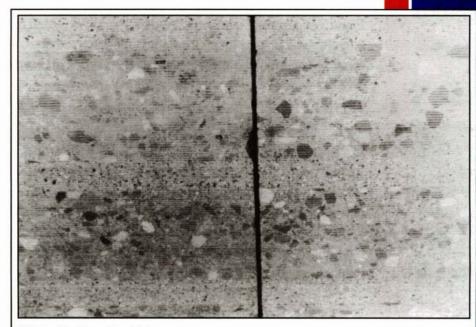
Photo 10. Completed joint.
