Pilots Give “Thumbs Up” to Smooth Runways

PL508P

The Osan Experience

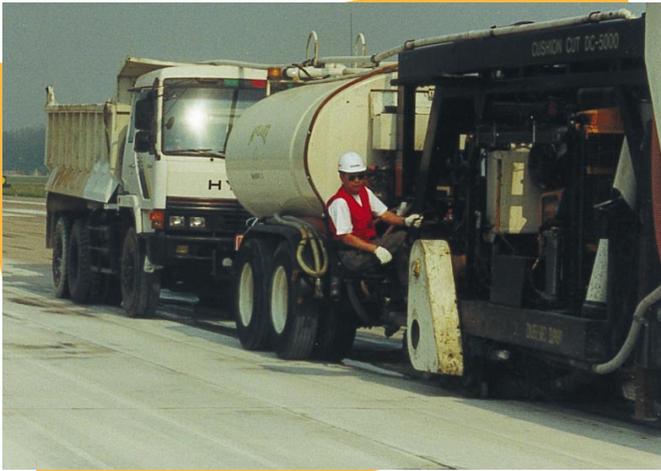
Diamond grinding restores a level profile to an otherwise strong pavement.

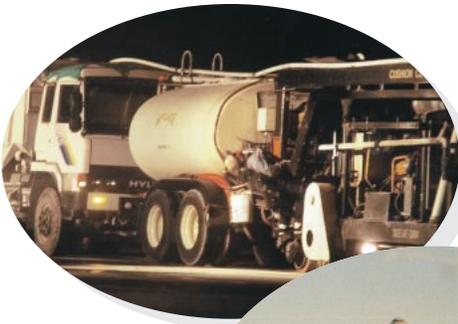
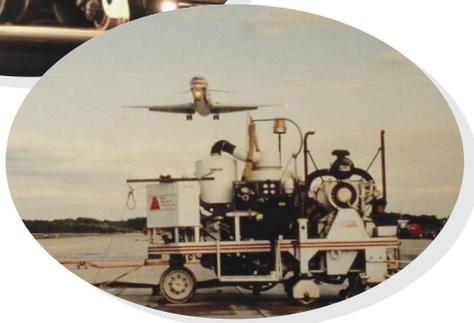
*Top: Diamond grinding under way at runway centerline
 Bottom: Patching, grinding and grooving operations took place around the clock to minimize runway down time.*

In 1999, the U. S. Army Corps of Engineers considered several options for a longer-term repair that would reduce runway roughness. Because Osan AFB has only one runway, minimum closure time was a critical priority. Replacing the most heavily damaged portion of the runway – the center 75 feet – was deemed prohibitive, for both the cost and the required downtime. The Corps decided to replace selected panels, diamond grind the center 100 feet of the entire runway, then regroove the pavement and reseal joints and cracks.

Diamond grinding on the 9000 foot long runway was completed by an ACPA contractor member within a forty day runway closure. Before and after grinding, runway roughness was measured using a California profilograph and a profile index value was calculated. Before grinding, the runway profile indices ranged from 14 up to 92 inches per mile. After grinding, every section showed at least a 70% reduction in profile index. This was a remarkable improvement as many sections came in with a profile index less than 7 inches per mile. Perhaps most significantly, the pilots are very pleased with the improved surface, citing increased control during takeoff and landing.

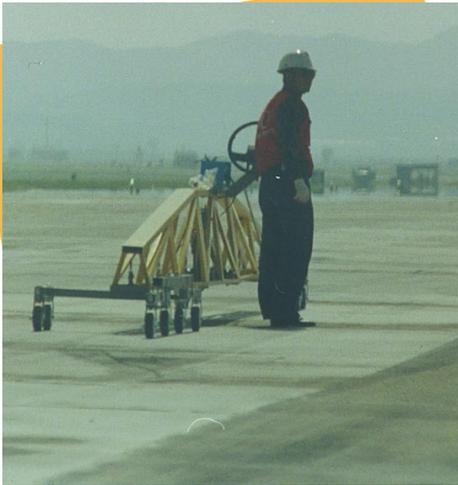
▼▼▼▼▼▼▼▼▼▼
*A California-style
profilograph recorded
smoothness before and
after grinding.*
