REPORT NUMBER: WI/SPR -11-99

# THE EFFECTS OF GRINDING ON PCC PAVEMENTS

FINAL REPORT

FINAL REPORT WI/SPR 11-99  
WisDOT Highway Research Study #92-06  
SPR #0092-45-46

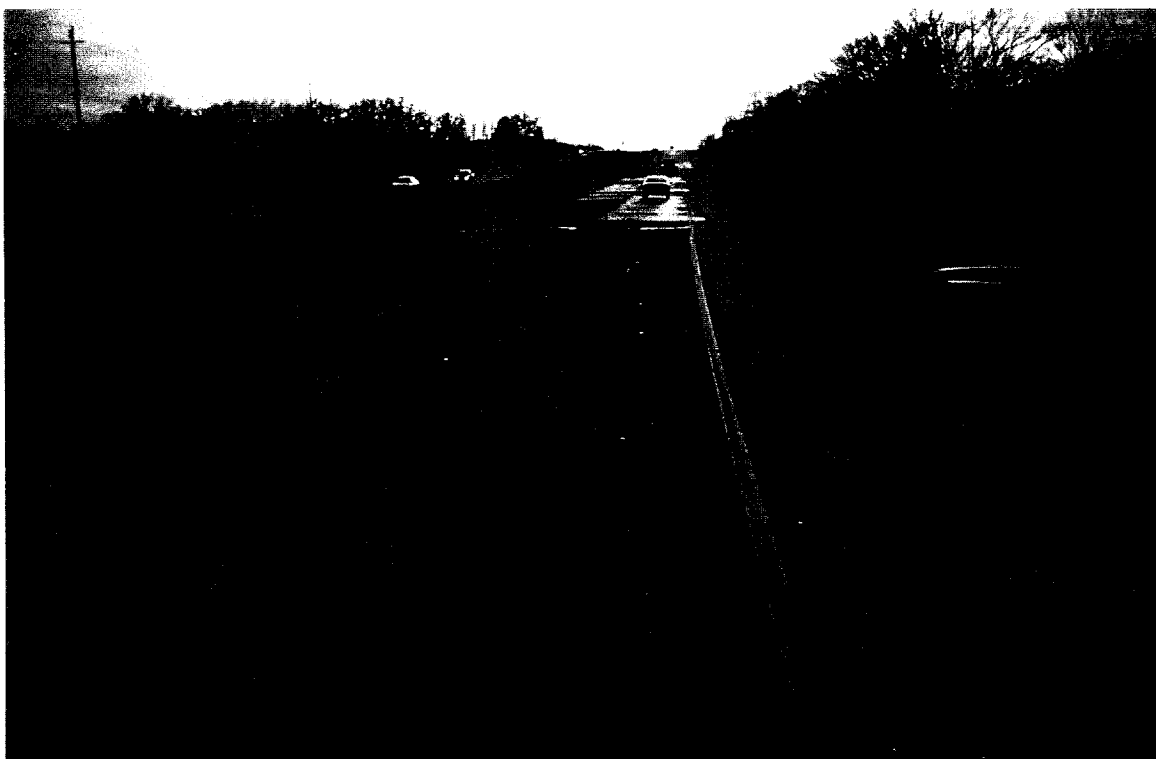
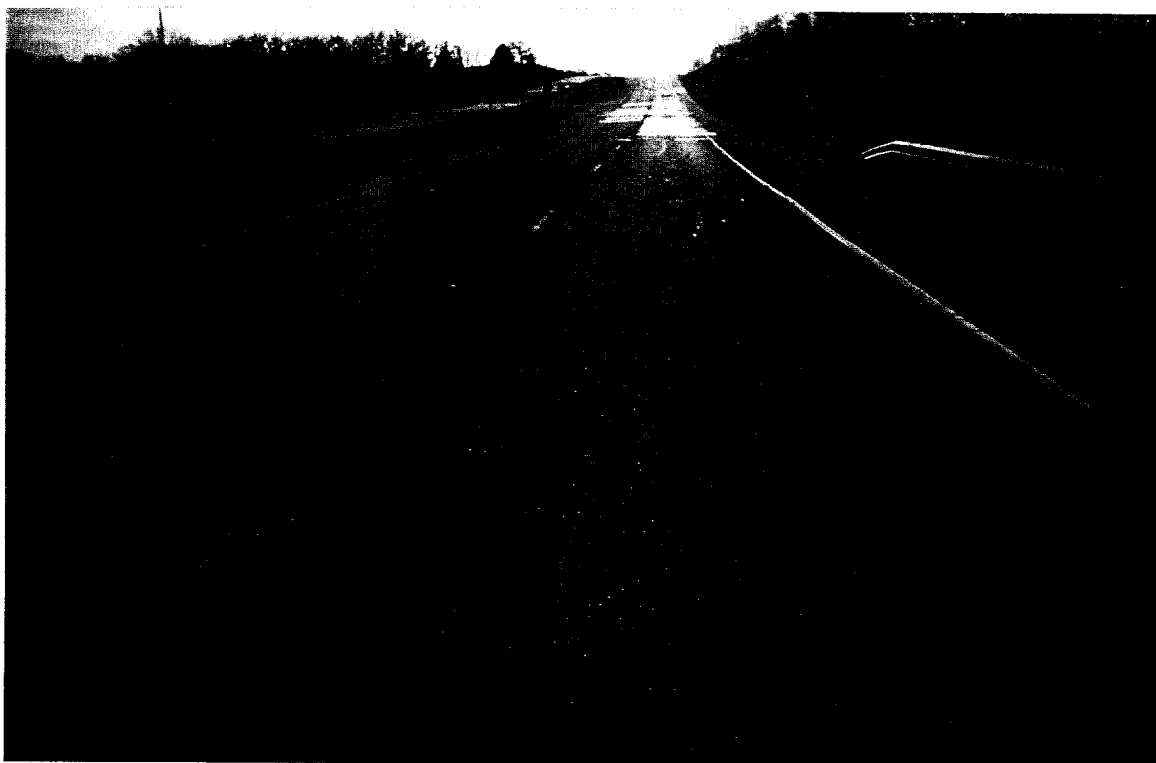
Figure 11 Photographs Showing the Solar Glare Phenomena

Spot diamond grinding affects the pavement surface appearance and its color. The ground areas could be noticed by the approaching motorists, under certain atmospheric conditions, from a relatively long distance (sometimes over 1000 feet). In freezing temperature and/or wet pavement conditions, motorists may perceive the ground areas to be icy and/or slippery patches. Also, spot ground sections may have a glaring effect (creating blinding light) through the reflection of the sun (in the afternoon) when driving in the westerly direction and/or through the reflection of the headlights (at night).

The survey results are shown on pages 37-39. According to the survey results, motorists driving neither section experienced glare from the pavement or noticed any icy spot. Although some drivers indicated that they changed lanes or slowed down as they approached the ground or non-ground areas, their action(s) was not influenced by the surface condition. Two of the many pictures taken showing the solar glare phenomena are shown in Figure 11.
